April 15, 2020

**Re: Request for Correction Under the Data Quality Act to NIST's Final Report on the Collapse of World Trade Center Building 7**

Part 1: NIST’s Computer Simulations

Part 2: NIST’s Omission and Distortion of Evidence of Explosions and Incendiaries

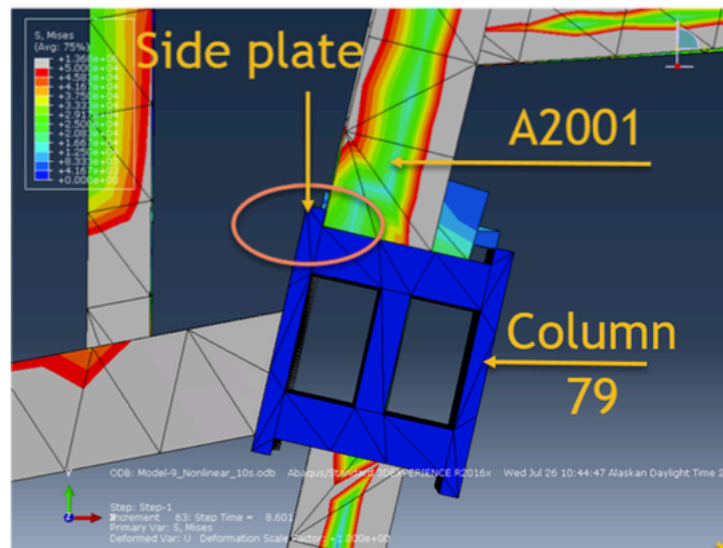
First, we found that when girder A2001 is heated, it expands such that it becomes trapped behind the side plate on the western side of Column 79 as it is pushed to the west by thermally expanded beams K3004, C3004, B3004, A3004, and G3005 (see Figure 3.4). . . .

Figure 3.4 Plan view showing girder A2001 trapped by the Column 79 side plate.

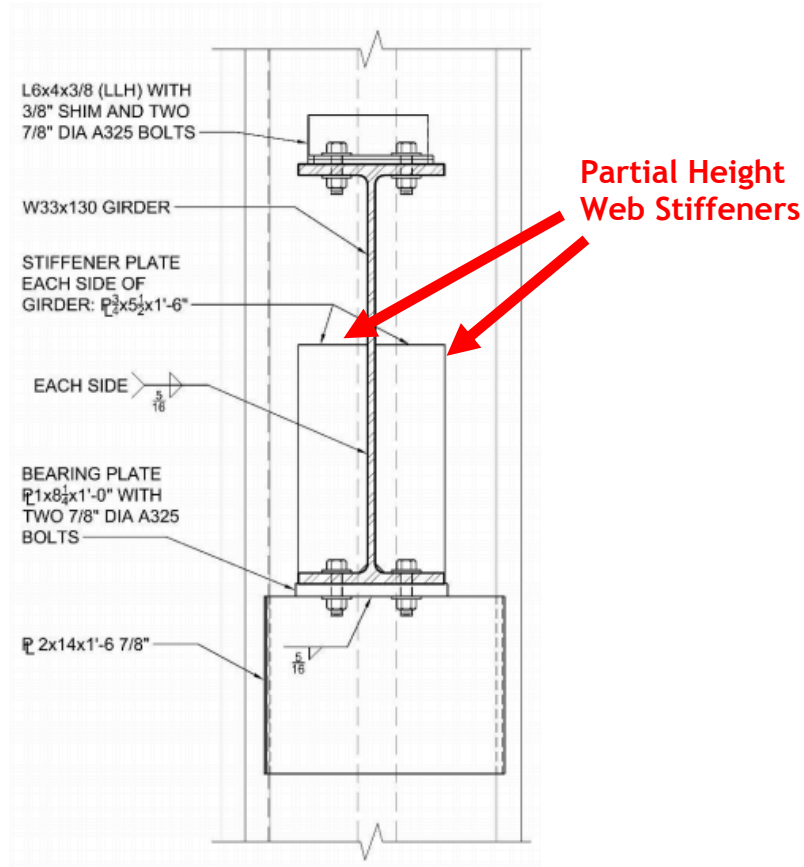
Girder A2001 had partial height web stiffeners measuring 3/4 inches thick x 5.5 inches wide x 18 inches high, as indicated in fabrication shop drawing Frankel 9114. (See Frankel Steel Limited.) These web stiffeners are drawn to scale in Figure 2 of Ronald Brookman's 2012 paper, "A Discussion of 'Analysis of Structural Response of WTC 7 to Fire and Sequential Failures Leading to Collapse'," shown below. (See Brookman 2012, p. 8.)

Figure 2: Section View at Floor 13, Column 79 Seated-Beam Connection  
(Data from Frankel Steel Limited, 1985b)

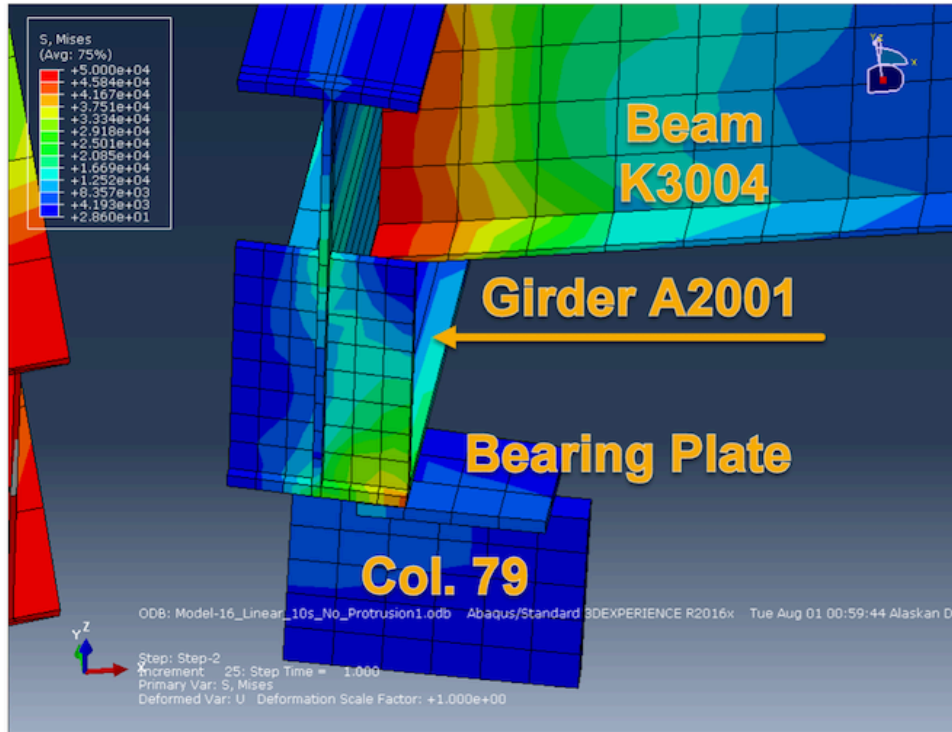
NIST's stated reason for omitting the web stiffeners from its analyses is fundamentally unsound. As noted in the UAF Report, "In addition to stiffening the web, these stiffeners significantly increase the bending resistance of the flange and would have prevented it from failing due to flexure (assuming the girder were somehow able to bypass the column side plate)." (*See UAF Report*, p. 81.) As illustrated in Figure 3.8 of the UAF Report, shown below, the stresses in the girder flange and stiffener are not sufficient to cause the flange to fail, and thus Girder A2001 would not have walked off its support at Column 79 when pushed westward 6.25 inches. (*See UAF Report*, p. 82.)

Figure 3.8 Analysis showing girder web A2001 pushed laterally past the bearing seat at Column 79. The column is removed for clarity.

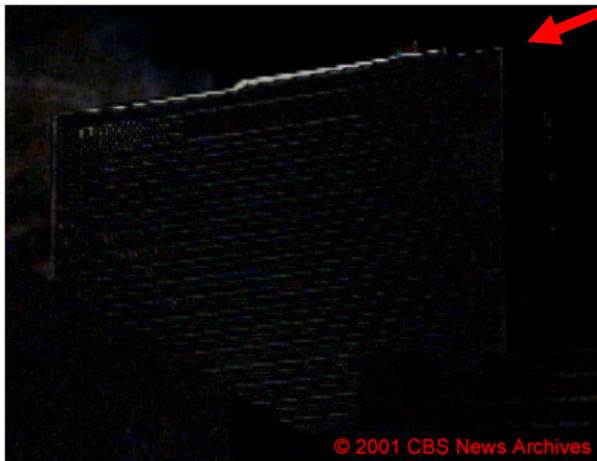
**Absence of white at corners indicates no deformation or displacement of upper exterior corners.**

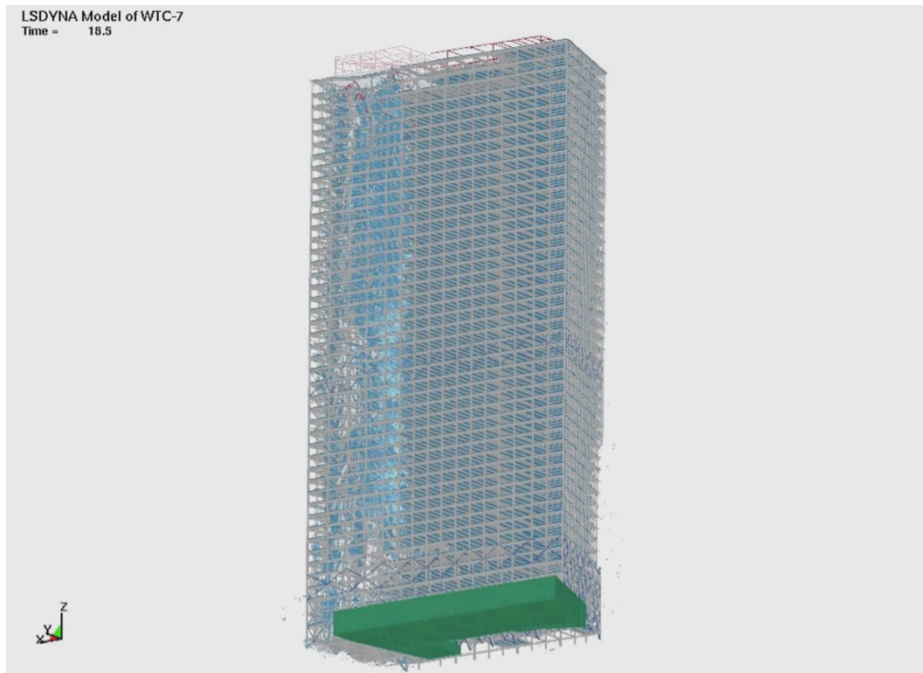
Meanwhile, as noted above, the NIST global collapse analysis predicts significant deformation of the upper exterior walls *both before and after the initiation of global collapse*. The four figures below illustrate the increasing deformation of the upper exterior walls predicted in NIST’s global collapse analysis at four different points in time by overlaying each animation frame on top of the animation frame just before the initiation of the east penthouse collapse (which is at 16 seconds in NIST’s global collapse analysis animation). 2.5 seconds is where the first deformation of the exterior appears; 6.3 seconds is the time that NIST identifies as the initiation of global collapse in its global collapse analysis; 7.5 seconds is the time examined in the figures above, when the upper exterior corners had still experienced no deformation or displacement; 8.1 seconds is the final frame in the global collapse analysis. NIST claims in NIST WTC 7 FAQ #35 that **“Only in the later stages of the animation, after the initiation of global collapse, do the upper exterior wall deformations from the NIST analysis differ from the video images.”** (Emphasis added.) That claim is false, as shown in the first two figures below.

Figure 1: NIST's global collapse analysis at 2.5 seconds after the initiation of the east penthouse collapse laid over .1 seconds before the east penthouse collapse initiation.

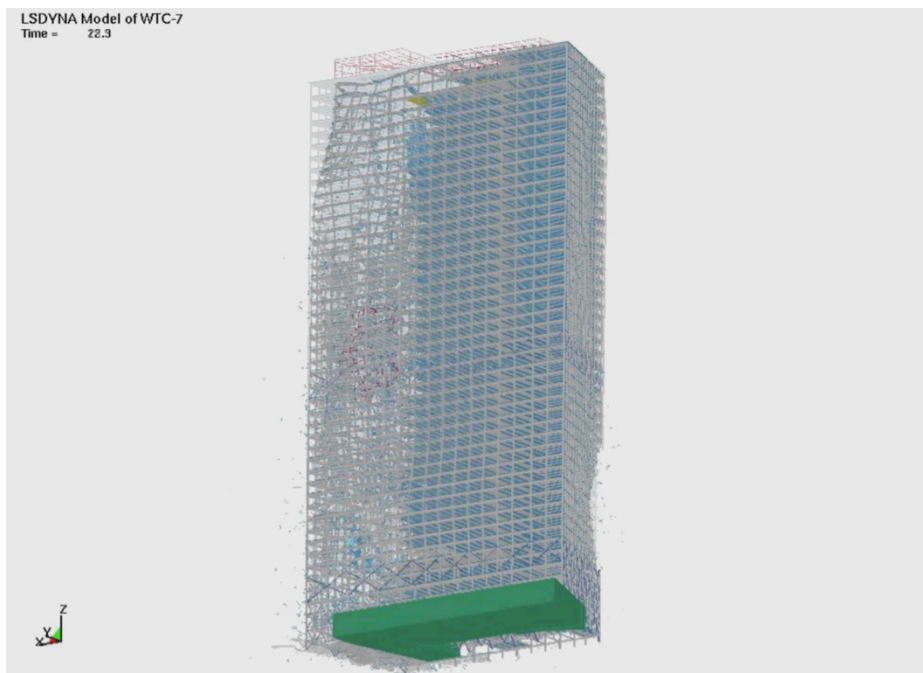
Figure 2: NIST's global collapse analysis at 6.3 seconds after the initiation of the east penthouse collapse laid over .1 seconds before the east penthouse collapse initiation. 6.3 seconds is the time that NIST identifies as the initiation of global collapse in its model. Therefore, substantial deformation of the upper exterior walls occurred prior to the initiation of global collapse in NIST's global collapse analysis.

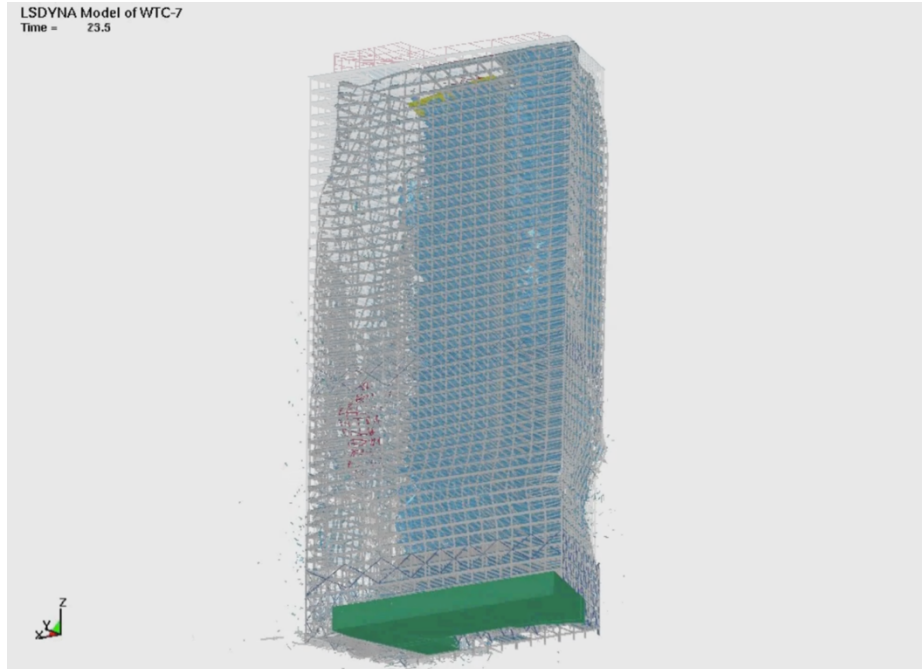
Figure 3: NIST's global collapse analysis at 7.5 seconds after the initiation of the east penthouse collapse laid over .1 seconds before the east penthouse collapse initiation. This is the time when, in the video, the upper exterior corners had still experienced no deformation or displacement.

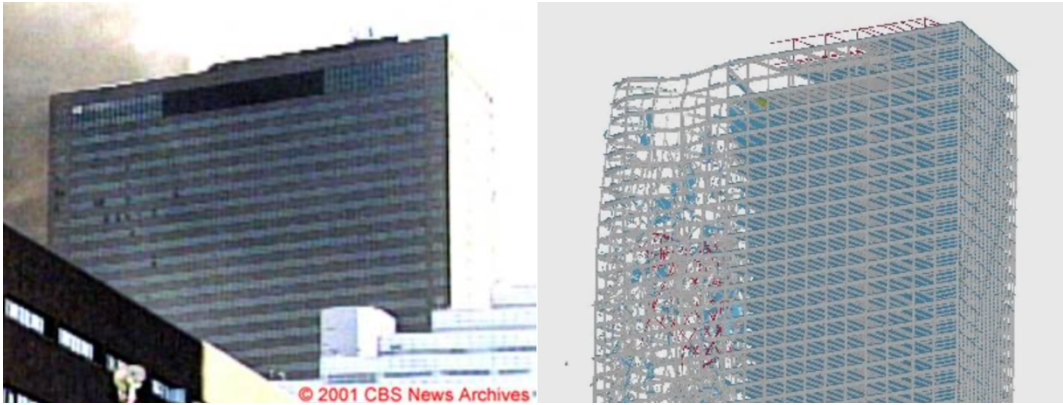
collapse. The video stills are taken from Figures 5-199, 5-200, and 5-202 of NCSTAR 1-9. The global collapse analysis animation frames are cropped and scaled to approximate the scale of the video stills, and their timing aligns perfectly with the timing of the video stills.

Figure 5: Video and analysis animation at 5 seconds after initiation of east penthouse collapse.

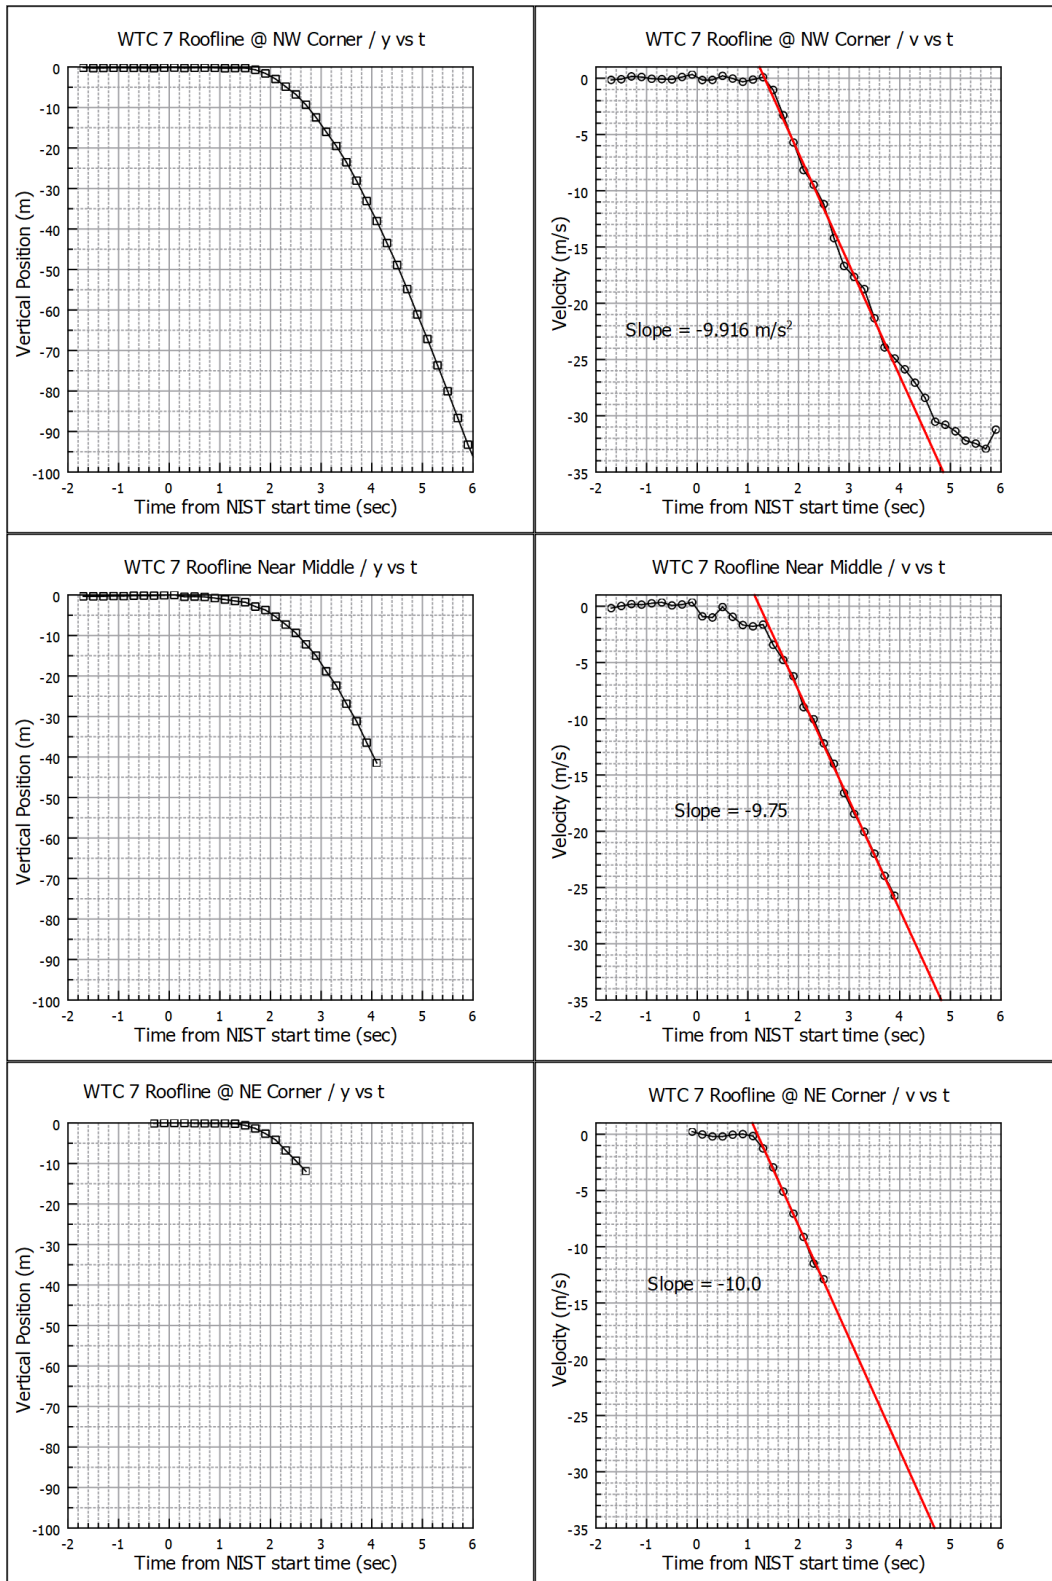
Careful measurement by physicist and researcher David Chandler using the video that NIST labeled as Camera 2, which has a line of sight approximately level with the roofline, shows that a point near the center of the roofline did indeed begin to move downward at about 6.9 seconds after the east penthouse collapse initiation, but that the northeast and northwest corners of the roofline did not begin to move downward until about 8.2 seconds after the east penthouse collapse initiation. Chandler’s measurement is corroborated by Figure 5-201 of NCSTAR 1-9 above, which shows a slight displacement at the middle of the roofline and zero displacement of the upper exterior corners 7.5 seconds after the east penthouse collapse initiation. Figure 9 below presents the downward displacement and downward velocity of the north face roofline versus time at the northwest corner, middle, and northeast corner of the roofline. In the time axis, zero represents NIST’s initiation of global collapse, which is 6.9 seconds after the east penthouse collapse initiation.

Figure 9: Left: Displacement versus time of north face roofline at northwest corner, middle, and northeast corner. Right: Velocity versus time of north face roofline at northwest corner, middle, and northeast corner.

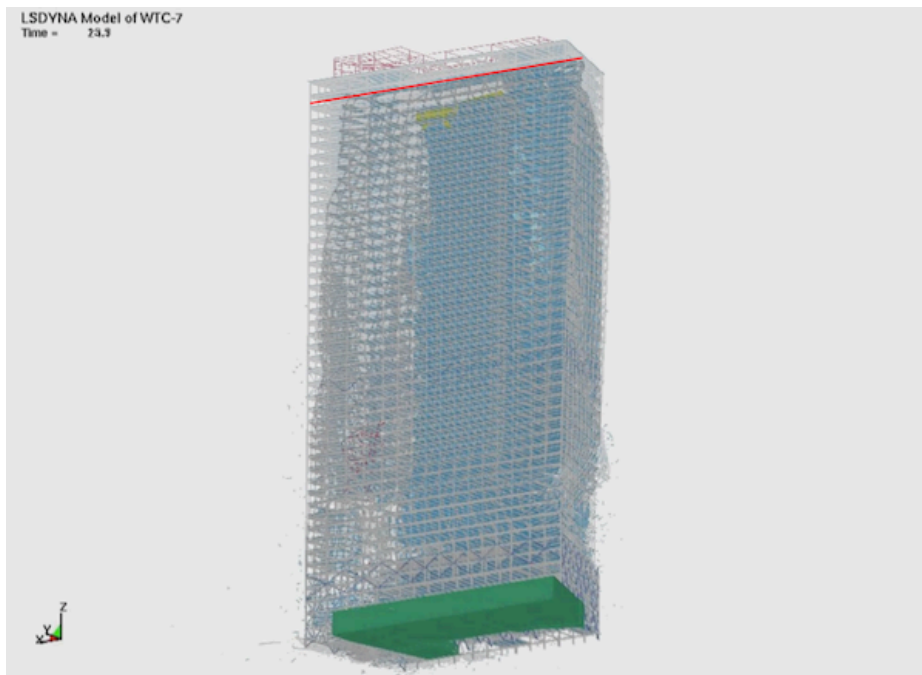
In fact, the animation of NIST’s global collapse analysis shows neither a 1.75-second period in which the north face descended approximately 2.2 meters (NIST’s inaccurate observation), nor a 1.2-second period in which the middle of the roofline descended approximately 1.5 meters (Chandler’s observation), nor the sudden transition to free fall of the entire roofline (Chandler’s observation). Rather, as shown in Figure 10 below, NIST’s model shows a highly deformed roofline descending approximately one and a half stories (approximately 6 meters) during the 1.8 seconds from the initiation of global collapse (6.3 seconds after the east penthouse collapse initiation in NIST’s global collapse analysis) to the termination of the model (8.1 seconds after the east penthouse collapse initiation). This amount of displacement is significantly greater than the initial displacement observed by both NIST and Chandler just prior to the onset of free fall.

Figure 10: Roofline in NIST’s global collapse analysis descends ~1.5 stories (~6 meters) in 1.8 seconds.

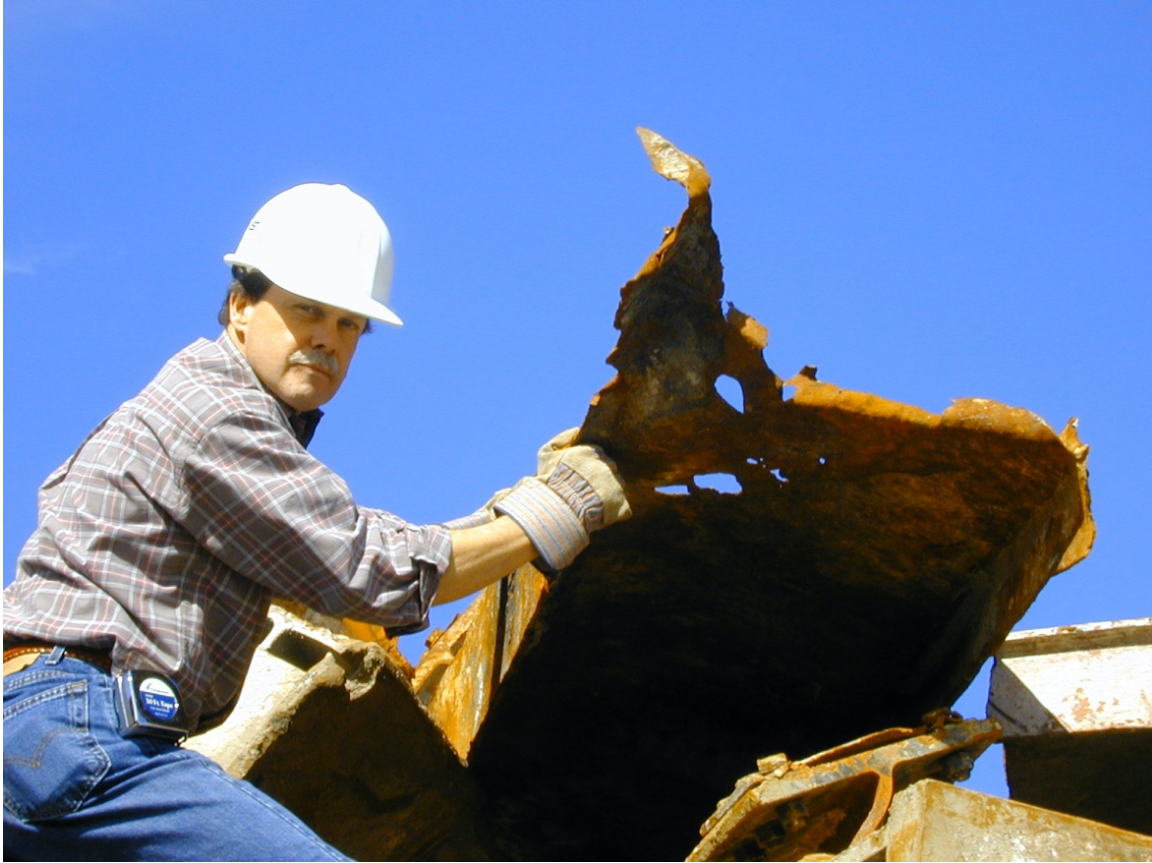
Figure 17: NIST’s John Gross next to the severely eroded WTC 7 steel member during the FEMA investigation.
