Large Plane Impact Damage to the Wall of the Pentagon and Adjacent Objects

By David Chandler and Wayne Coste¹

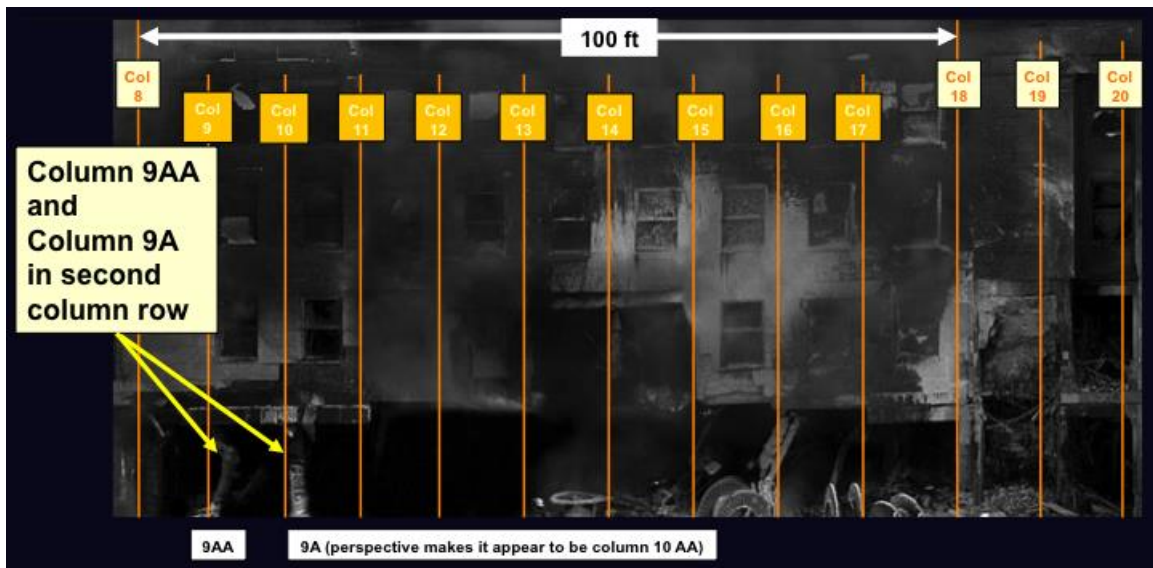
The opening in the Pentagon's outer wall extends from column 8 to 18. The columns are 10 ft apart, so overall the opening is approximately 100 ft. The 100 ft width of the opening rules out a small plane or a missile. Furthermore, a missile would be expected to punch a small hole then explode, producing focused blast damage centered at the point of detonation. No evidence for this kind of damage is found.

Figure 2: This is a composite photograph, which introduces some distortions. Column 9A is actually behind Column 9AA, as shown in Figure 3.

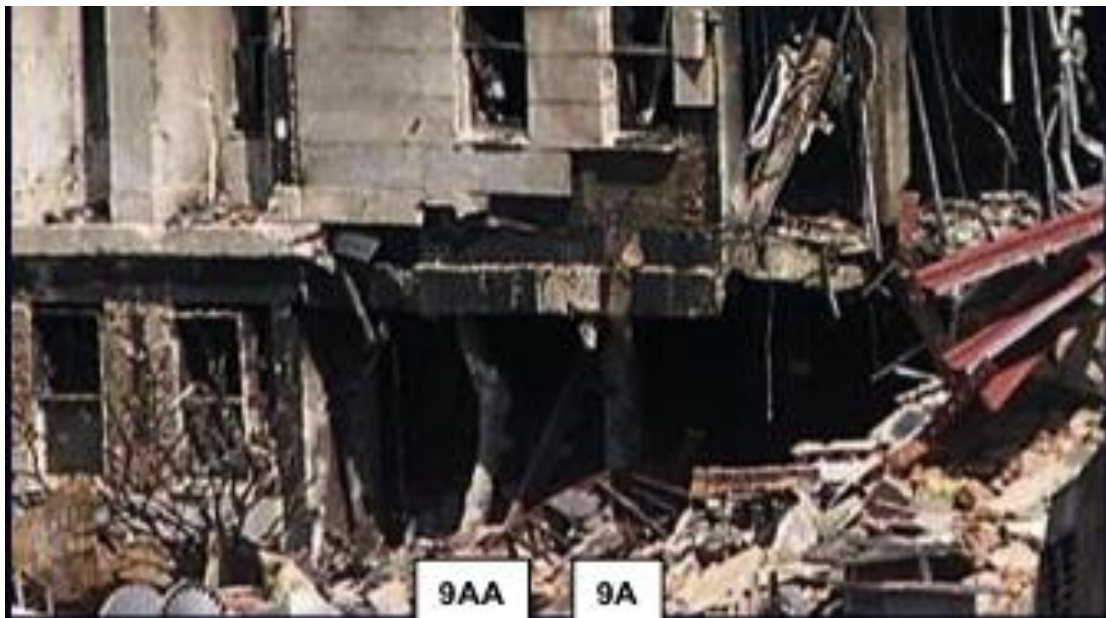
Within the open region, Column 9AA survived, largely stripped of its concrete and bowed inward. This indicates a heavy impact from the outside, but falls short of complete column failure.

Figure 3: The inward bowing of column 9AA is a clear sign of impact.

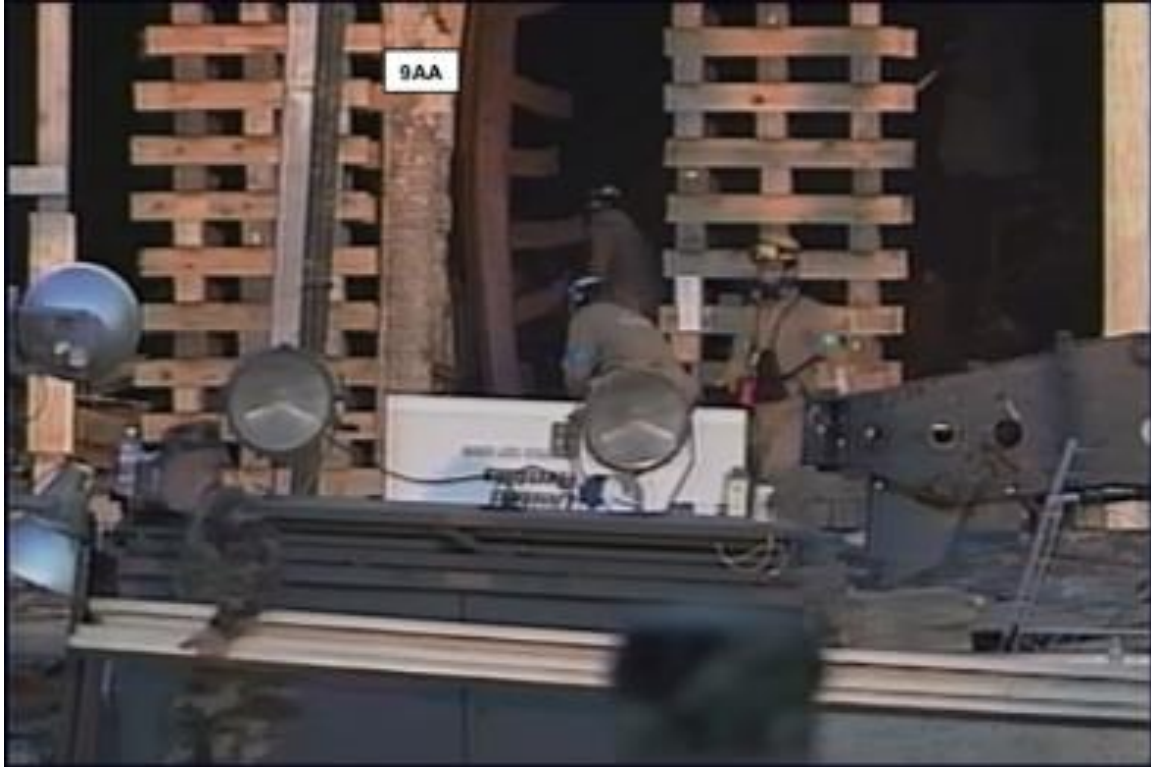
Just to the right of Column 9AA is a section of 8-inch steel tubing, attached top-and-bottom to the floor slabs, with several steel plates (“fingers”) that originally pointed outward used to hold the blast-resistant windows that were installed during the Pentagon renovation. The fingers, bolted to the

window frame, were rotated through a large angle, as the window was pushed inward, twisting the steel tubing.

Figure 4: Note the steel "fingers" attached to the 8-inch square steel tubing. These originally pointed outward toward the lawn to hold a heavy blast-resistant window.

A bowed column requires an impact by something with sufficient mass and energy to produce the observed damage but insufficient to break it. The direction of twist of the steel tubing is consistent with the left wing impacting the window and twisting the tubing as the wing is dragged into the Pentagon by the air frame.

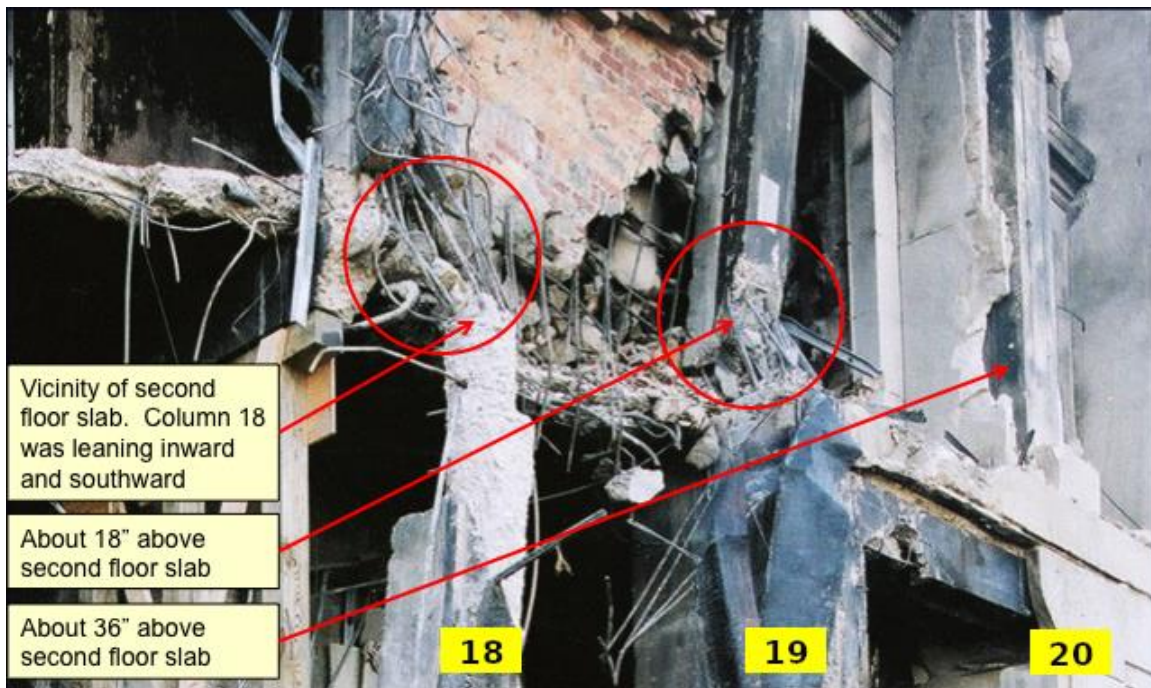
To the right of Column 18, on the exterior of the building, there is surface damage that extends to Column 20.

Figure 5: The outer part of the right wing of the plane, angled upward to the right, impacted Columns 18, 19, and 20.

The strength of the second-floor slab, hit edge-on by the wing, explains why Column 18 was not destroyed. The damage continues along a sloped line through Column 19 and 20. Column 19 is hit just above the slab and Column 20 sustained minor damage a little higher, in line with the other two impact points. This external surface damage, with inward displacement, is a clear sign of impact. It could not have been caused by internal explosions. We propose that the damage was caused by the outer end of the right wing of a large plane which hit the wall and then was dragged into the building around Column 18.

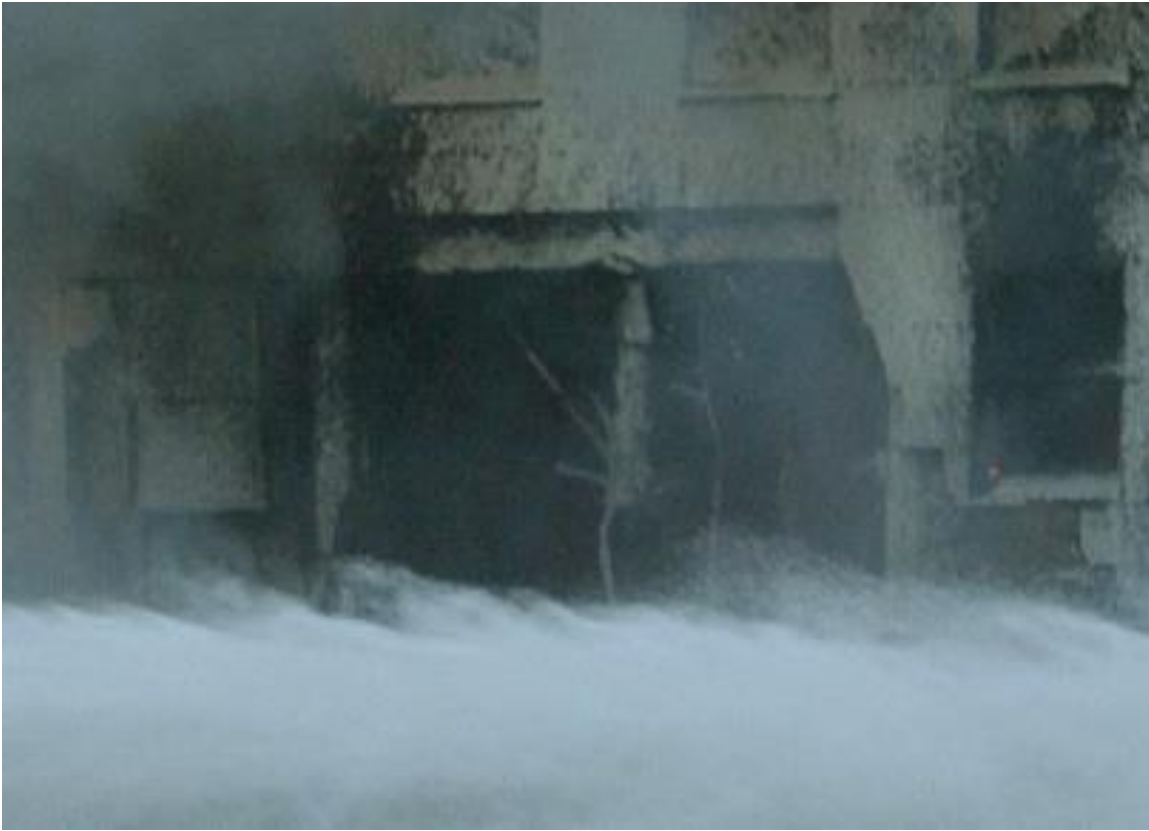
The two wall panels on the second floor centered on Column 14 are missing. The width of the opening is 20 ft minus the half-widths of the adjacent columns. The first questioning of the official narrative of the Pentagon strike was the book, *9/11: The Big Lie (L'Effroyable imposture)*, by Thierry Meyssan which presented this second floor opening as the full extent of the hole in the Pentagon wall, concluding that the hole was too small for a large plane.

Figure 6: The highly misleading "small opening in the wall" at Column 14 on the second floor.

and the second-floor section of Column 14 (shown in Figure 6) is badly damaged, detached at the bottom, and dangling by its rebar.

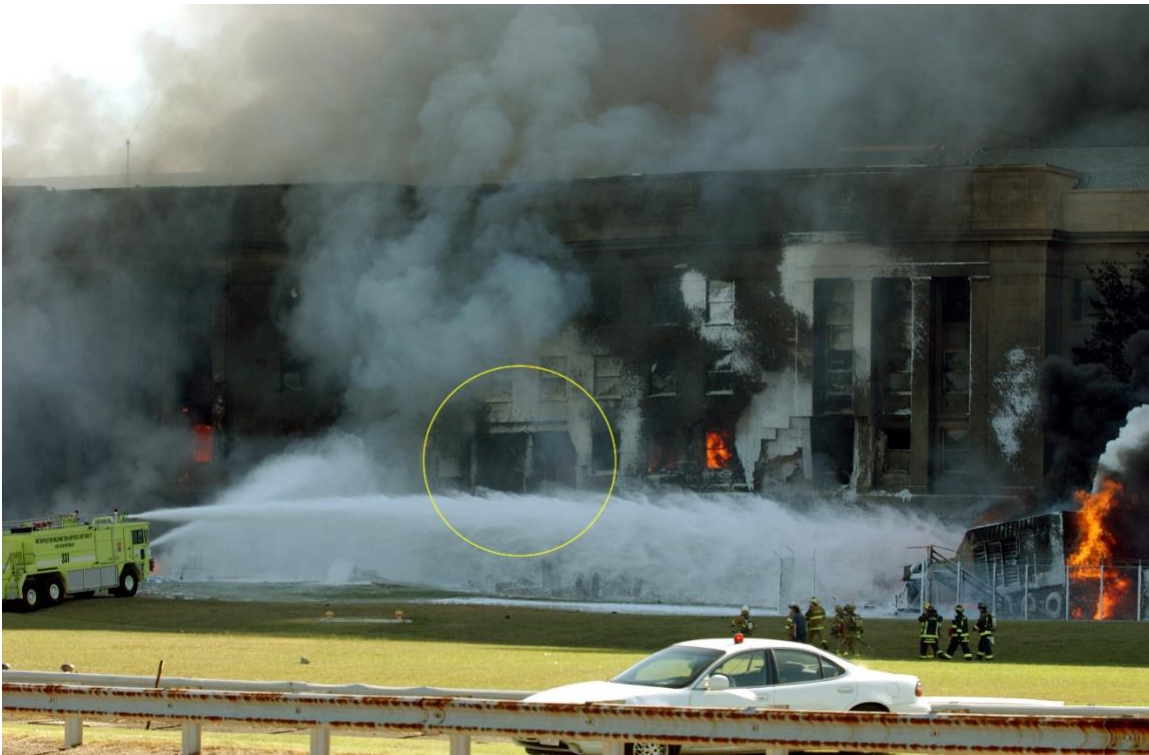
Figure 7: Jason Ingersol photograph from which the small second-floor opening was cropped. The first-floor damage is obscured by fire hose spray.

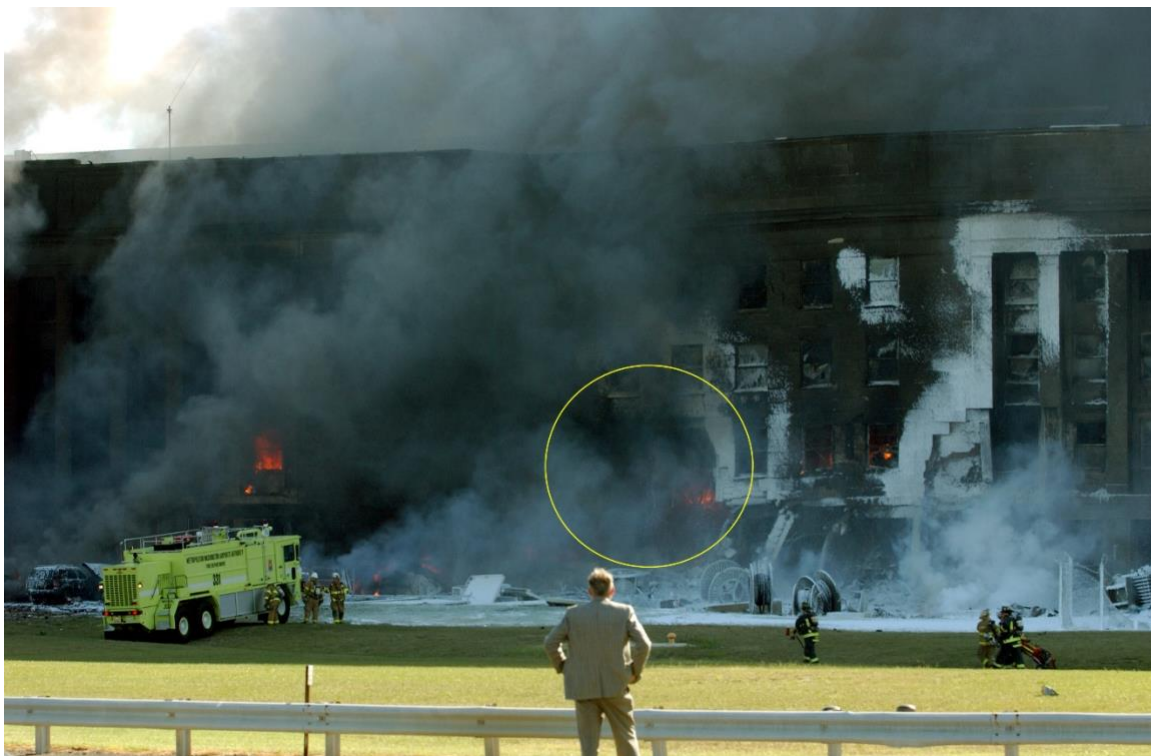
However, the same photographer, a few frames later, presumably on the same roll of film, took two other photos that show large portions of the first-floor damage, but Meyssan did not show these photographs. That omission is the basis of the long-standing meme in the 9/11 Truth Movement that “the hole was too small.”

Figure 8: Jason Ingersol photo showing the extensive damage to the first floor. The "small opening" of the cropped image is hidden behind smoke, above and slightly to the right of the spectator's head. For reference, the large slanted column on the first floor is Column 16.

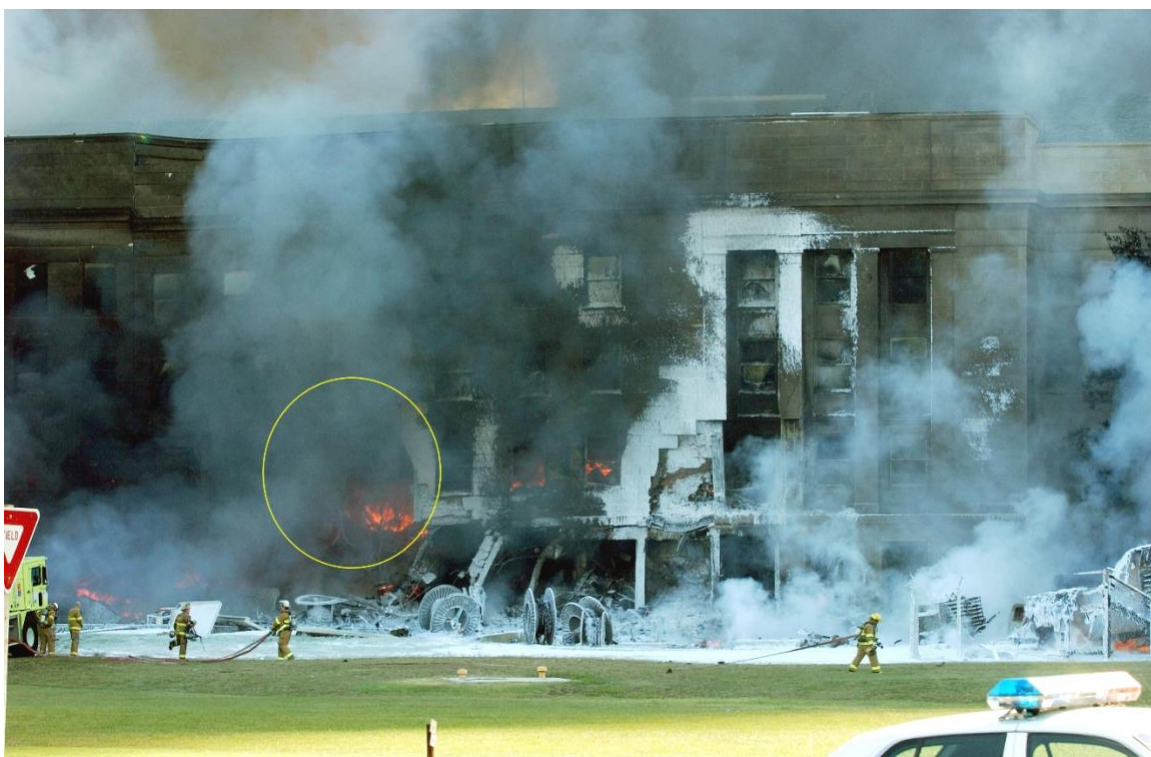
Figure 9: Another Jason Ingersol photo showing the extensive damage on the first floor. The "small opening" is engulfed in flames.

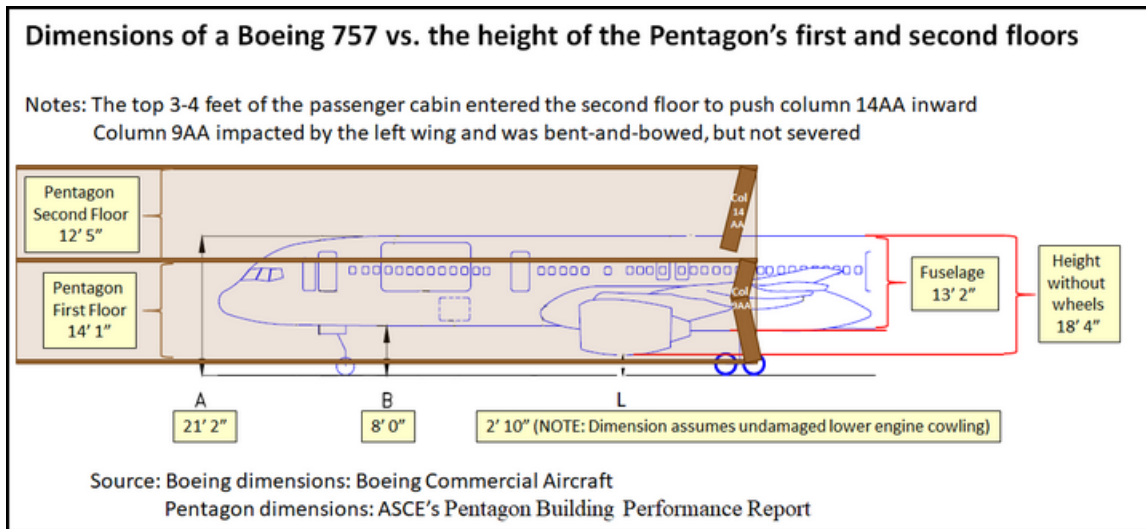
The nose of the plane impacted the ground floor near Column 14. The fuselage does not quite fit into the ground floor, causing it to overlap into the second floor. This impact severely damaged the second-floor slab at this point.

Figure 10: The two shaded columns represent Column 14AA on the second floor, impacted by the fuselage, and Column 9AA, impacted by the left wing.

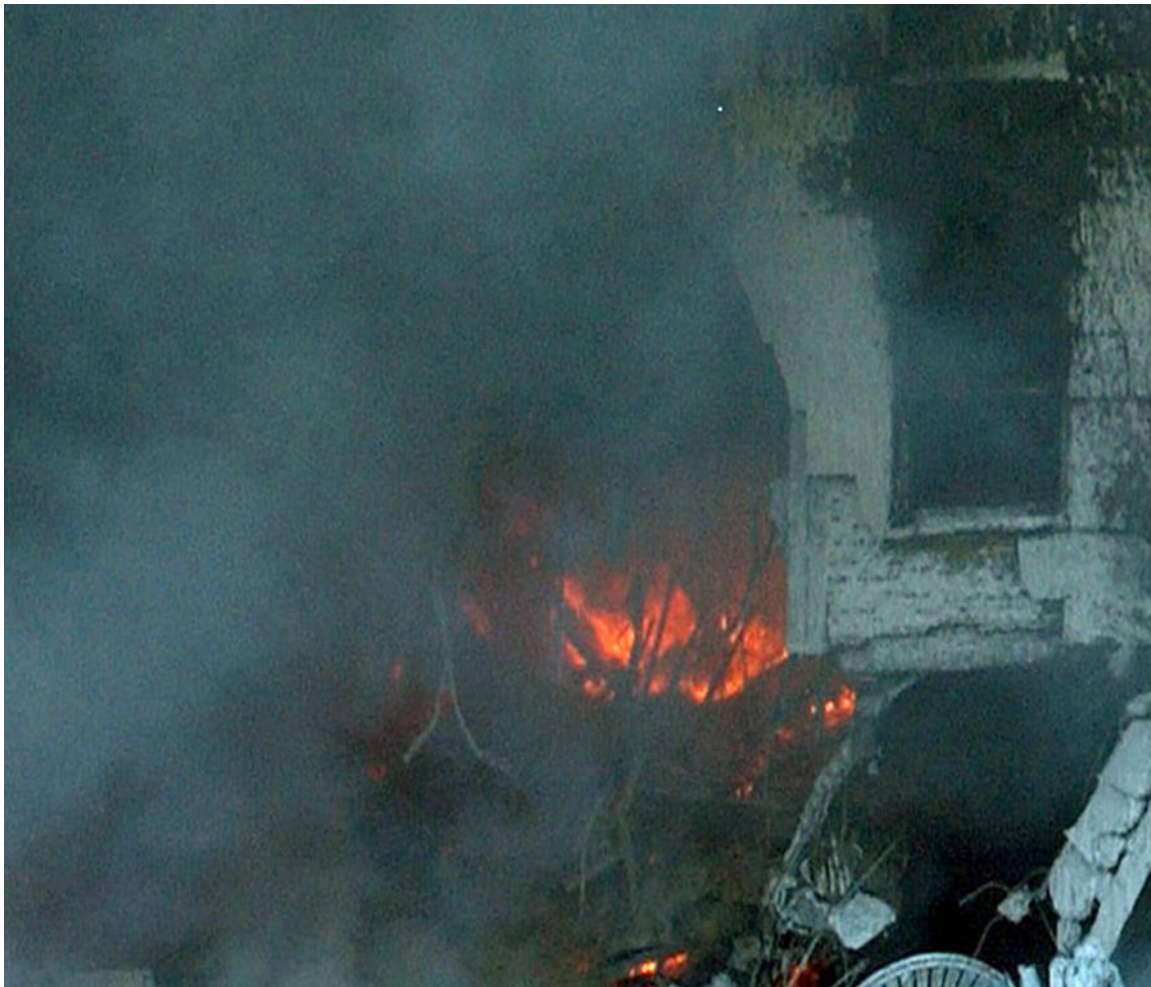
Fire can be seen where the second-floor slab should be, near Column 14, ...

Figure 11: Fire is visible where Column 14 should have been attached to the second-floor slab, proving the slab was missing and the column was detached.

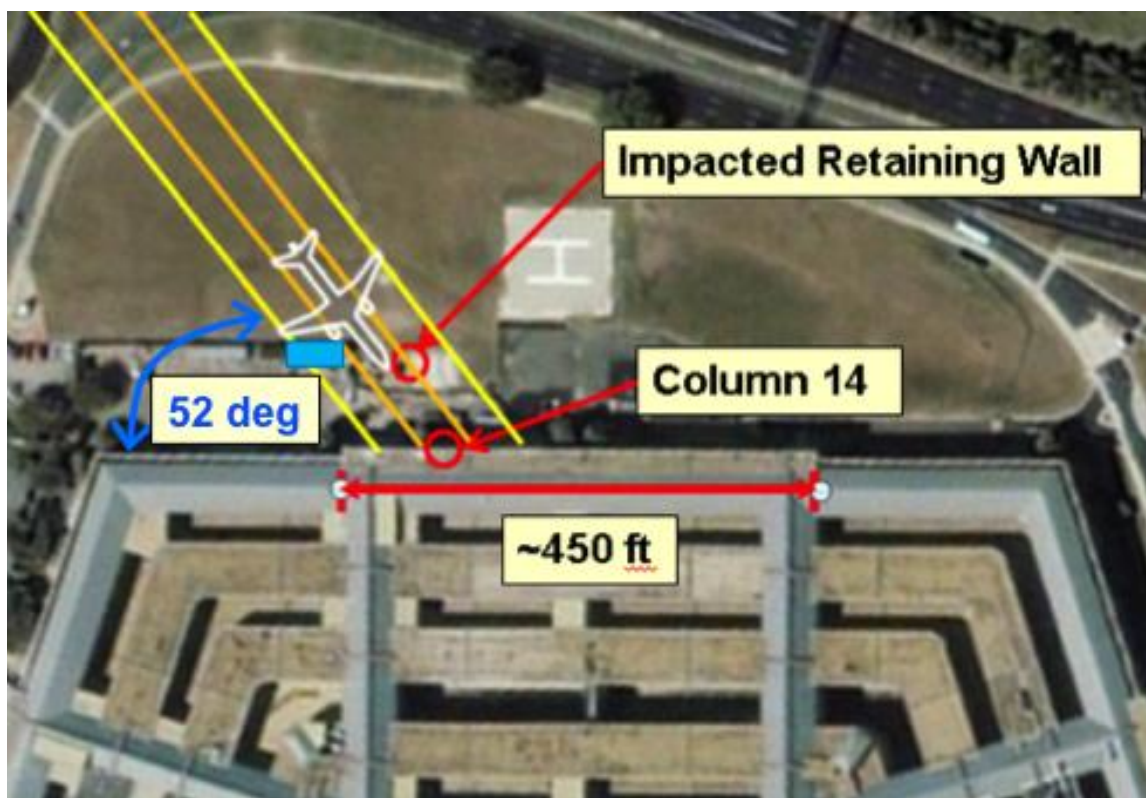
Just outside the Pentagon wall, the incoming plane impacted a diesel generator trailer, surrounded by a chain link fence, a concrete retaining wall, and a tree.

Figure 12: Plane impact path.

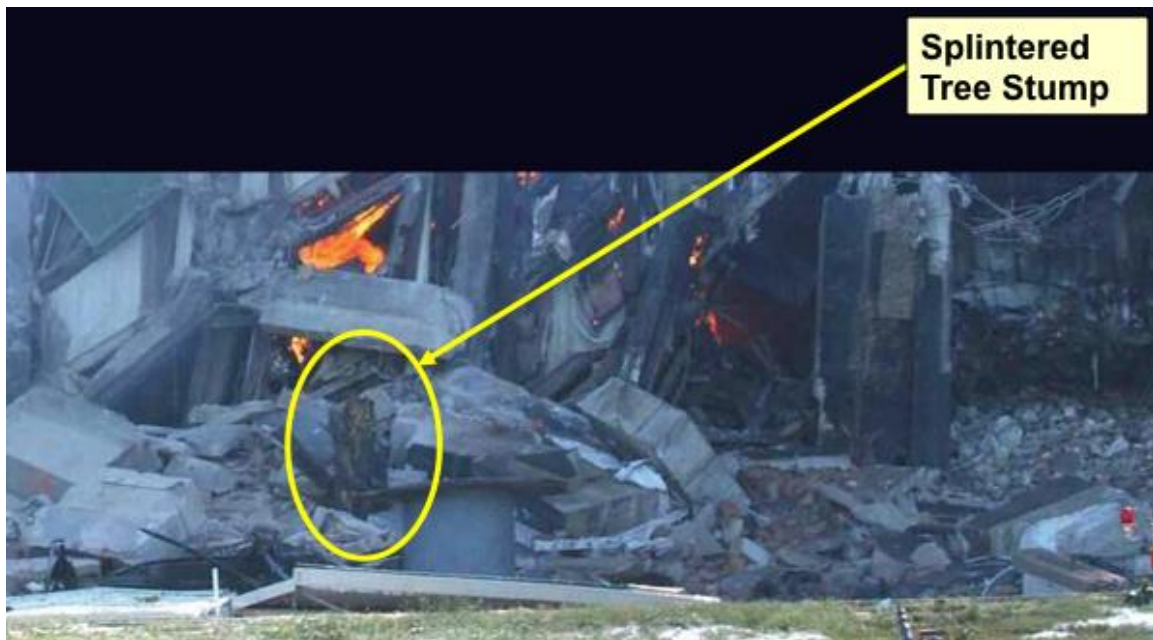
A large tree was present in front of Column 16. It is visible in prior photography and the shattered stump is visible in the rubble. The height of the stump is consistent with the height of the right wing spar.

Figure 13: The stump from the tree in front of Column 16 shows that the trunk was literally torn off.

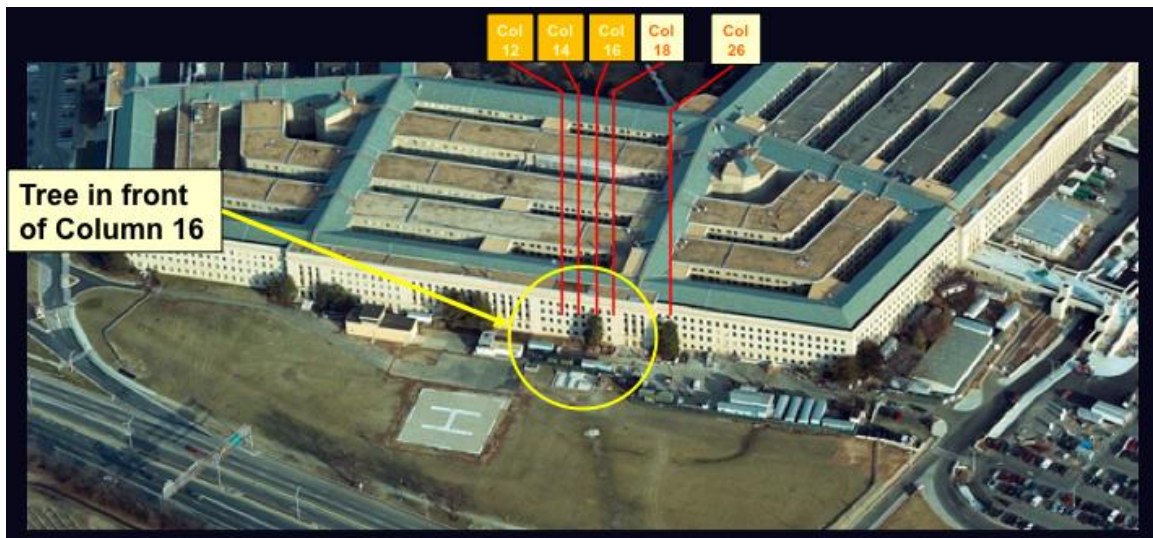
Figure 14: A large tree is present just to the right of the center of impact.

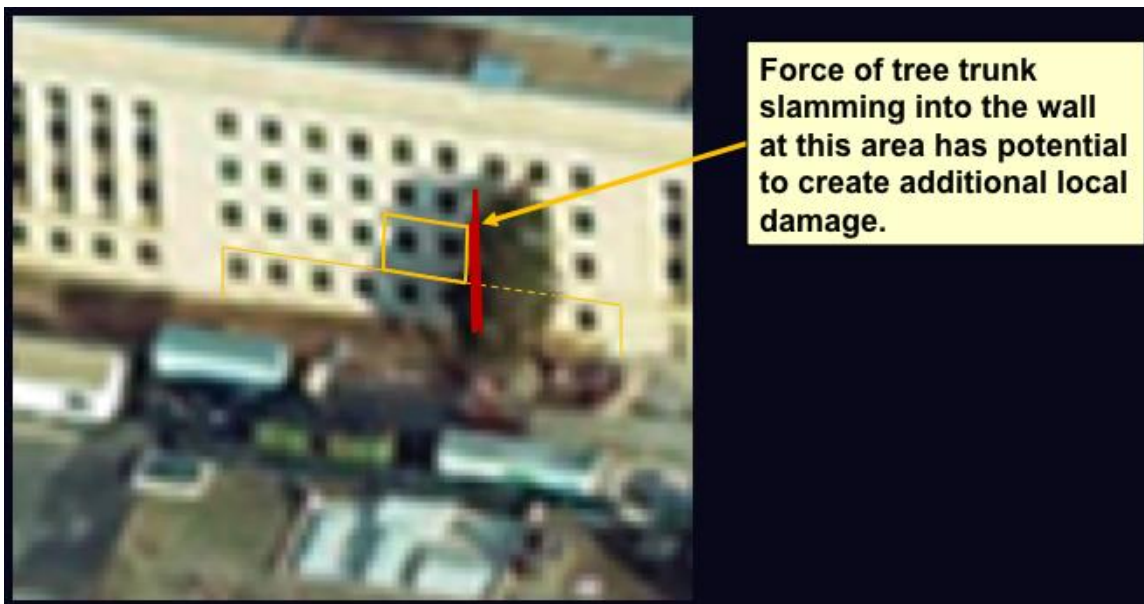
The direction of motion of the plane, coming in at a 52° angle, would tend to throw the tree northward and into the Pentagon wall. The tree could be the cause of much, if not most, of the second-floor damage near Column 14.

Figure 15: The tree is pushed into the building and northward (leftward) along the wall, which could help account for the elimination of the second-floor wall panels in the vicinity of Column 14.

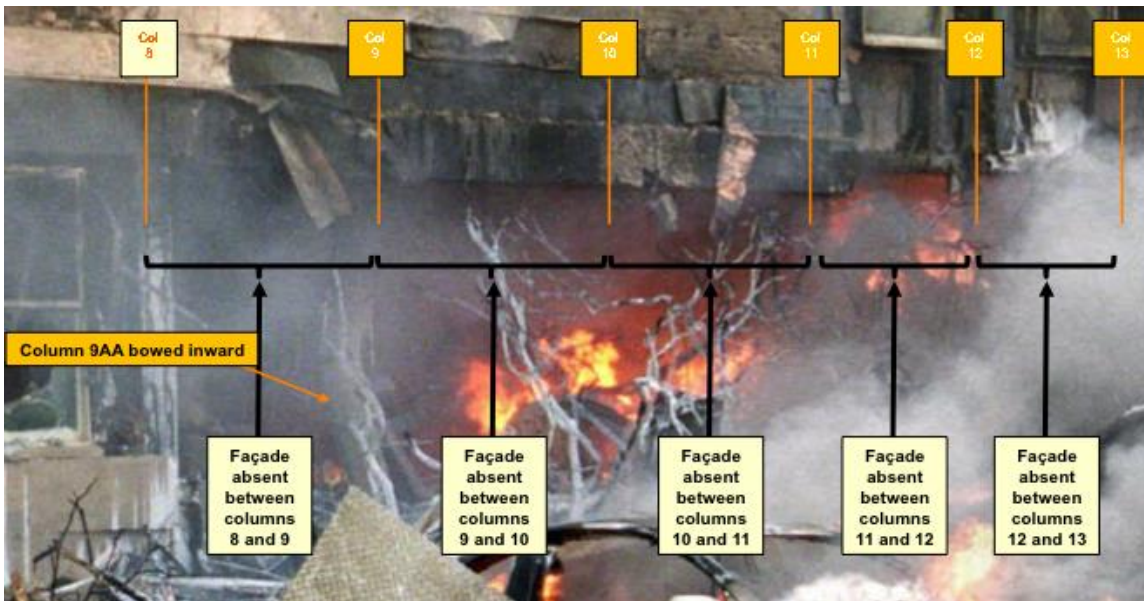
The tree was thrown base-first and landed northward along the Pentagon wall. Tree branches litter the lawn.

Figure 16: A number of photographs show the tree lying parallel to the Pentagon wall, with the base to the left and branches rising up.

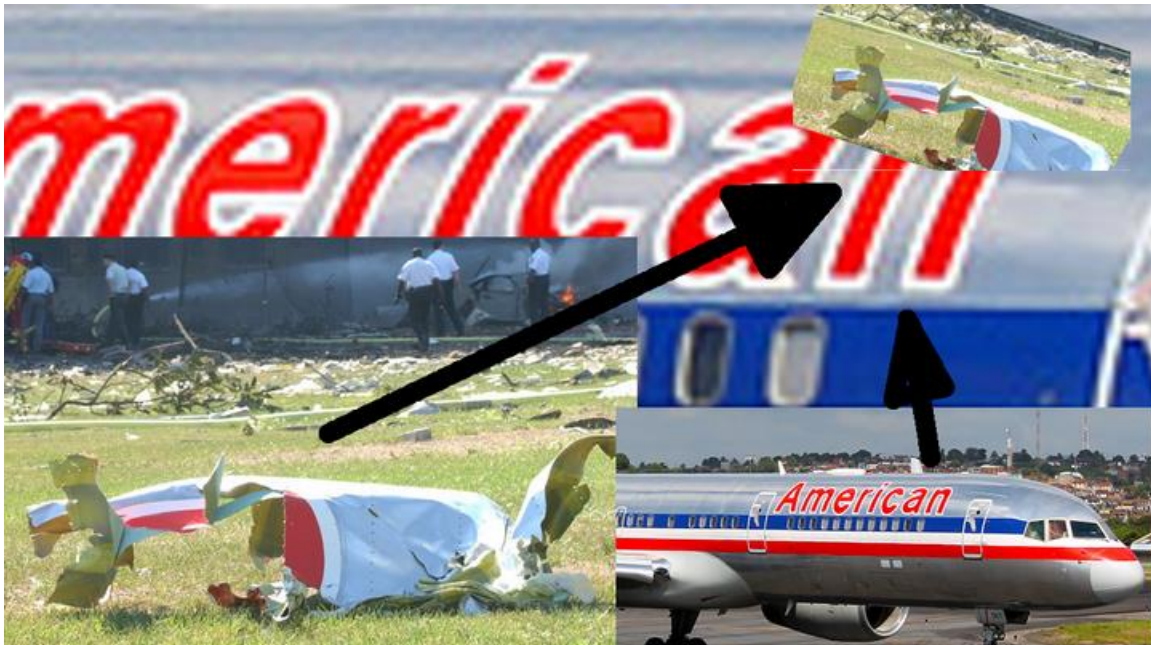
Interestingly, to land as it did, the trunk would have to have torn through the fuselage of the plane. One piece of direct evidence that this actually happened is that a sheet of aluminum, found to the north of the plane’s path, can be identified as coming from the right side of the fuselage. Most of the fuselage went directly into the building. The fact that this piece landed to the north on the lawn is evidence that

something tore it from the plane and threw it northward. A section of the overhead luggage rack (not shown) was also found on the lawn.

Figure 17: A piece of fuselage wall from the right side of the plane, was torn out by the northward moving tree trunk and landed to the north on the lawn.

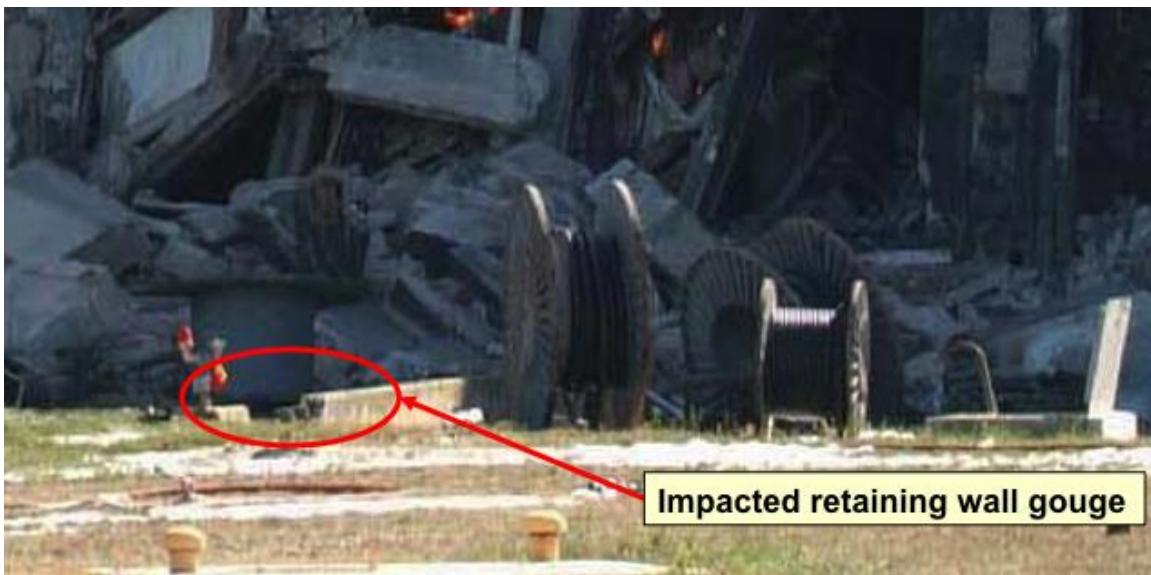
A notch in a low concrete retaining wall locates the left engine of the incoming plane. The left engine appears to have dipped to just above ground level at that point.

Figure 18: The notch in the retaining wall locates where the left engine nearly touched the ground. The wing was sufficiently high to pass over the cable spools.

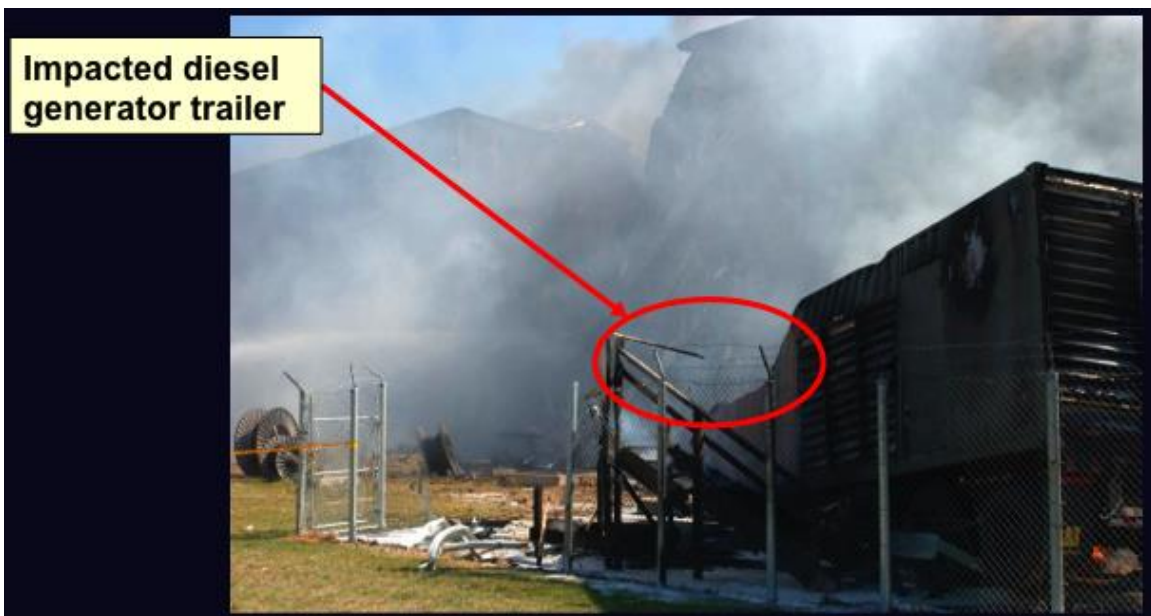
The damage to a massive generator trailer locates the right engine. Note also that the chain link fence that surrounded the generator trailer is torn away in the vicinity of the damage to the trailer, but not elsewhere. The selective tearing away of the chain link fence is evidence for impact rather than explosions or fire, as some have proposed.

Figure 19: The generator trailer was gouged and rotated toward the Pentagon. This impact caused the plane to roll to the left and rotate around a vertical axis.

The generator trailer was rotated toward the building, which is a clear indication of a heavy impact. This could not have been accomplished with an explosion. The distance from the retaining wall to the generator trailer damage, measured perpendicular to the flight path, is 42 ft, which is the spacing of the engines on a Boeing 757. The right engine would have hit the generator trailer first. This would have caused the plane to roll leftward, bringing the left engine into contact with the retaining wall. It would also apply a retarding force to the right side of the plane causing a clockwise rotation about a vertical axis which would rotate the tail northward.

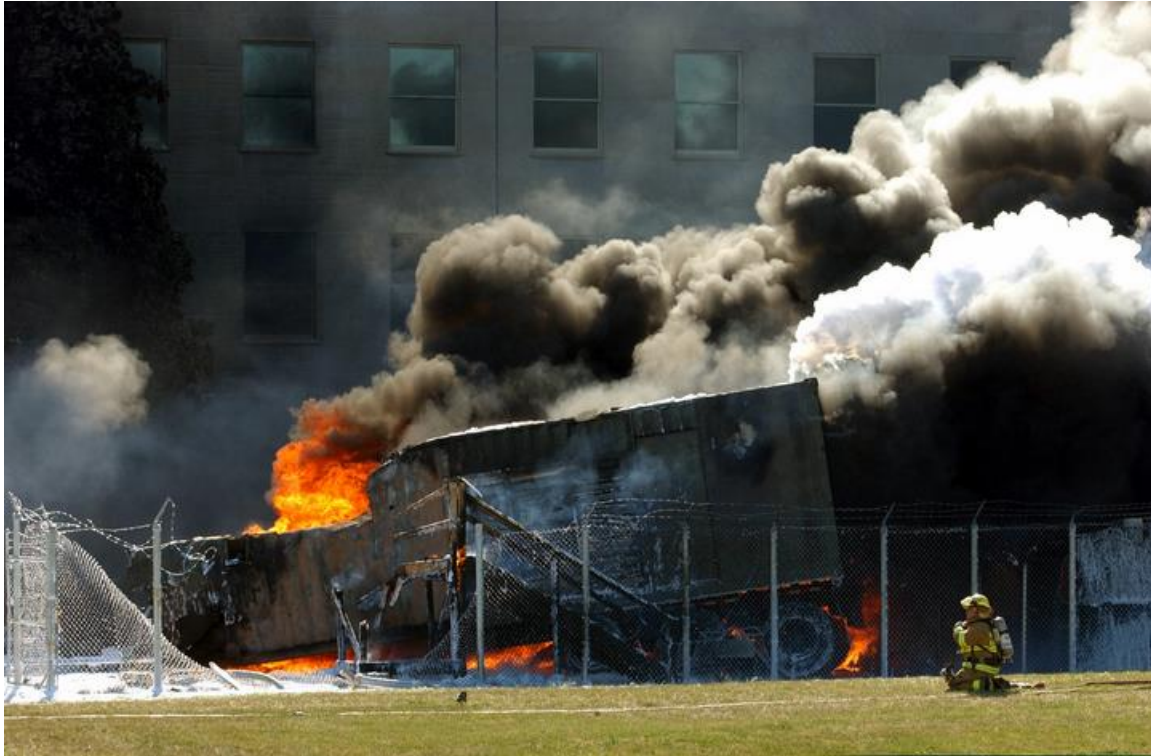
Figure 20: The fence is damaged in the path of the right engine but not elsewhere.

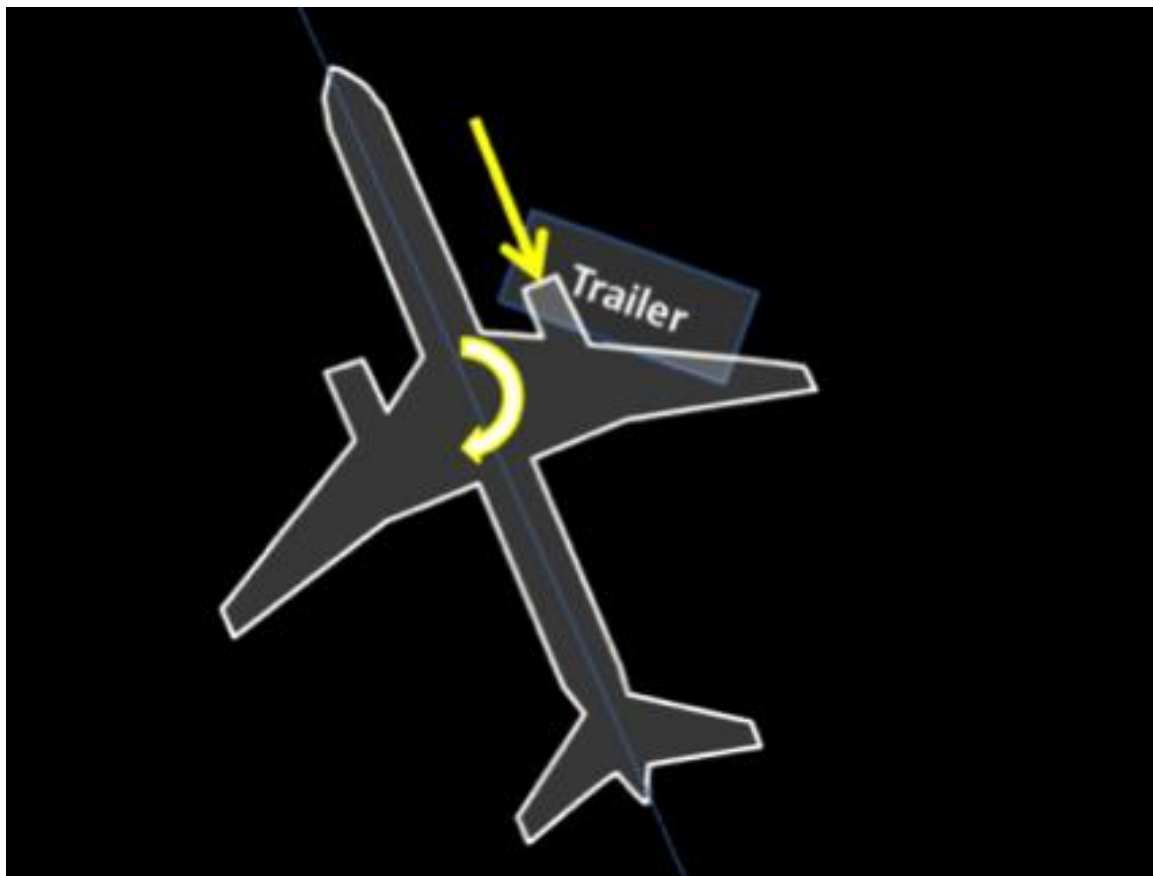
Figure 21: The right engine impact with generator trailer results in a torque on the plane that rotates it clockwise as seen from above.

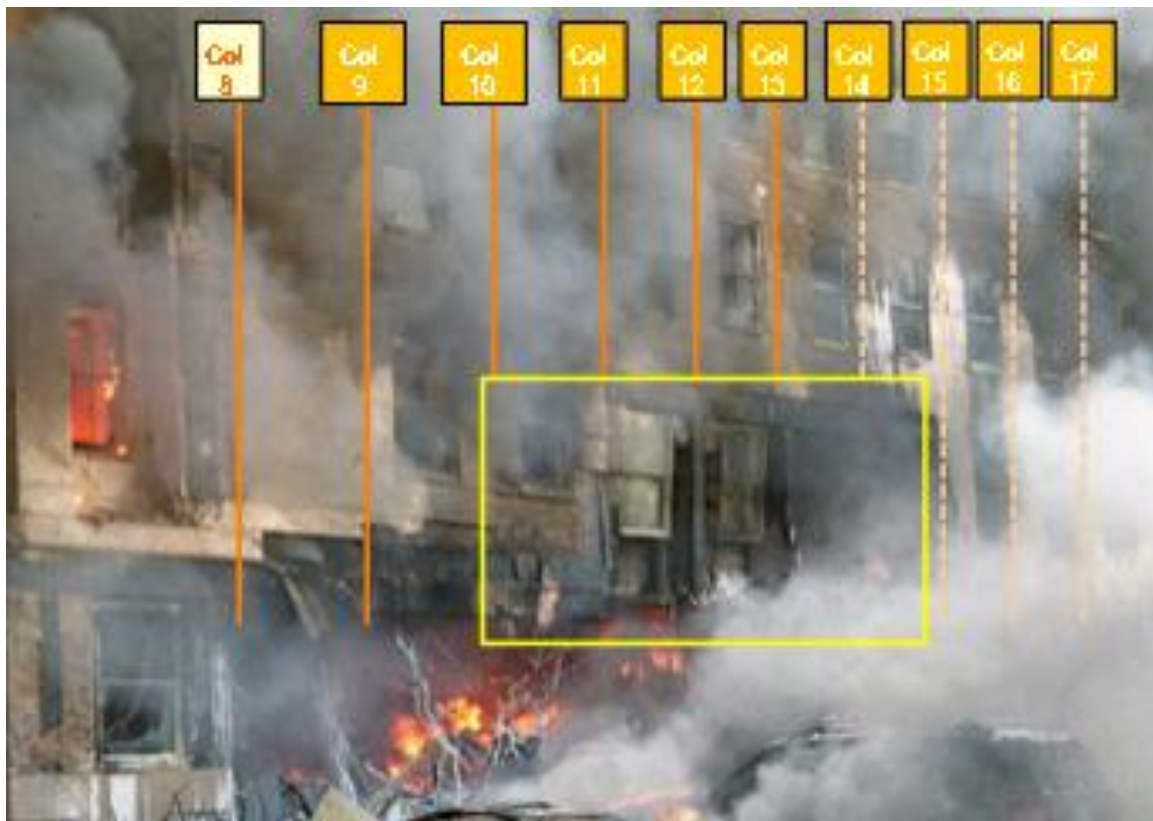
This would account for the missing damage to the building caused by the tail in the vicinity of Column 14. However, if we look at the second-floor slab in the vicinity of column 12 (a northward displacement of about 20 feet) we can see that the bricks and concrete beam under the second-floor windows are missing.

Figure 22: Damage around and under the second-floor windows near Column 12 indicates a second-floor impact. This could not have been due to the wing, which was entirely below the second-floor slab. This suggests that the tail impacted and was dragged in.

The left wing of the plane was parallel with the ground, so the entire left wing would have passed under the second-floor slab. This would leave the tail as the only part of the plane that would reach the second-floor slab in this vicinity. We can conclude that the tail must have been dragged into the first floor, pivoting on the second-floor slab in the vicinity of Column 12.
