Controversy About the Uplifted Second-Floor Slab at the Pentagon: Identifying a Likely Source of Upward Mechanical Impact

By Wayne Coste

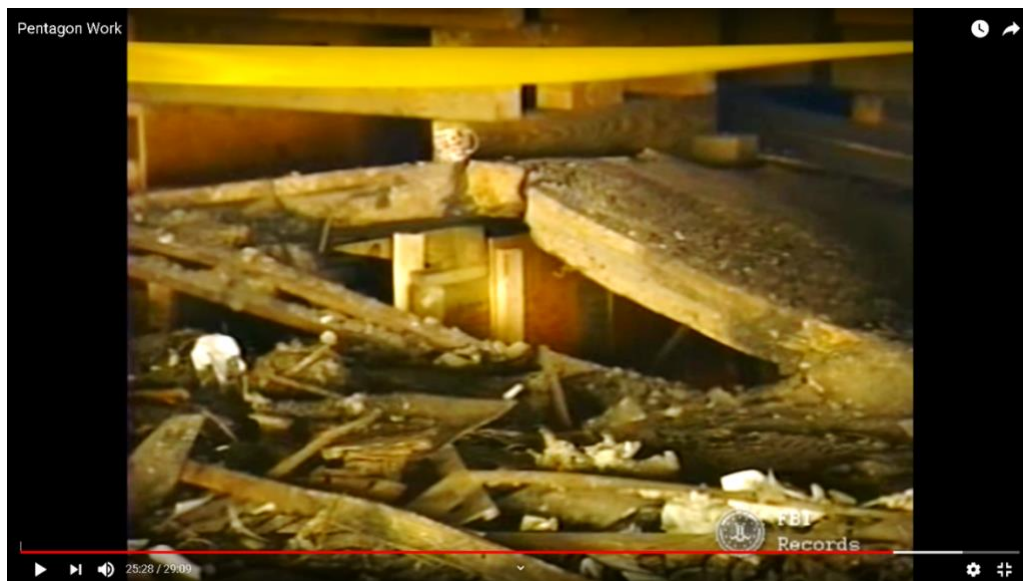
The uplifted second-floor slab is the most prominent evidence for a powerful vertical force originating from within the first floor. The sharpness of the break and “tenting” shown in Figure 1 clearly suggests a mechanical origin rather than the fracturing and crumbling of concrete that a pressure-wave blast from below would have created.

Figure 1: Uplifted slab is cleanly split along a single straight crack¹.

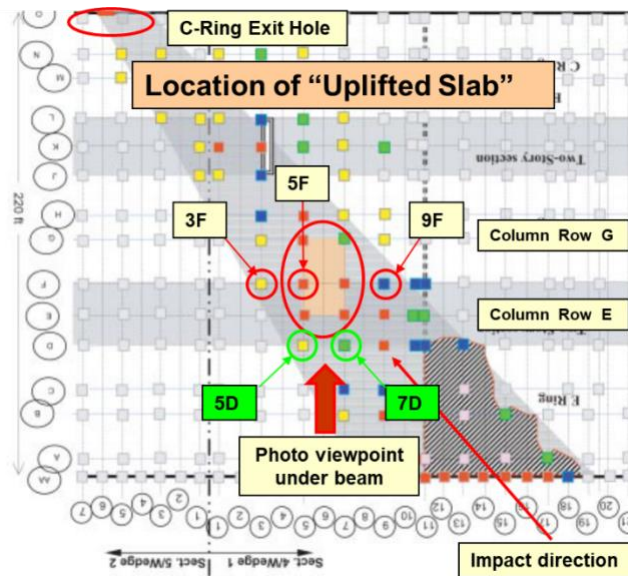
The uplifted slab is located inside the D-Ring of the Pentagon, approximately 100 feet from the exterior façade where the damage trail from the impacting aircraft begins. Figure 3 shows the location of the uplifted slab as a tan rectangle. In terms of column-based coordinates, the location is bounded by columns E5, E7, G7 and G5.

Figure 3: Location of the uplifted second floor slab along the impact path.

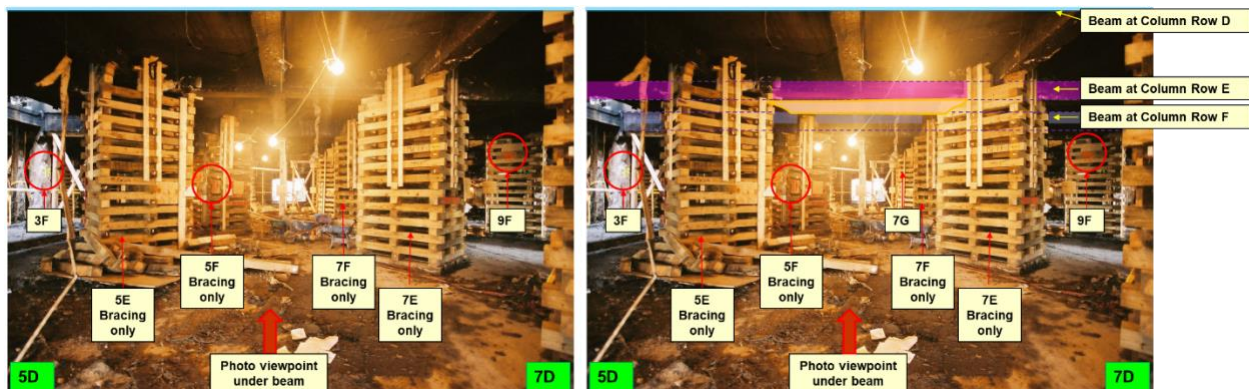
A photographic record of the area underneath the uplifted slab is shown in Figure 4. Several columns are identified to clarify their locations to facilitate comparisons in Figure 3. While this photo was taken during the clean-up, there are no signs of a significant detonation capable of snapping and uplifting a small, localized area of the second-floor concrete slab.

Figure 4: View of the area under the uplifted slab during clean-up³. Right side highlights beams and ceiling area from column rows E to F.

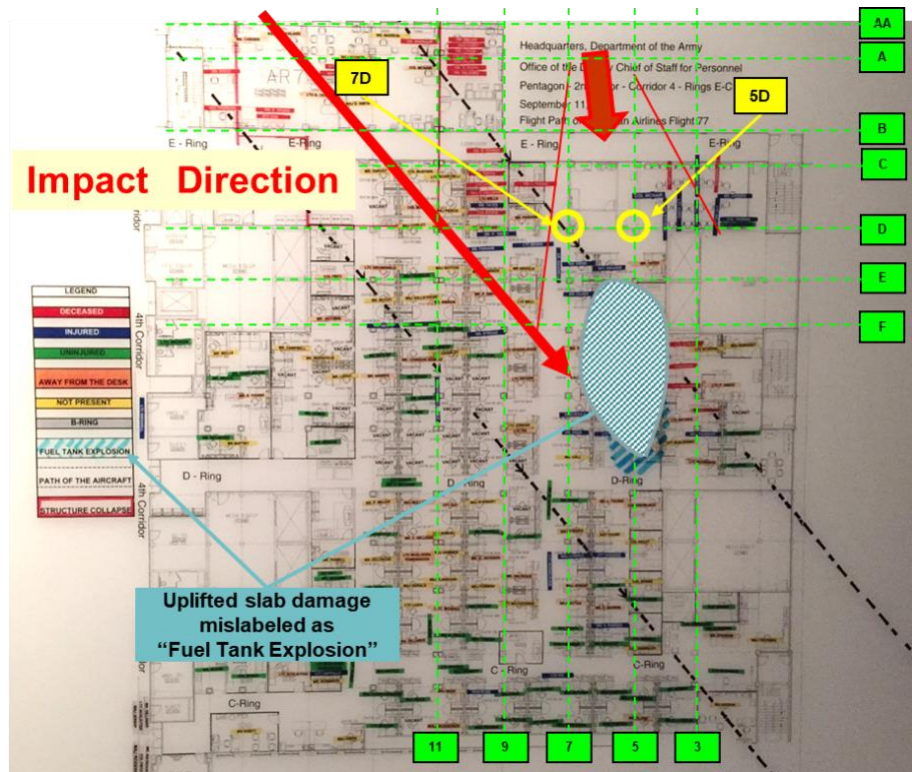
Figure 7 shows a floor plan for the second-floor of the Pentagon that was on display at the 9/11 Memorial Museum. The vicinity of the uplifted slab is shown by a blue/white hash-marked area and the legend for this region says "Fuel Tank Explosion." Given the lack of any other explanation, this seems to be a best-guess explanation even though there are contraindications; the impossibility of an explosive mixture of jet fuel 100 feet into the building (jet fuel is formulated to be flammable, but non-explosive) and David King's survivor's story.

Figure 7: Floor plan in 9/11 Memorial Museum exhibit identifies the uplifted slab as a result of an exploding fuel tank.

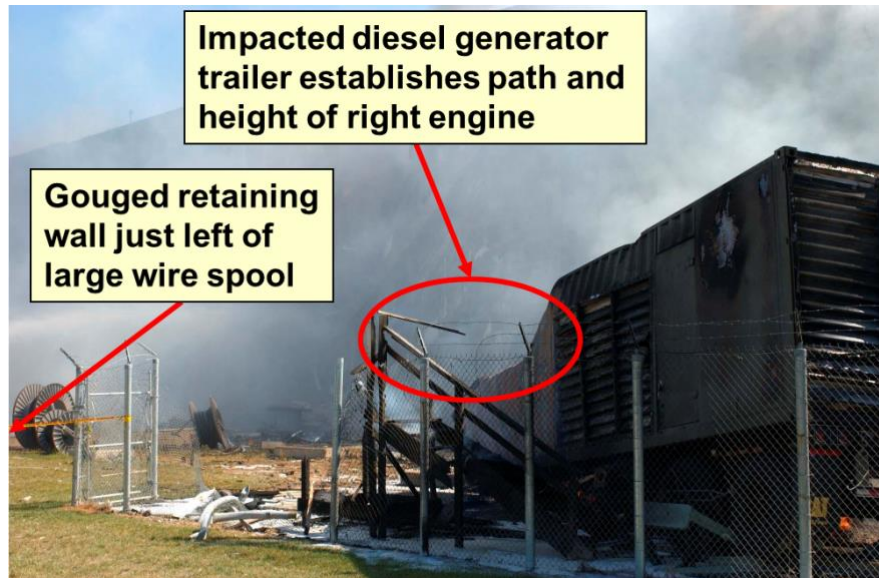
The physics of the impacting aircraft and evaluation of the damage has been discussed in various papers and videos⁸. As shown in Figure 8, the damage to the diesel generator trailer establishes the height and path of the right engine. Additionally, a notch that was gouged into a concrete retaining wall establishes the location and height of the left engine. This paper will focus on the trajectory of the left engine.

Figure 8: Impact of right engine onto diesel generator trailer and left engine into gouged retaining wall establishes path and heights.

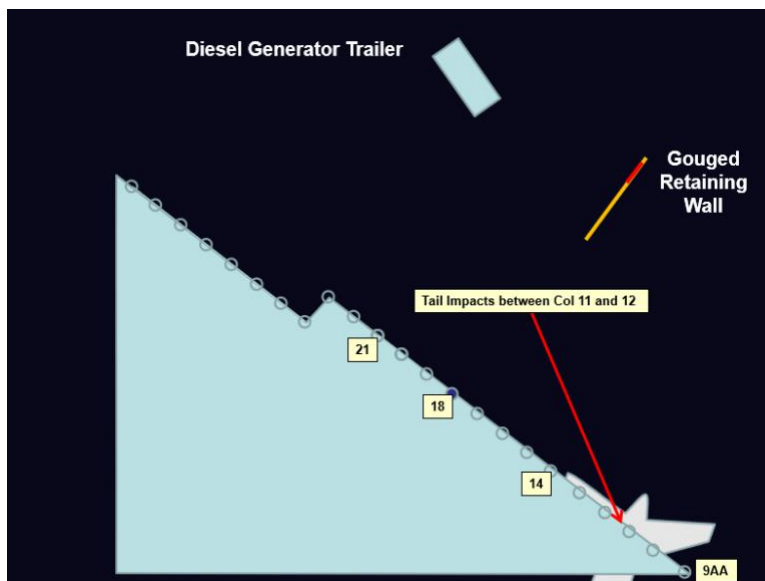
Figure 11 shows the tail impacting between columns 11 and 12 because of the yaw rotation which validates the change in impact angle for the engine. Because the entire left wing was well below the second-floor slab upon impact, the tail's impact accounts for the destruction of the concrete beam and in-fill bricks below the windows in this area.

Figure 11: Yaw rotation causes tail section to impact between columns 11 and 12

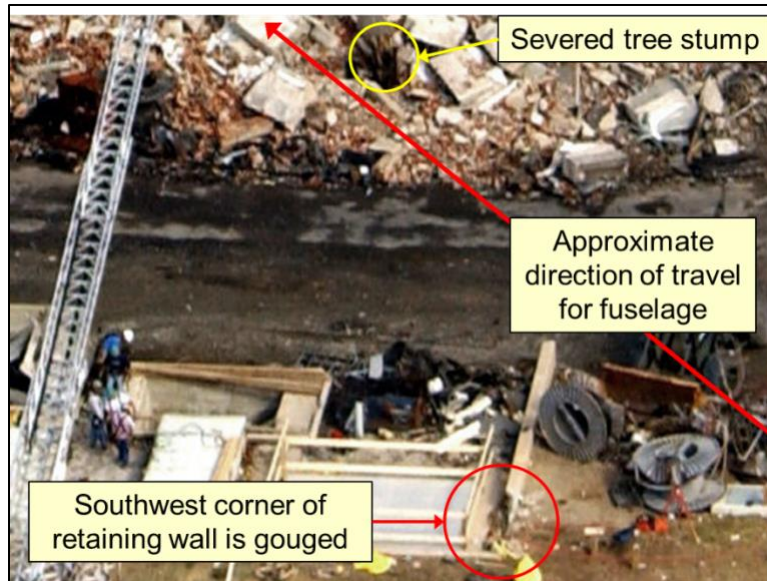
Figure 12: Gouged retaining wall as seen during the clean-up

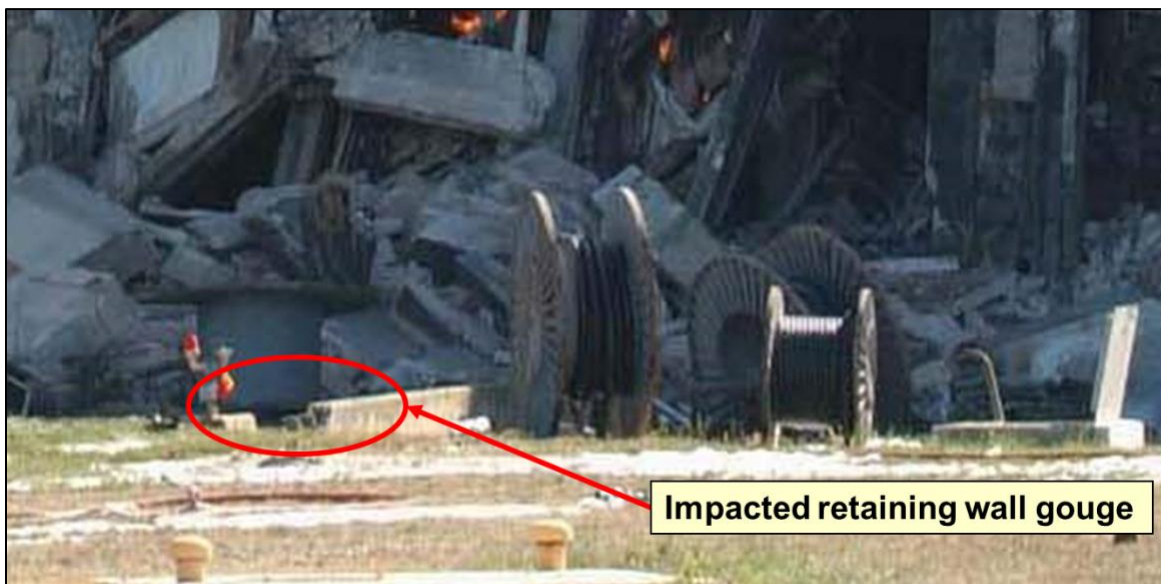
Figure 13: Gouged retaining wall

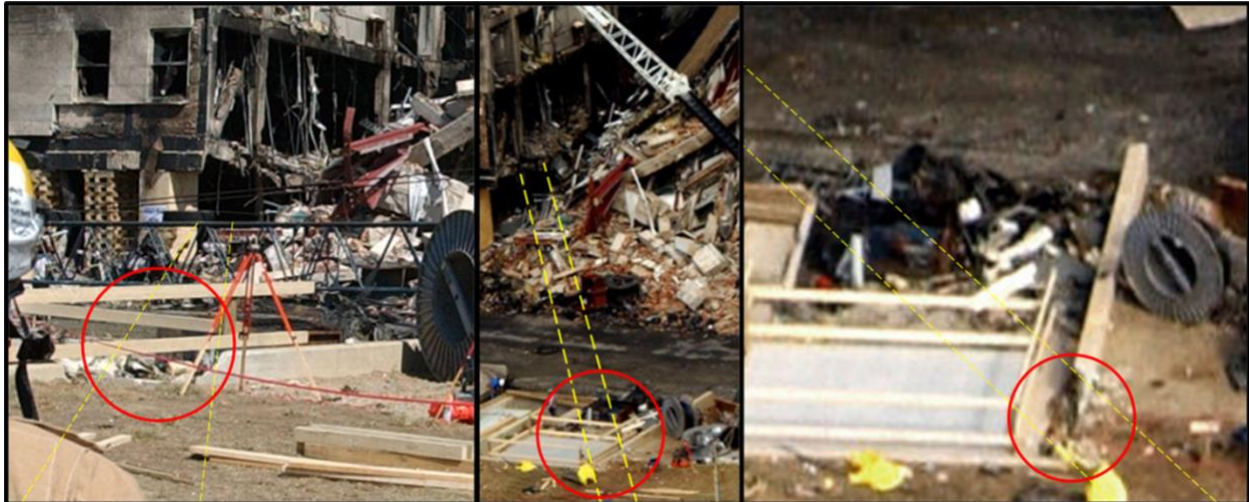
Figure 14: Composite images of gouged (or milled) retaining wall. Dotted lines should be redrawn to show effect of yaw rotation.

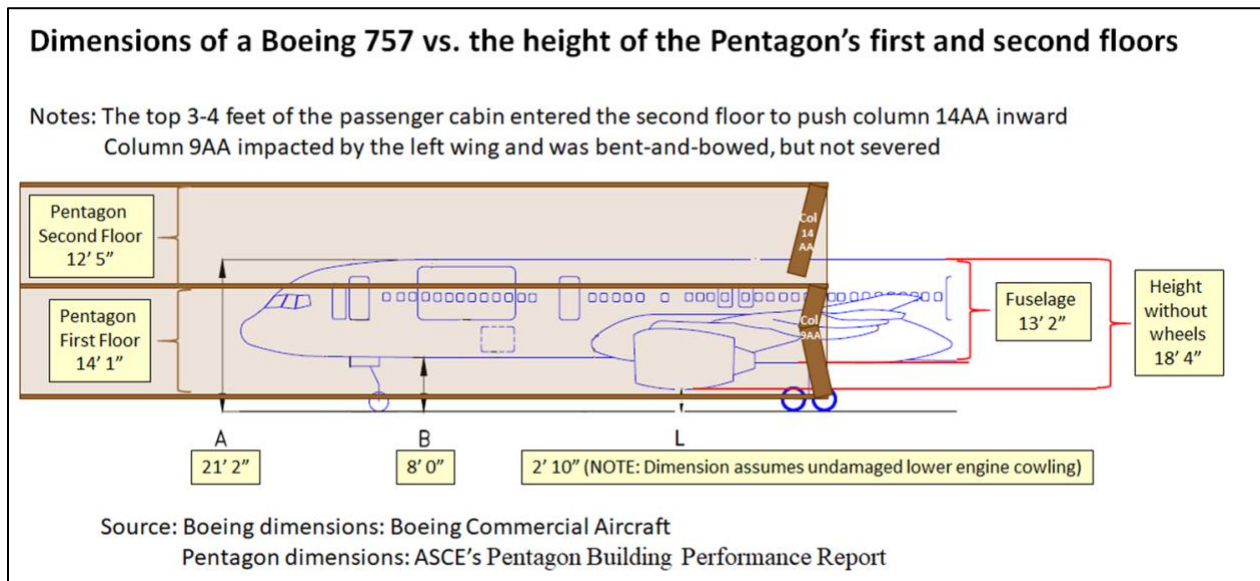
With the implied height at the left engine roughly established by the gouge, Figure 15 illustrates the height of the left engine inside the Pentagon by aligning the left wing with the maximum indent in the bent-and-bowed column 9AA as well as the fuselage impacting the lower three feet of column 14AA on the second-floor. At this height, the left engine will be inches above the floor and will impact column 9B – leaving its unmistakable impression in the form of an arc that was bashed into the column’s steel-reinforced concrete.

Figure 15: Dimension of a Boeing 757 aligned with impact damage at column 9AA and Column 14AA

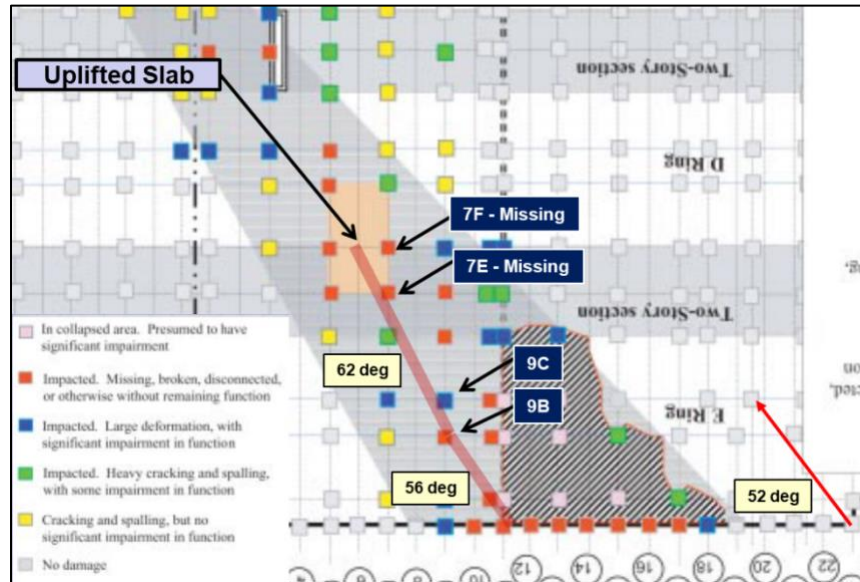
Figure 16 traces the trajectory of the left engine inside of the first floor as it impacts column 9B, 9C and potentially other columns. From the damage to the right side of column 9B in association with damage to other columns, it is assumed that the engine was deflected to an angle of about 62 degrees and this horizontal force imparted the gyroscopic vertical rotation. With this change in direction, the engine would miss column 7D. This

would place the engine directly under the uplifted slab with a tumble and bounce motion that would create the upward force to snap and uplift the slab.

Figure 16: Path through the Pentagon from facade to uplifted slab

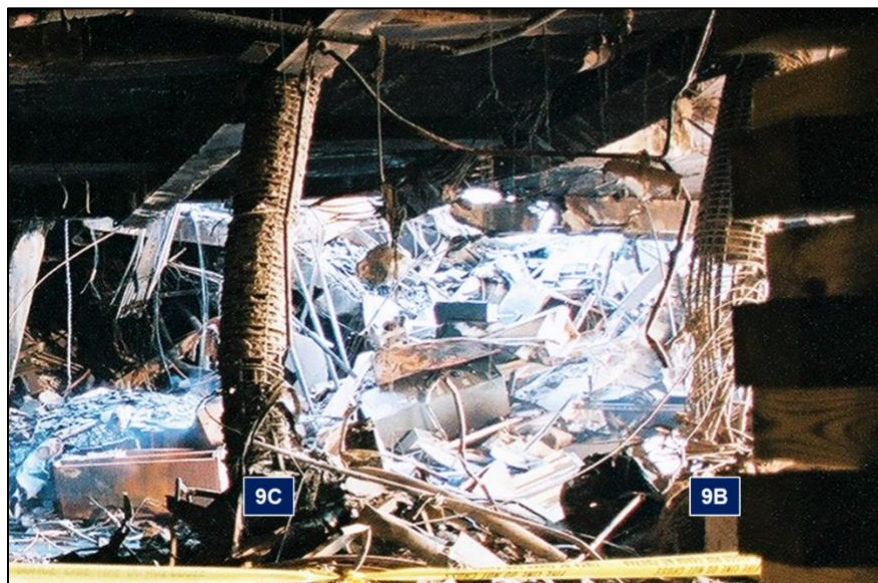
Figure 17: Columns 9B and 9C⁹

Column 9B and 9C are shown in Figure 17. They are both impacted and bent in the direction of the impacting aircraft.

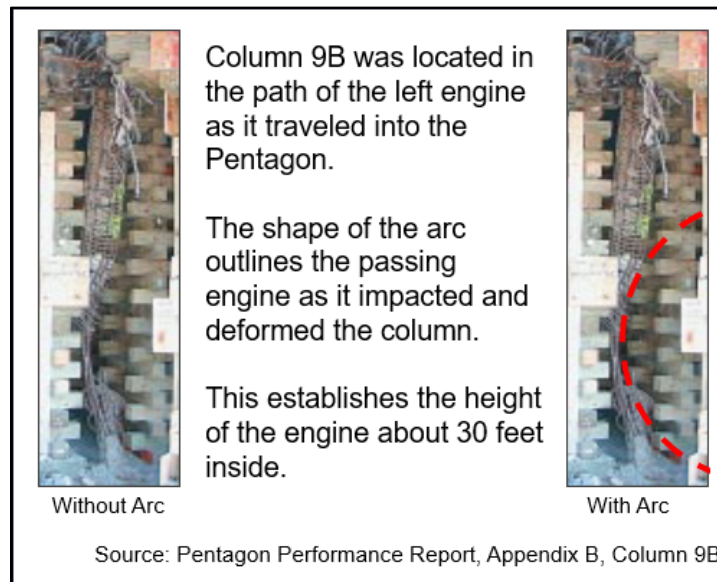
Figure 18 shows damage consistent with a large roundish object approximately 6 feet in diameter passing by and impacting. This circular impact damage is highlighted by a red arc.

Figure 18: Column 9B as shown in the Pentagon Building Performance Report.

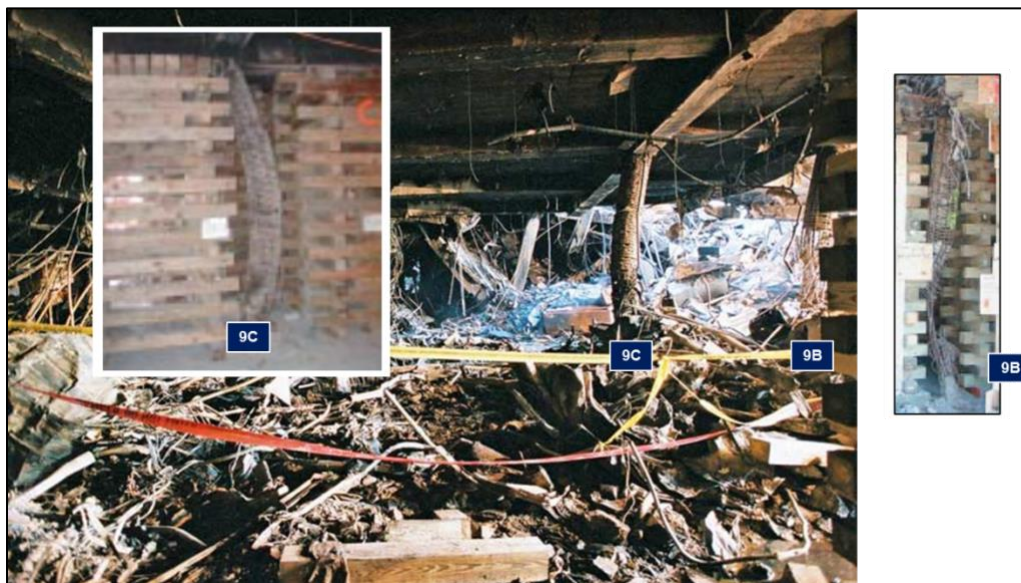
Figure 19 and Figure 20 show the damage to column 9C in the context of the overall damage where the columns are bent and bowed.

Figure 19: Columns 9B and 9C shown in context of other damage.
