## Identification of the plane model that impacted the Pentagon

By Mehmet Inan

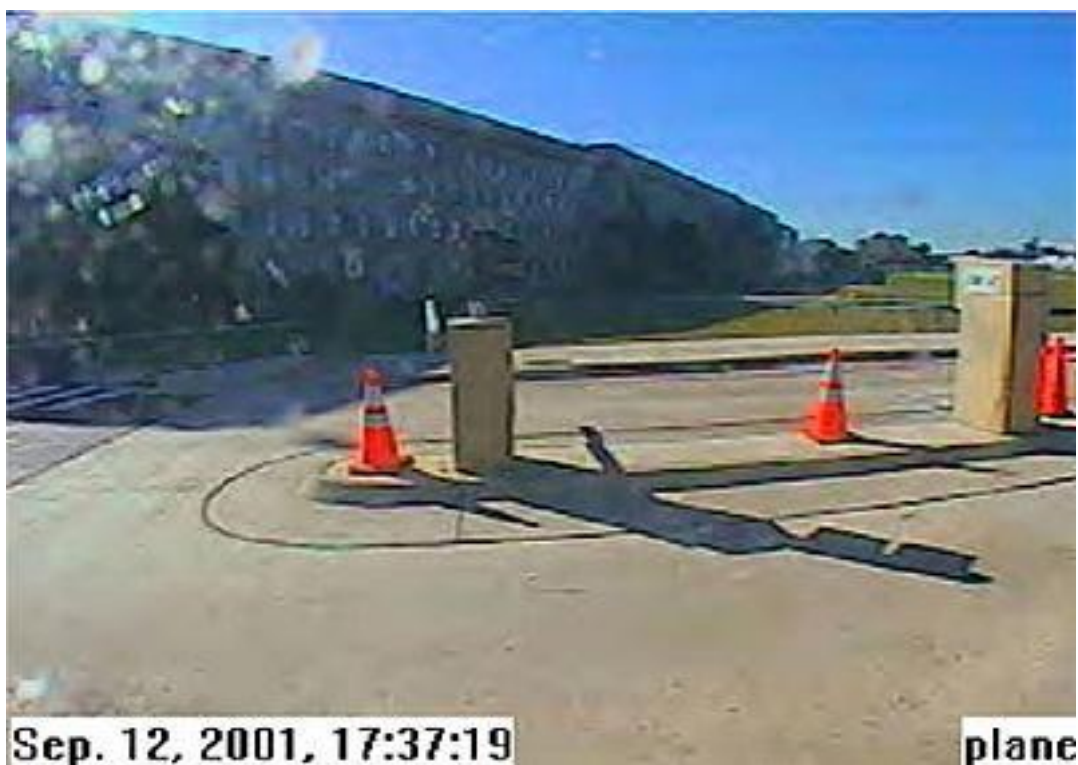
Figure 1 shows the first, and Figure 2 the second of these images. In the first image, we see the tail of the plane. The fuselage is hidden behind a box. The second image shows the explosion which is much hotter than kerosene explosion of the twin towers. In the following three images we see the explosion progress and cool down. Nothing permits to identify the aircraft.

Figure 1: First published image of the Pentagon attack.

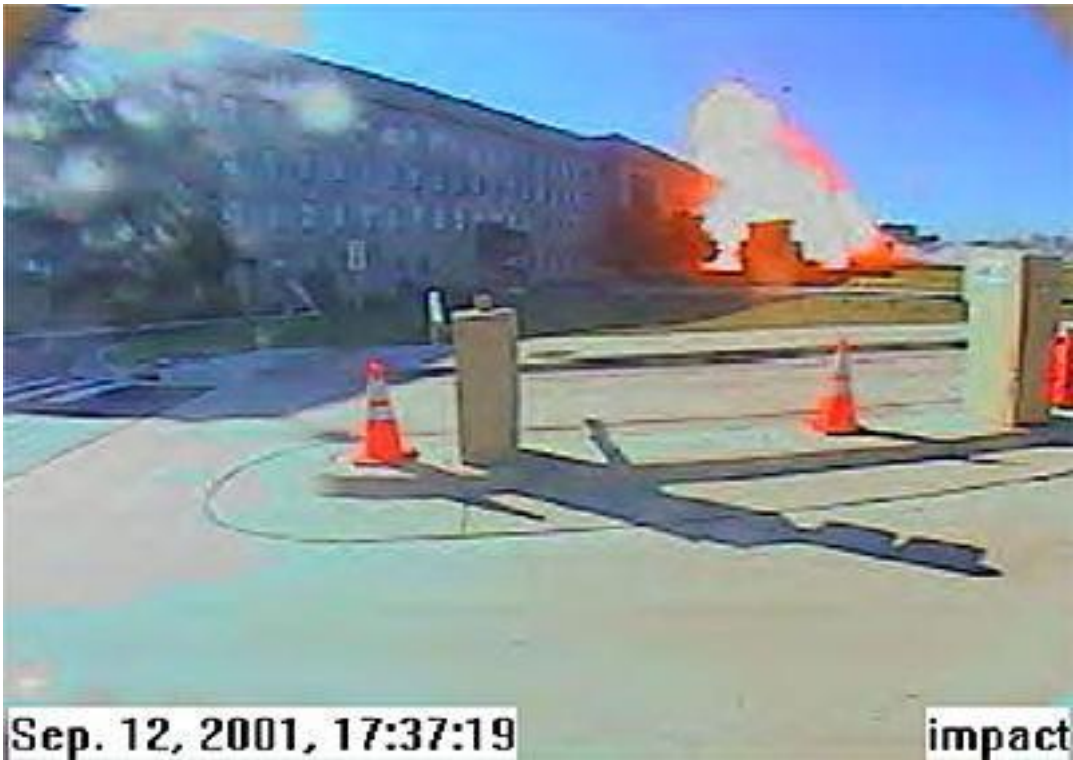
Figure 2: Second published image of the Pentagon attack.

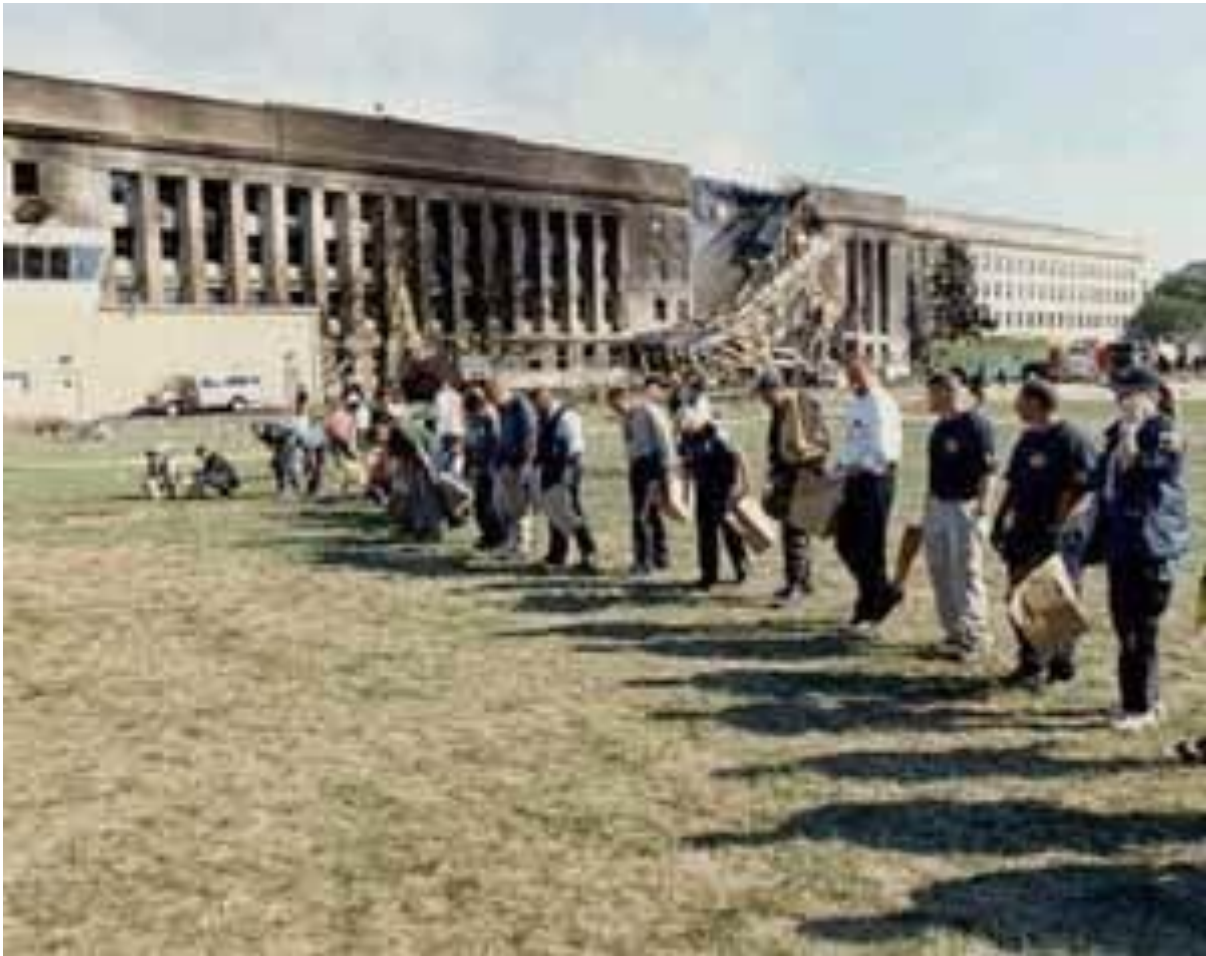
Figures 3 and 4 show two pictures of people clearing the lawn from all debris. One shows people walking in line on the grass, occupied to collect all remaining debris on the Pentagon lawn. The other one shows people, in white shirt and tie, picking up debris and hurry to gather them. That can be considered as normal, gathering all evidence of a crime scene. But it also means that there is a will to hide all images and evidence of this plane.

Figure 3: Cleaning the lawn from debris.

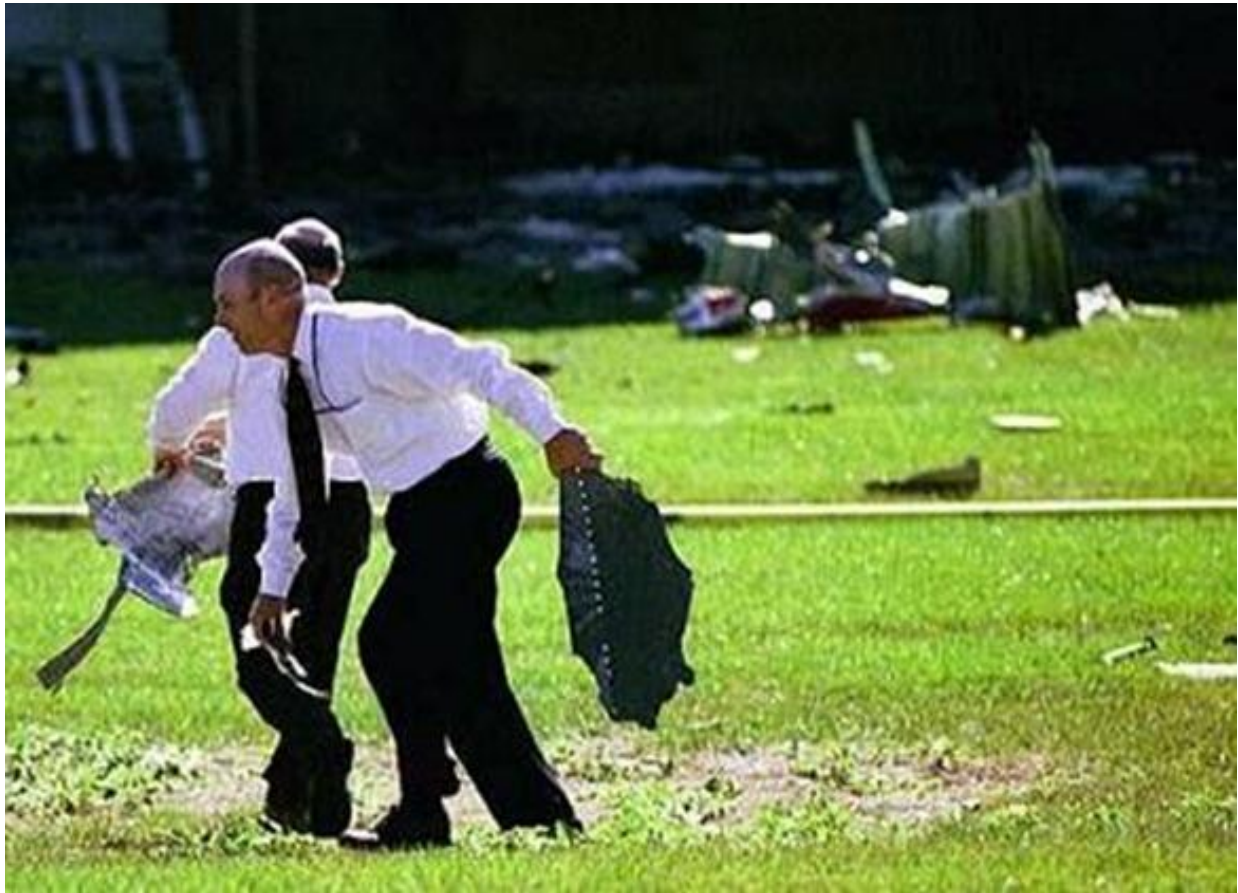
Figure 4: Cleaning the lawn from debris.

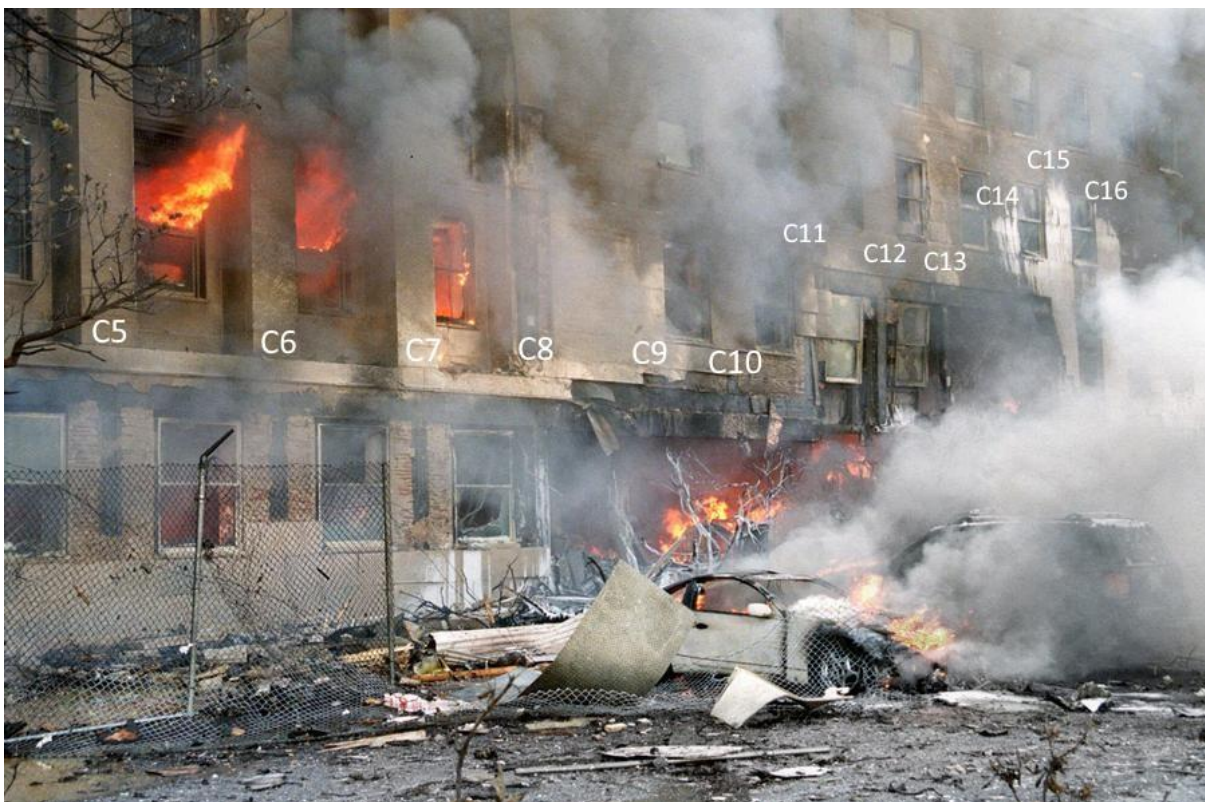
Figure 5 (similar to Figure 3.8 of ASCE report) shows the left side of the entry hole. We can see the entry hole between columns 13 and 15. The last damaged is column 8.

Figure 5: Left side of the entry hole on the Pentagon.

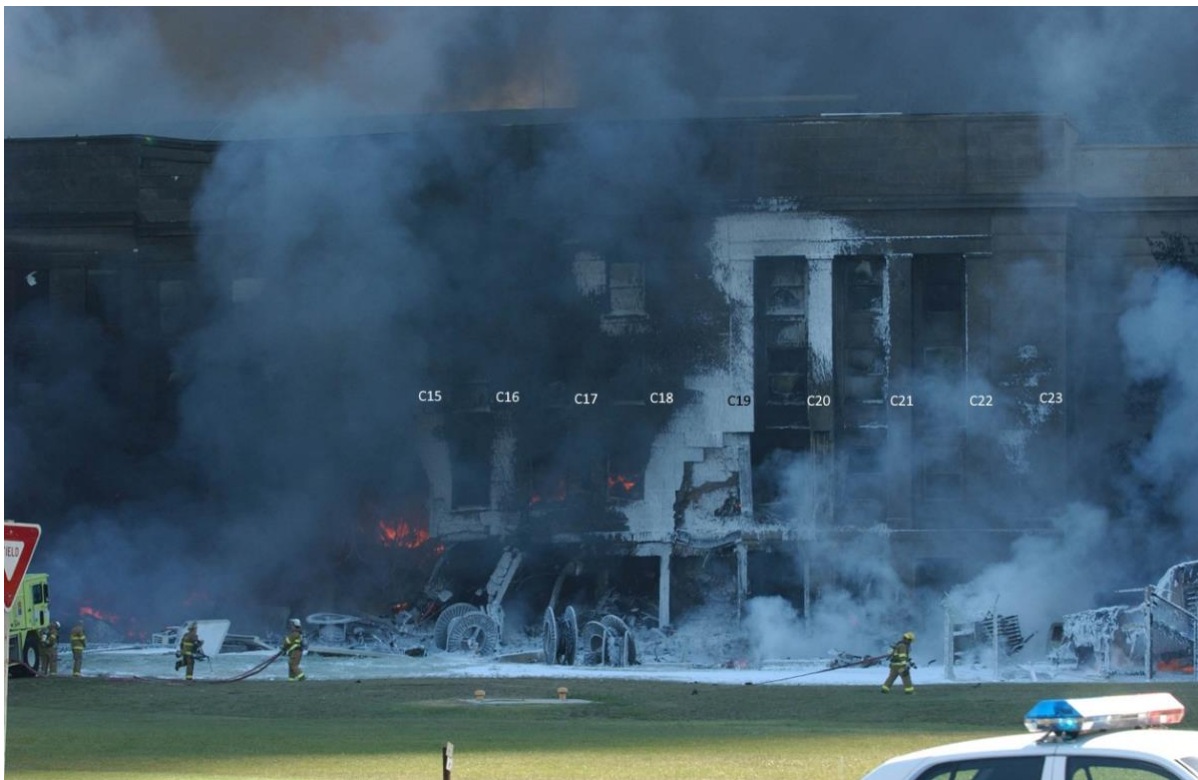
Figure 6 (similar to Figure 3.9 of ASCE report) shows the right side of the entry hole in the façade after the impact and before the collapse of that part of the facade. We can see the entry hole in the left of the image centre, where the fire continues to burn. On the right of the image centre, we can see the last damaged column 20.

Figure 6: Right side of the entry hole on the Pentagon.

first floor. This wing also destroyed the columns 15, 16 and 17. The pending concrete parts at the places of these columns in Figure 6 are collapsed horizontal parts of the second-floor level.

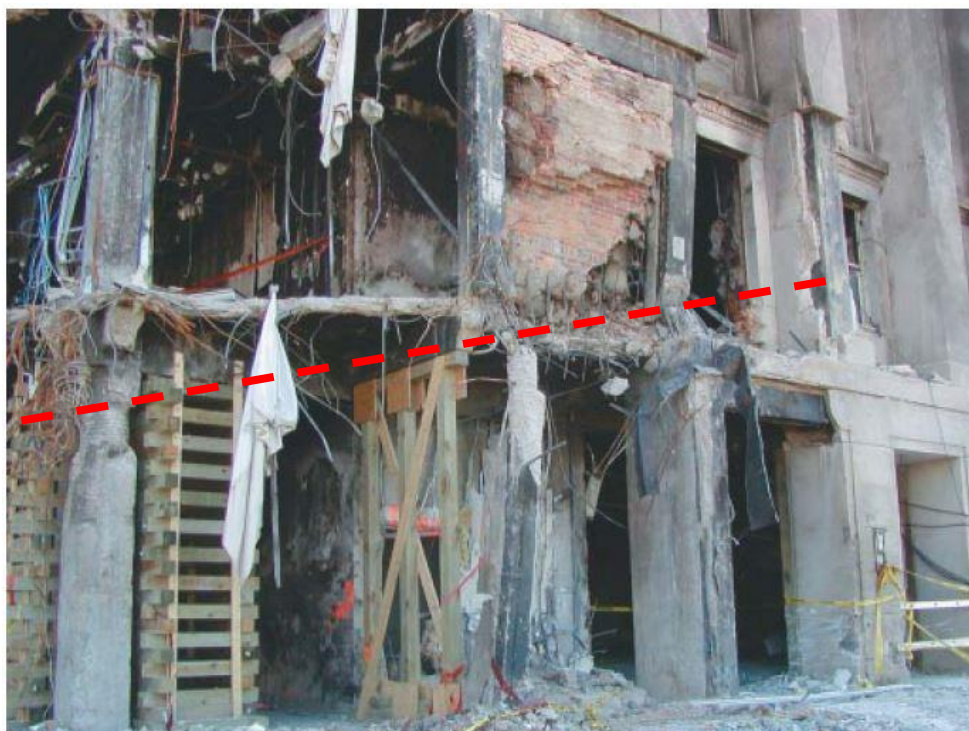
Figure 5.8 Facade damage to the south of the impact area

Figure 7: Damages on columns 18, 19 and 20 of the Pentagon.

- The extremity of the right wing hit the column 20 at the level of the second floor, leaving straight traces of a wing on columns 19 and 18. Figure 7 (Figure 5.8 of ASCE report) shows a close image of damage on C18, C19 and C20. The damage is consistent with the impact of a right wing of a commercial airliner. The traces of the wing go from C20 on second floor down to the entry hole on

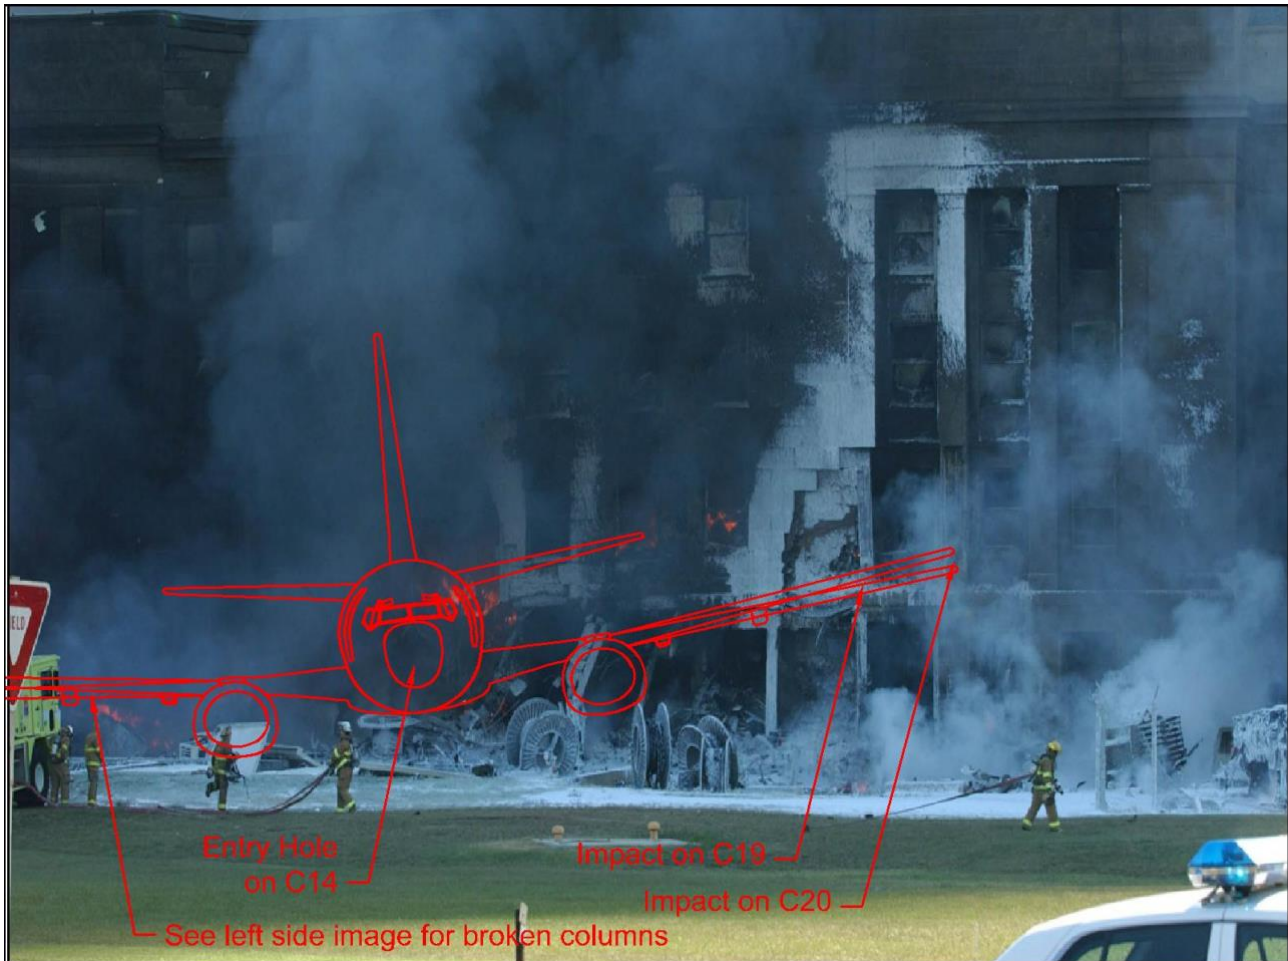
Figure 8 shows these traces with the image of an aircraft. The wings of the plane in this image were doubled. The upper wing represents the position of the wing in flight which is slightly raised, although its curve is not perfectly represented.

Figure 8: Traces of the wings on the damages of the Pentagon.

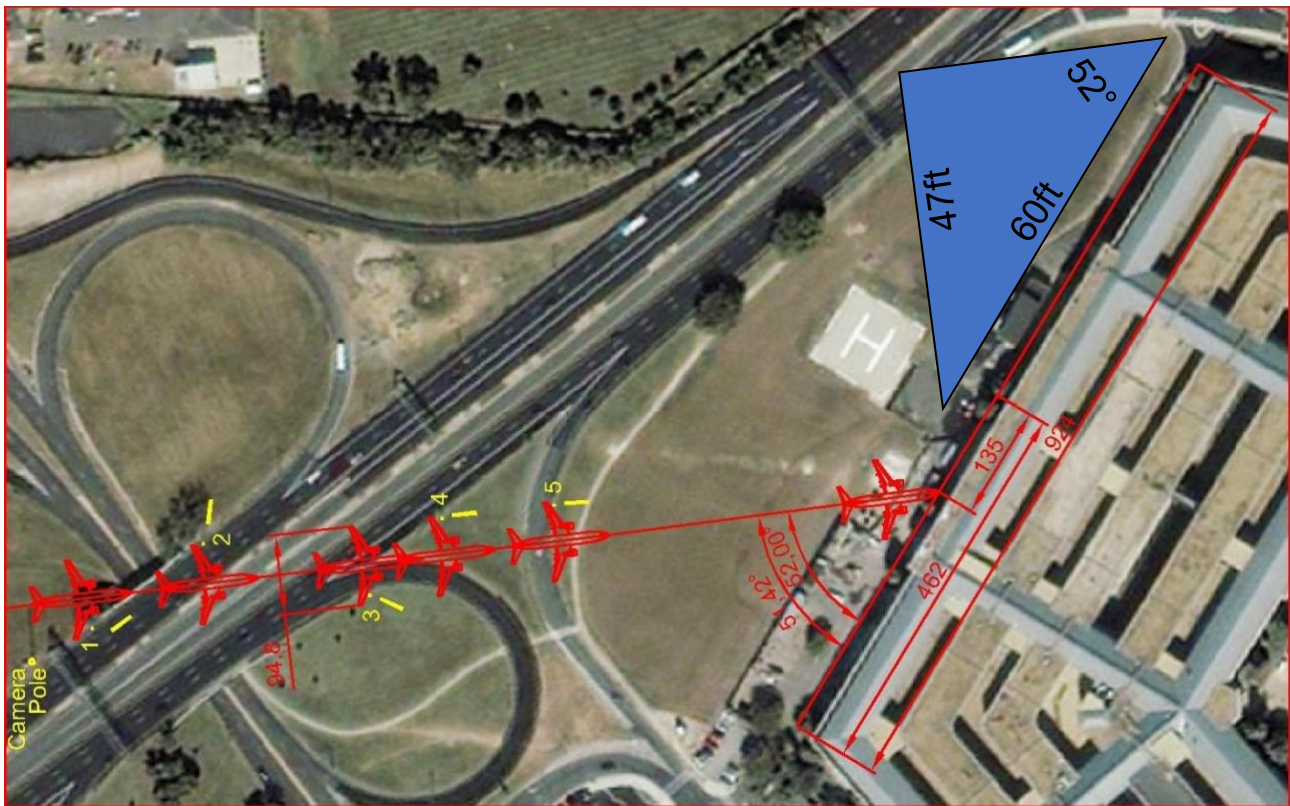
- Figure 9 shows the approach angle of the aircraft toward the building. This angle is about  $52^\circ$ . Taking into account the impact with the generator which turned the plane a little to the right, the angle becomes a little smaller. This angle was measured on basis of the light poles destroyed before the impact and the direction of damages inside the building.

Figure 9: Approach angle of the plane according to the façade.

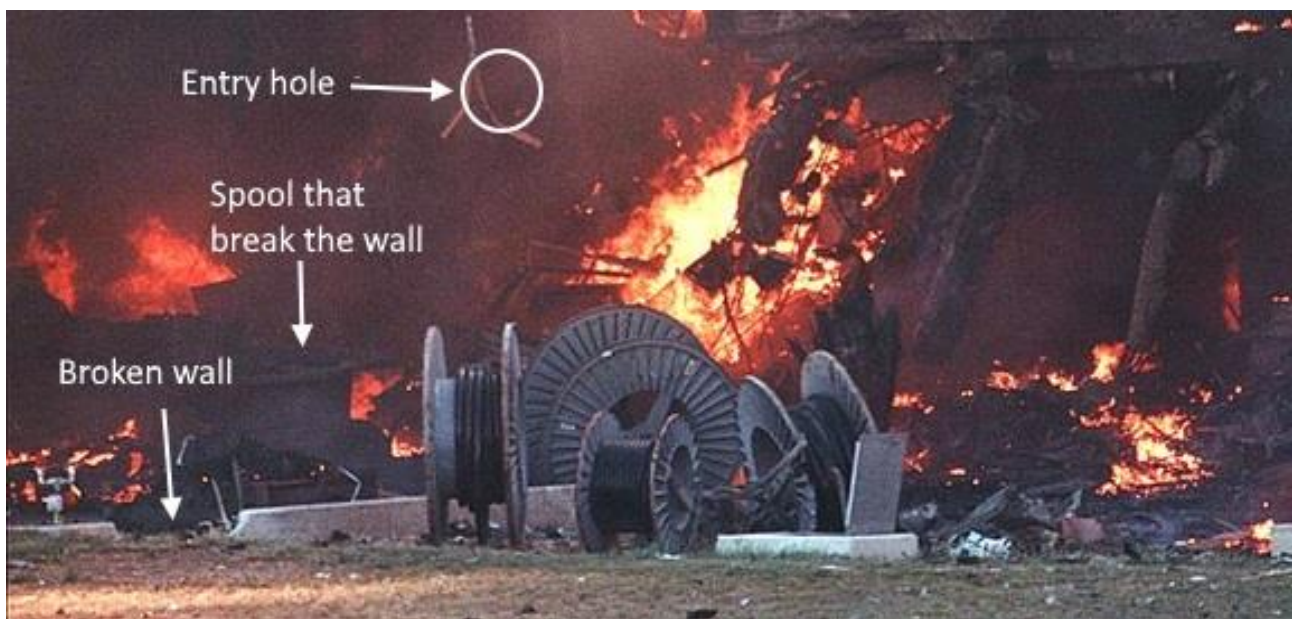
Although the impact of the right engine, not the wing, to the generator is visible, it cannot in any way explain the break of the wing tip. For the left engine, there is no evidence explaining that it hit the wall on the ground. There is a notch in the wall visible in Figure 10.

Figure 10: Broken ventilation wall and the cable spool that crossed it.

The notch in this wall cannot be made by the left engine, because there is no trace on the ground before and after the wall. This break is clear to the ground. The engine cover would touch the ground before breaking the wall at the ground.

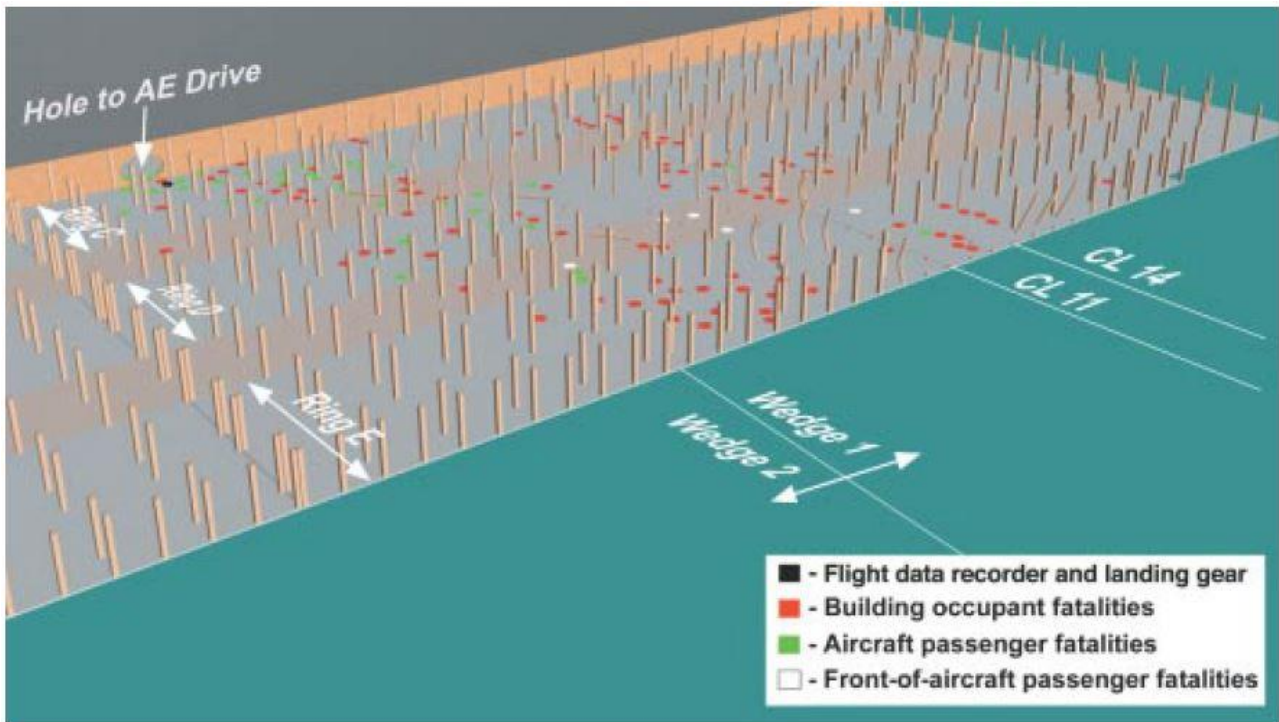
Figure 3.17 Fatalities found in first story

In ASCE report "Figure 3.17 Fatalities found in first floor", see Figure 13, the black square near the exit hole in ring C shows the position of "Flight data recorder and landing gear". This position is straight forward in the path of the aircraft. But these parts are strongly tied to the aircraft. They cannot be separated from the aircraft at the beginning of the impact where the weak nose does not create much deceleration. Later, during the progression of the impact, the aircraft rotated leftward. See figure 17 for this rotation. When these parts detached from the aircraft, their direction was changed. They cannot go straight forward and they cannot reach the exit hole situated straight in the aircraft approach direction. For making these parts continue their way straight forward as shown in the ASCE report, these parts must be planted inside the aircraft with weak connections, such as used for transportation. That means these parts were planted inside the empty aircraft; they were detached from the aircraft immediately at impact time and continued their way straight toward the exit hole. These parts are not parts of the aircraft that impacted the Pentagon.

Figure 13: Debris localisation, from the ASCE report.

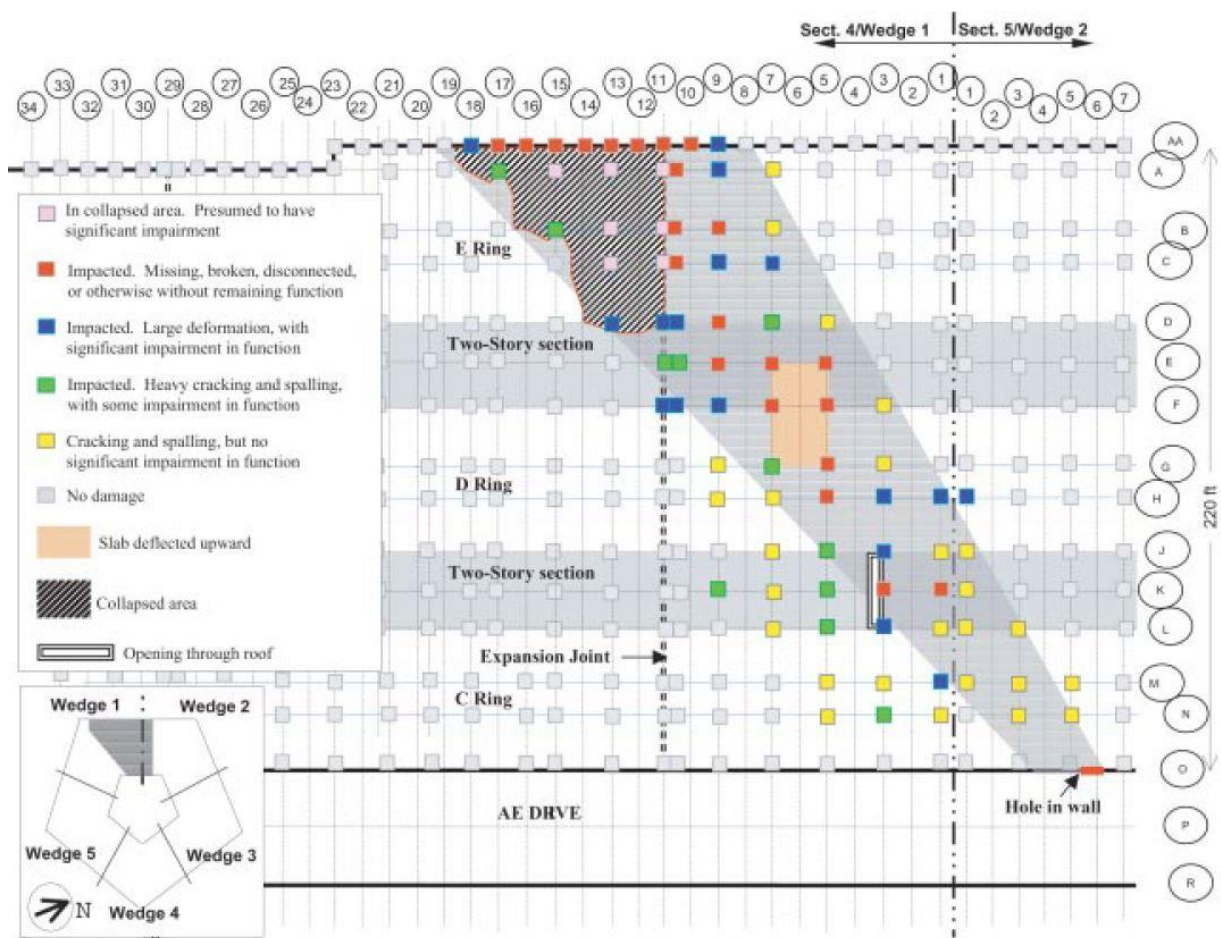
Figure 7.9 Path of ejected fuel in the first story

In ASCE report “Figure 7.9 Path of ejected fuel in the first story”, see Figure 16, an orange area is drawn between columns E5 and G7. Figure 17 is made on basis of this figure 7.9 of ASCE report. The orange area is identified as “Slab deflected upward”.

Figure 16: Damage in the first story, from the ASCE report.

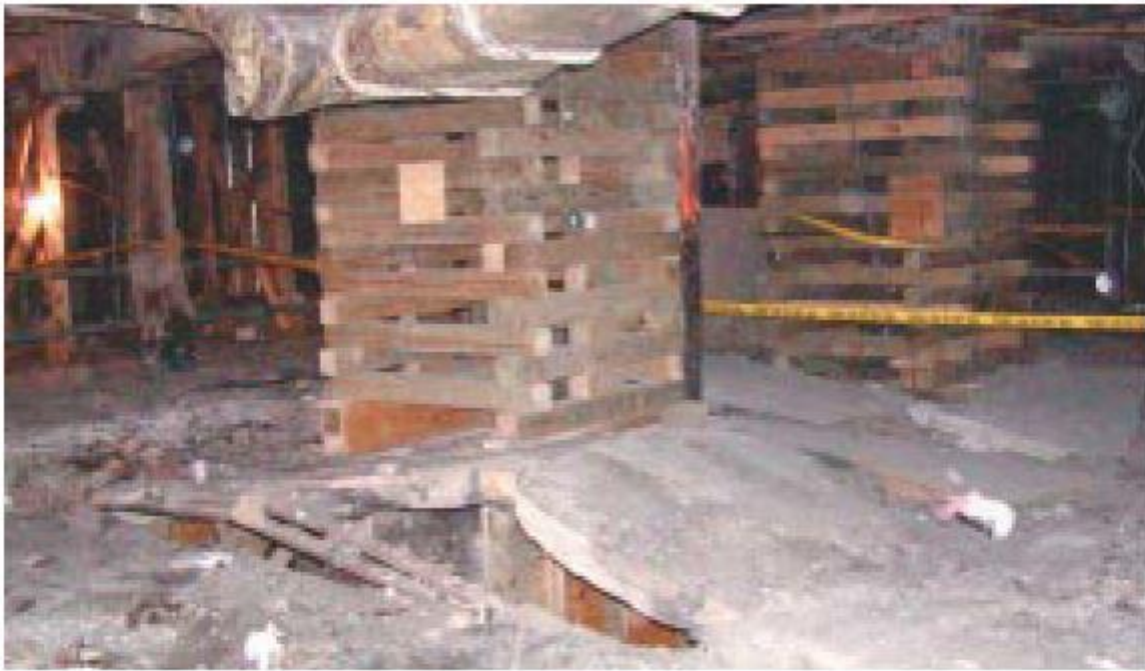
Figure 5.27 Breached second-floor slab

In “Figure 5.27 Breached second-floor slab”, see figure 18, this slab is shown from the second floor. This upward deflection is the consequence of an overpressure under this area. Such an overpressure can only happen in case of explosion under this area.

That means there was also a bomb inside the aircraft. This bomb also continued its way straight forward and exploded when it reached this orange area where the slab deflected upward. The overpressure of this explosion spread in all directions in the first floor, destroying the roll-up door in

Figure 18: Breached second floor slab, from the ASCE report.

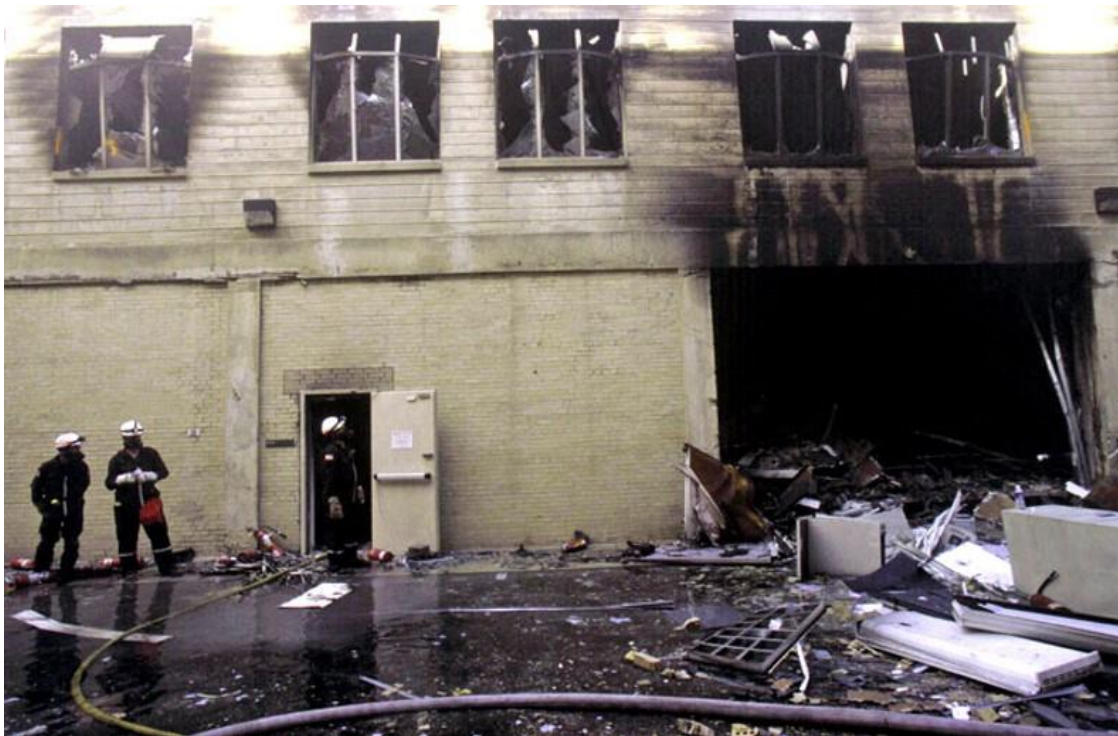
ring C and windows between columns 4 and 8 in ring E. When reached the second floor, the overpressure was much reduced and directed inward. That's why it bended the window frames and broken the glasses on ring C between columns 5 and 10 as visible in Figure 19.

Figure 19: Damage in ring C between columns 5 and 10.
