Reply to “Rebuttal to ‘Large Plane Impact Damage to the Wall of the Pentagon and Adjacent Objects’ ”

By David Chandler and Wayne Coste

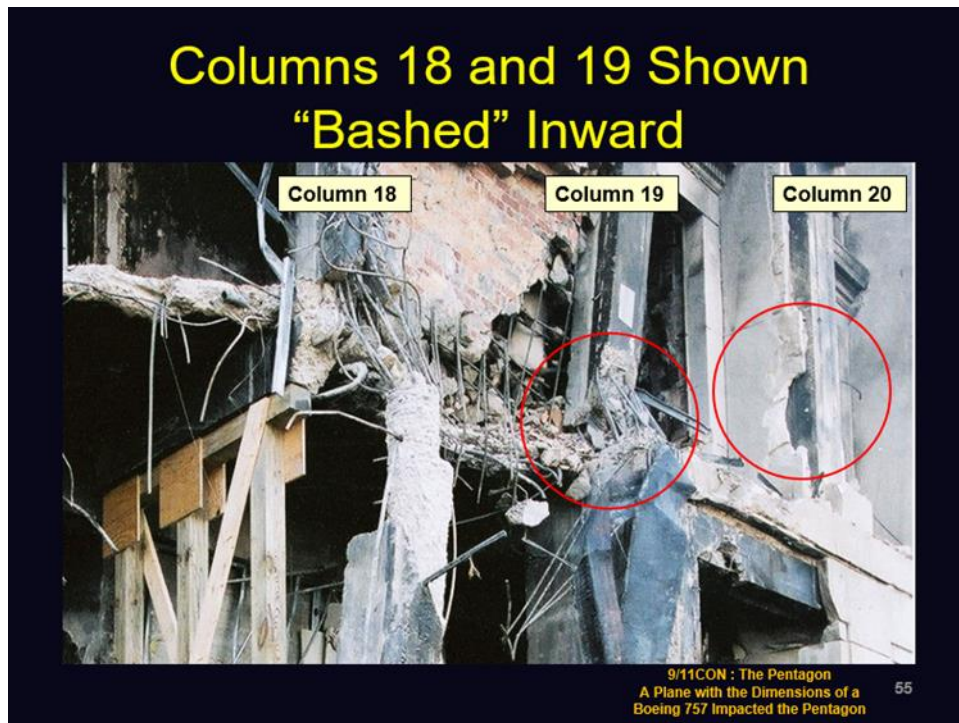
Figure 1: The outer part of the right wing of the plane impacted Columns 18 at the floor slab and angled upward to the right impacting Columns 19, and 20.

Upon reviewing the comment we received in 2020, it was clear that the collapse of the façade, rather than the dynamics of the plane impact, caused Column 18 to be pried to the right. However, the image in Figure 1 is still significant for understanding the geometry of the impacting plane’s right wing. The resistance from the mass of the floor slab itself, hit edge on, is what protected Column 18 from being mechanically snapped like Column 19. Figure 1 shows that Column 19 is bashed inward about 18” above the second-floor slab, and the impacted limestone on Column 20 is damaged approximately 36” above the second-floor slab. This would place the point of impact of the right-wing at the intersection of Column 18 and the second-floor slab. We therefore have a virtual imprint of the right wing of the plane as it impacted the Pentagon wall. None of the damage seen here can be attributed to explosives. This is clearly mechanical breakage, not pulverization by explosive detonations.

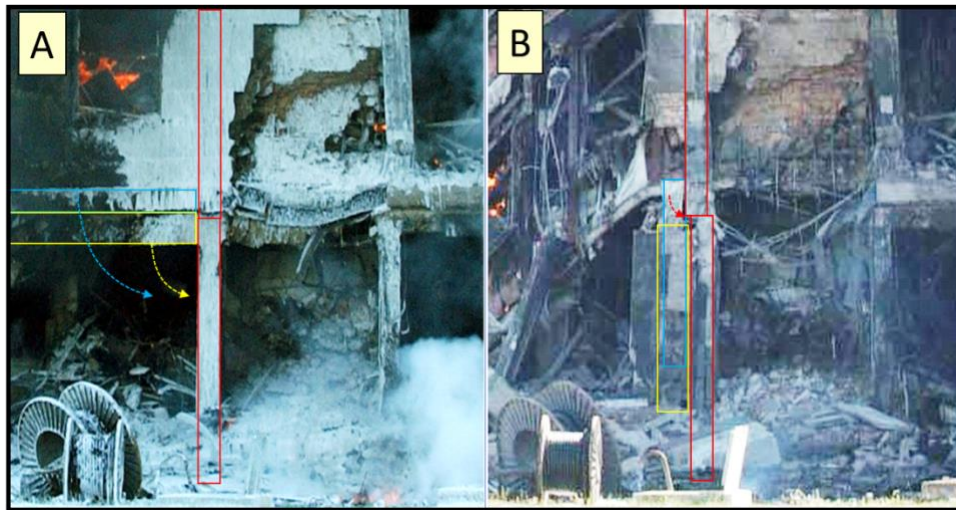
Figure 2: Pre collapse damage to Column 18 (left) and post collapse damage (right) showing that the beam (yellow) and portion of the floor slab (blue) between Columns 17 and 18 rotated down and pried Column 18 (red) to the south.

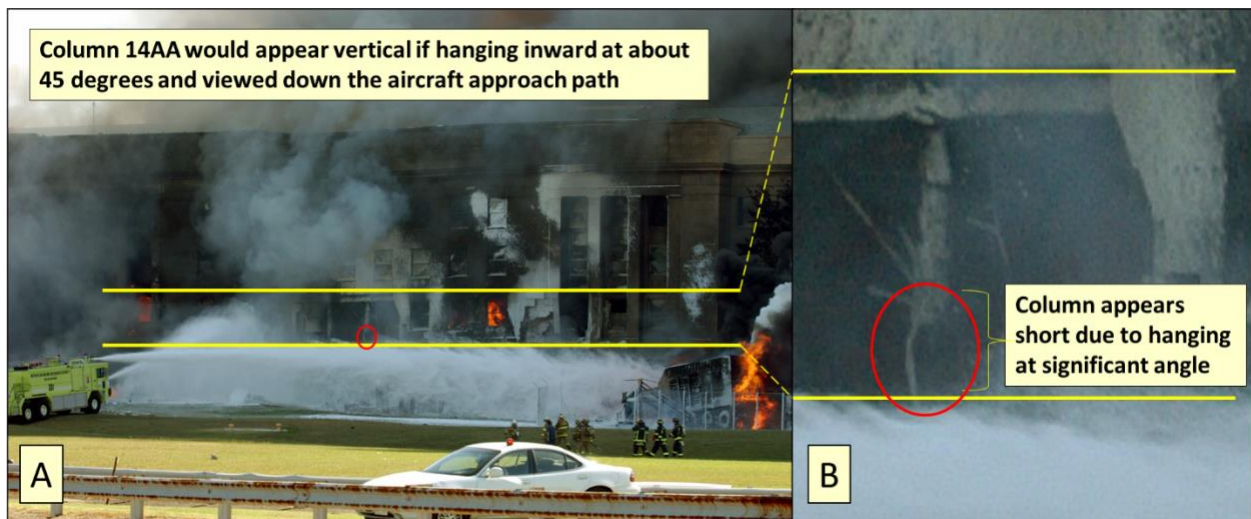
Figure 3: Column 14AA looks vertical when viewed from the approach angle, but is actually hanging and pushed in the direction of impact (left). The bottom of the column is fragmented (right) and clearly does not extend to the level of the second-floor slab.

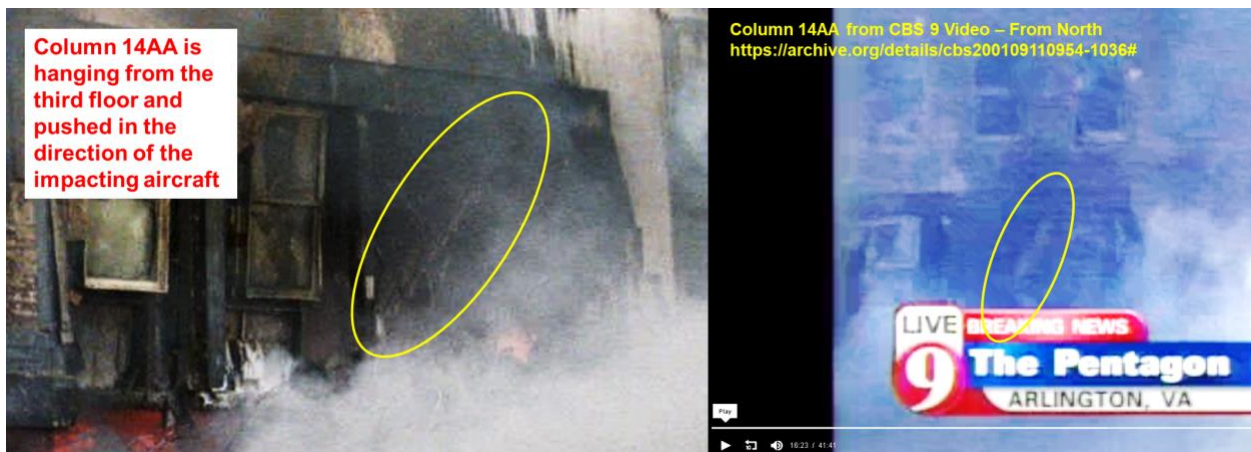
Figure 4: Column 14AA on the second floor is shown hanging from the third floor and pushed in the direction of the impacting aircraft.

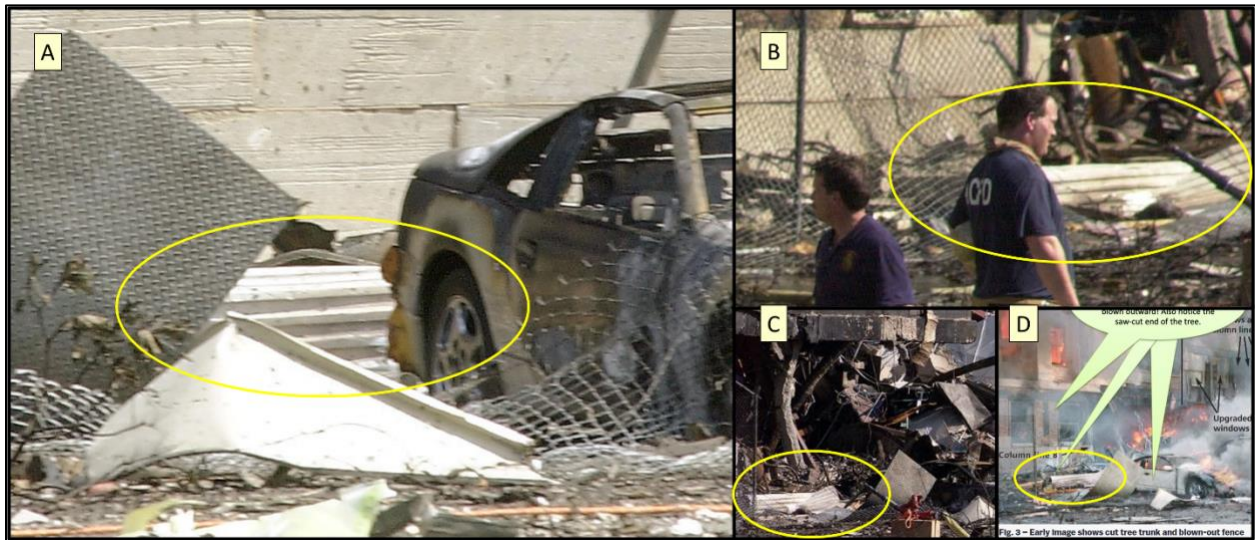
The pieces of “tree trunk” he refers to appear to be overly large for the size of that tree. A more comprehensive review of the photographic record shows the object in Figure XA-3 to closely resemble a roll of corrugated metal and not a tree trunk. Several different images from different perspectives are shown in Figure 5. The object in Figure XA-16 is clearly a sheet of plywood leaning against a fence as shown in Figure 6⁹.

Figure 5: The circled object in images A, B and C are clearly corrugated metal and not part of a cut tree trunk as alluded in figure XA-3 (repeated in image D).

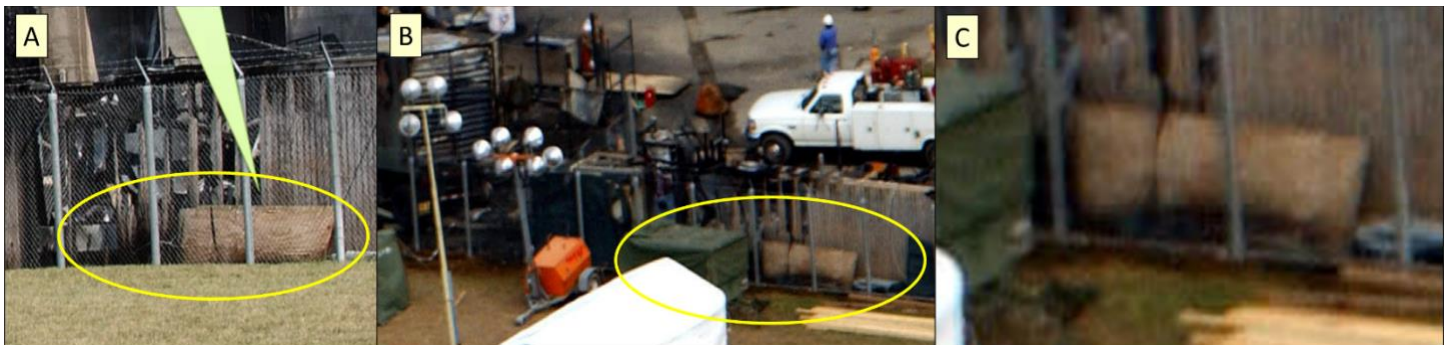
Figure 6: Image A (left) is from Figure XA-16 and asserts the brown object to be a cut tree-stump. Images B and C show it to be narrow and flat like plywood.

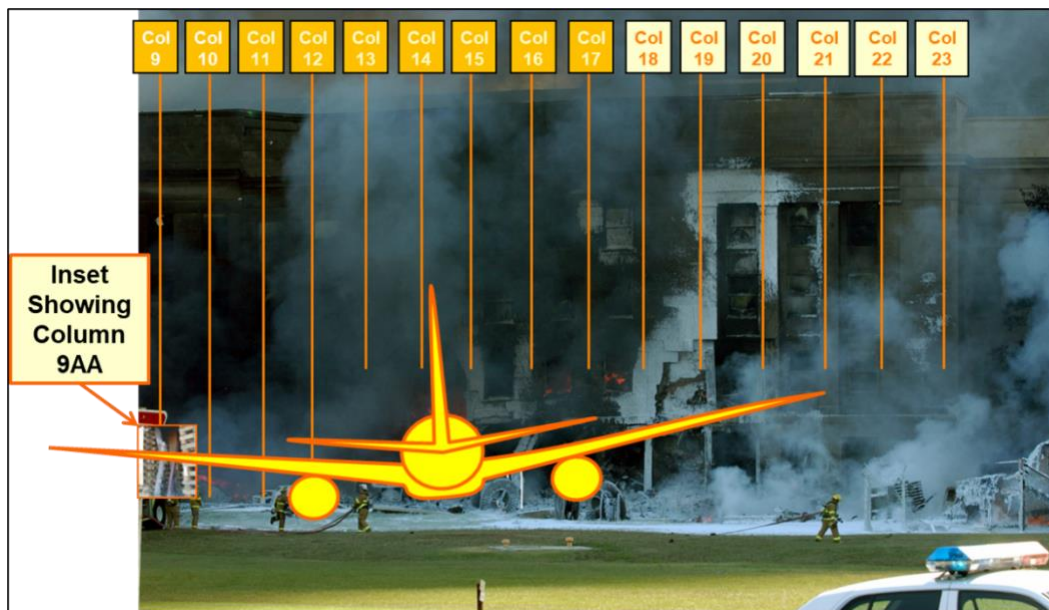
Figure 7: Approximate impact profile on to the Pentagon Facade showing left wing is under the second-floor slab.

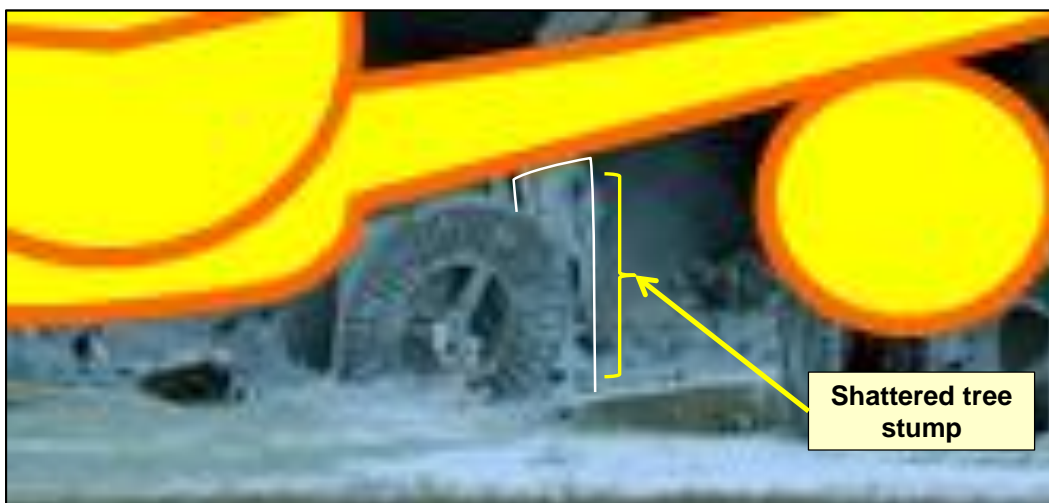
Note that the stump of the tree that had been in front of Column 16 can be seen protruding from the rubble (Figure LPI-13). It has a smaller diameter and is clearly splintered rather than cut. Therefore, based solely on size, what Arena identifies as part of the trunk could not possibly be from that stump. The height of the tree stump under the wing is shown in Figure 7 and a close-up is shown in Figure 8.

Figure 8: Detail showing height of the wing with respect to the shattered tree stump in front of Column 16. Many of the wire spools were located below the wing as shown.

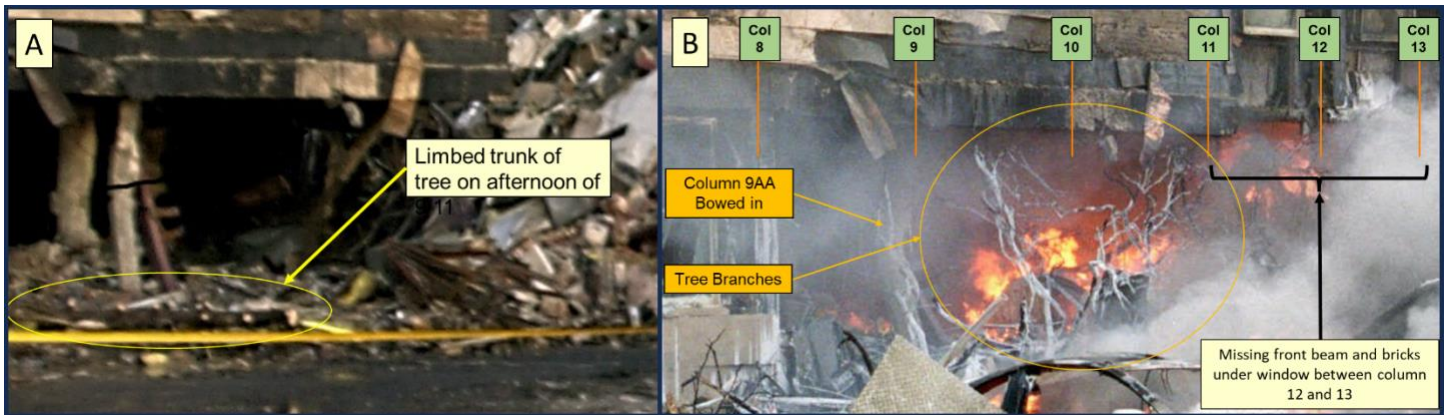
Furthermore, an actual tree trunk with some of its branches remaining can be seen lying along the base of the Pentagon wall to the north of the impact point, with the base of the trunk displaced the farthest. The fact that the tree traveled base-first is consistent with it being severed from an impact at its base and, because the center-of-gravity of the severed tree cannot accelerate instantaneously, the severed trunk will rotate slightly upward and above most of the plane’s structural frame. The impact mechanics show that the component of the momentum toward the building would impart a velocity to the base of the tree toward the wall, causing part of the damage seen in the 16 ft wide hole in the second floor, while the component of the momentum parallel to the wall would impart a velocity northward, dragging the upper parts of the tree behind. This mechanism is also consistent with the observation that the upper branches are engulfed in

flames in many photos of the area between Columns 5 to 10. Figure 9 shows the tree trunk during the clean-up on the afternoon of 9/11 (see Arena’s similar photo in Figure XA-6) and the burning tree branches in the Will Morris photo.

Figure 9: Cut up tree trunk on evening on 9/11 (A) and burning tree branches (B))

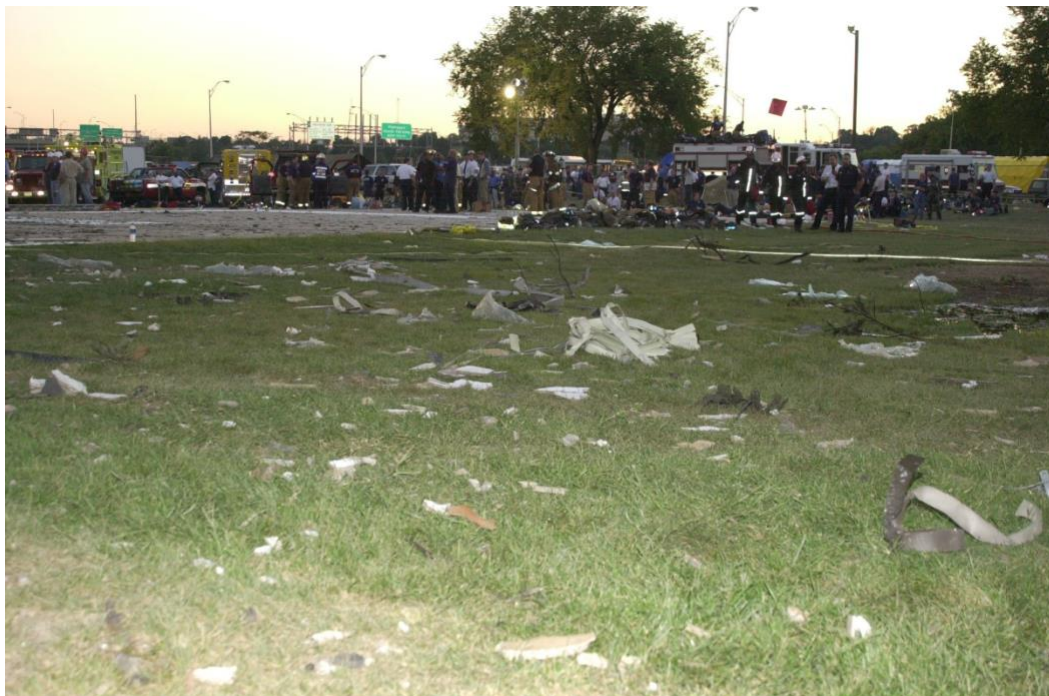
As shown in Figure 10, there is also a large amount of tree litter that is preferentially scattered northward across the heliport and onto the lawn which we identify as originating from this tree.

Figure 10: Tree branches and other debris north of the Heliport.

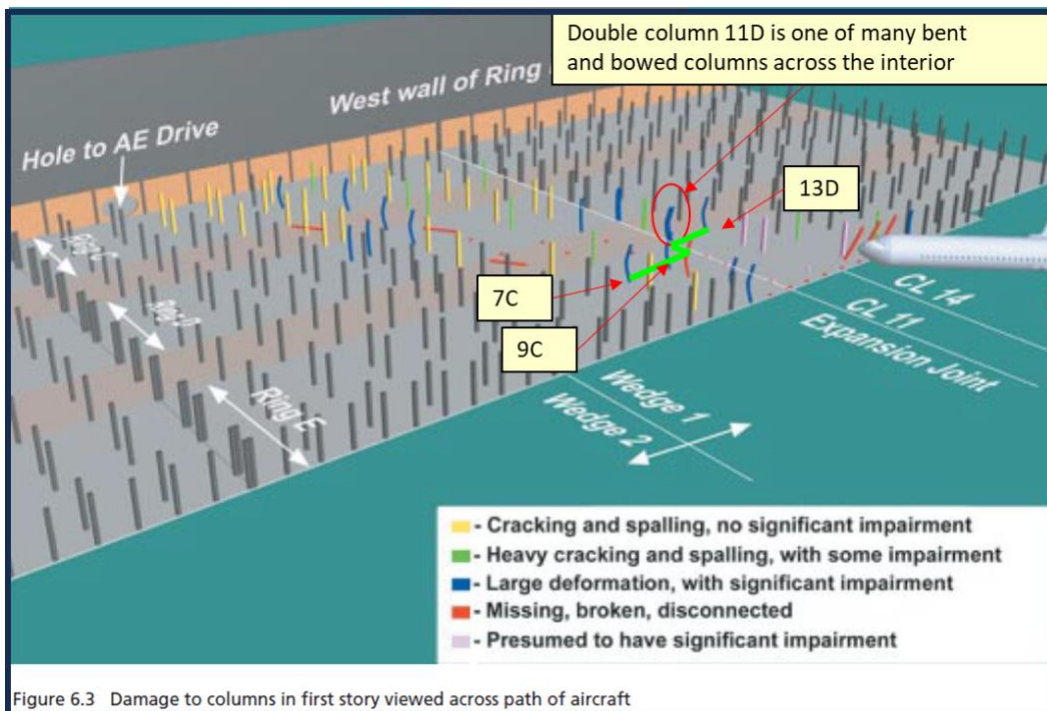
The blue columns in Figure 12 show the extent of bent and bowed columns across the impact path. A green line in the figure traverses a width of at least 60 feet from Column 13D to 7C. To claim the source of the energy was explosive detonation would require a detailed mechanism to channel the energy into the observed path of destruction hundreds of feet from the façade while constrained within a 15-foot vertical space.

Figure 12: Damaged first floor columns, documented to have been bent-and-bowed, are shown in blue.

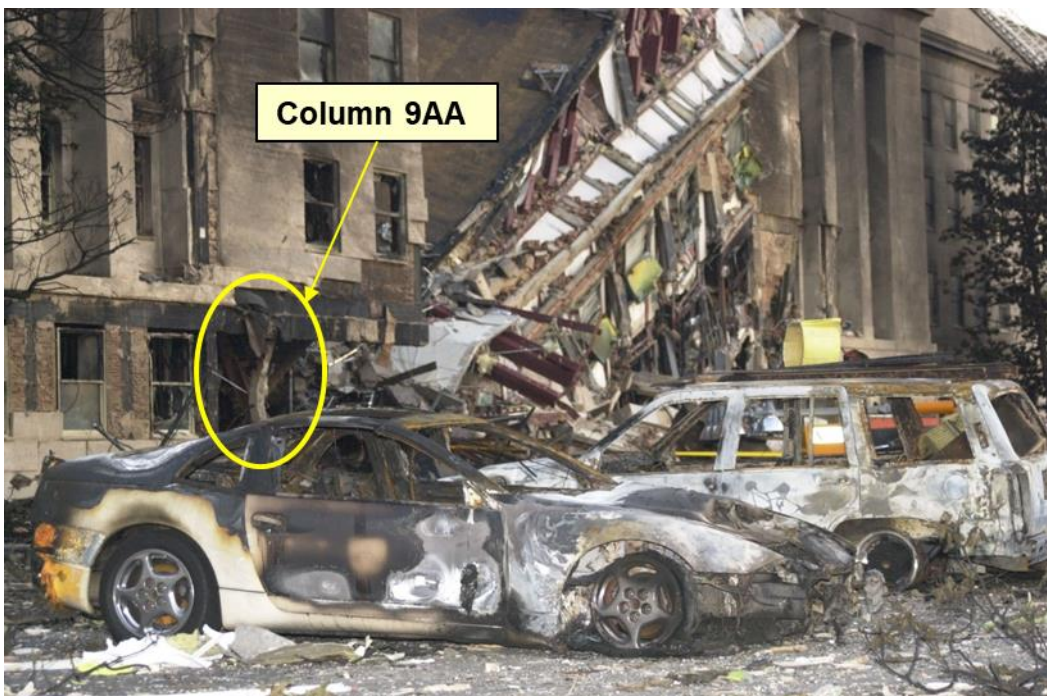
Arena says, “The column [9AA] could not endure a 52° incident angle impact and end up being bent to the east.” But Figure 13 shows that when viewed from about 45 degrees from the northwest, Column 9AA has a large deformation in the northeast direction. This is consistent with the northeast direction seen in Column 14AA and the other columns on the first floor.

Figure 13: Column 9AA is seen from a vantage point showing the near maximum deformation.

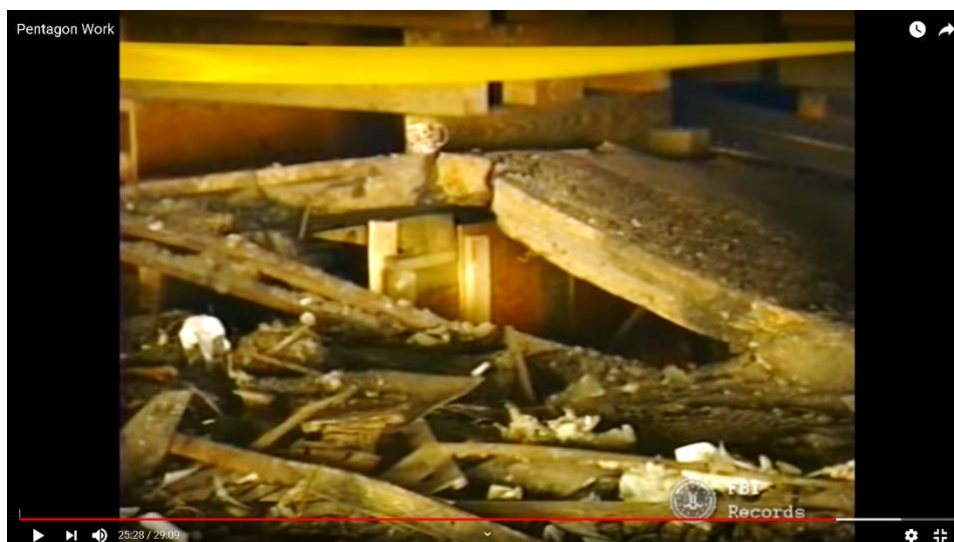
This damage was the topic of a recent Debated Topics Forum paper that was written by one of the authors of this paper that identifies its source as the kinetic energy of the rapidly rotating jet engines¹⁰ which were caused to redirect their motion chaotically due to torques from multiple impacts with columns and the dynamic effects of precession. Analysis of the aircraft approach and impact provides an explanation of how the left engine entered the Pentagon, with a documented trajectory through the columns. Impacts along this path would create a tumbling and bouncing 5-ton gyroscope directly under the uplifted slab. The tenting of the slab, shown in Figure 15, reflects a mechanical snapping that would be characteristic of impact damage, not a detonation with the pulverization characteristic of “focused ordinance.” Context is important as Major David King was nearby the location of Arena’s alleged explosion and was not injured by what would have been a massive explosion.

Figure 15: Uplifted Second Floor Slab illustrating mechanical damage, not explosive detonations.

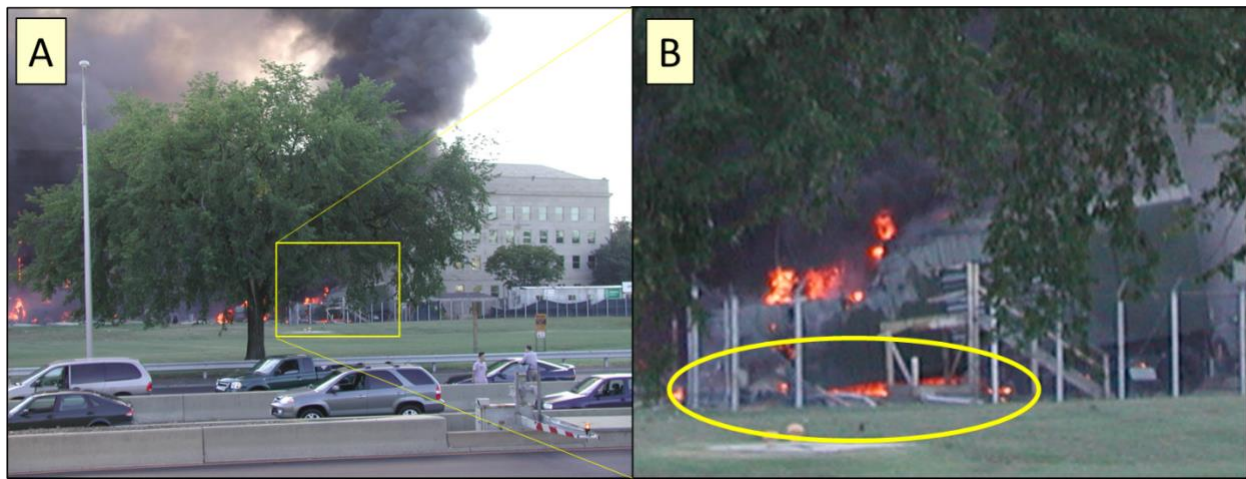
As shown in Figure 17, Steve Riskus’s photograph¹² was taken very nearly perpendicular to the façade which minimizes perspective errors. In this image, the fence posts are shown to be pushed in the direction of the impacting aircraft. Because this image was taken before any firetrucks arrived, any conjecture that firetrucks bent the posts is unfounded.

Figure 17: The Image from Steve is effectively perpendicular to the façade (left) and shows the fence posts pushed in the direction of the impacting aircraft.

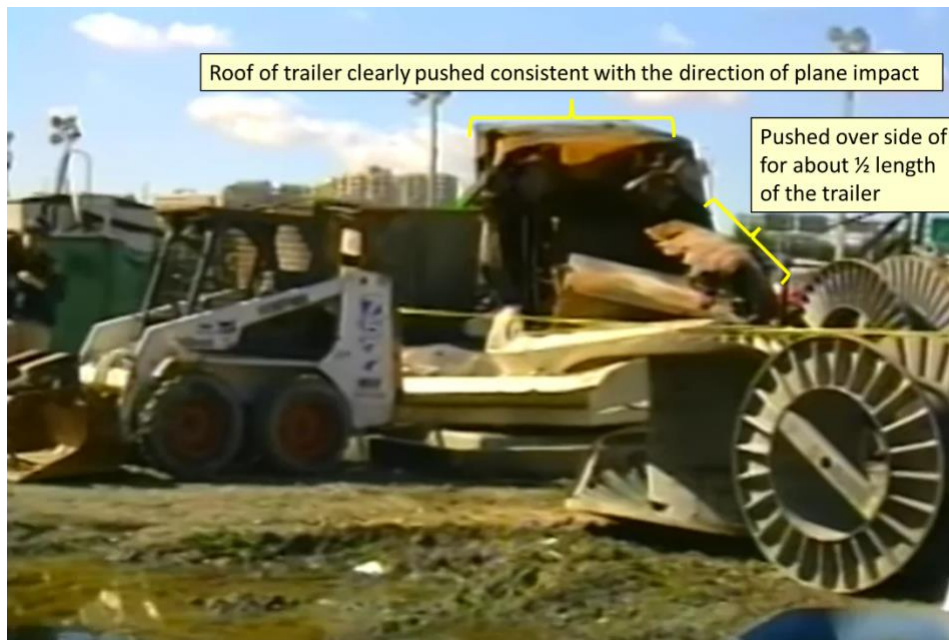
Figure 18 is an annotated copy of Figure XA-24 which shows that the generator trailer cover was violently pushed and ripped in the direction of the impacting aircraft. While, as Arena says, “... interpreting such an image would be challenging,” there is a lot of information in this image that supports an impact by an object that pushed over and ripped the generator’s steel cover. This was followed by fire as shown in the Riskus photo. It is well known that fires, of the magnitude documented on 9/11, burn paint off of steel and that subsequent exposure to rain results in quick formation of a coating of rust.

Figure 18: Ripped and pushed over covering of the generator with obvious distortion in direction of impact.

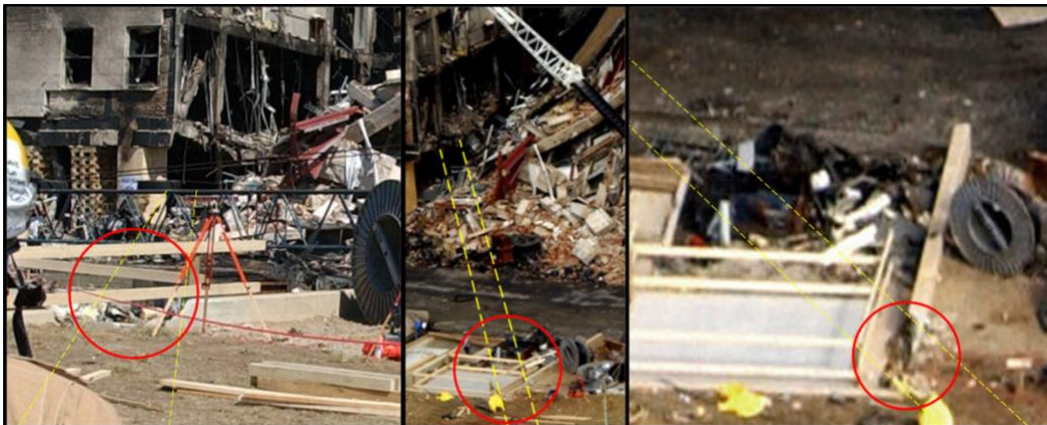
When discussing the gouged retaining wall, Arena says, “... the retaining wall appears broken, with fracture patterns that are incongruent with the alleged angle of approach.” Our analysis shows that the shape of the damage has an angular characteristic to it that aligns with the impact direction of the impacting aircraft. Figure 19 shows three different images with yellow dotted lines indicating a consistent path of the left engine through the retaining wall to the façade between Columns 10 and 11. Furthermore, the engine would have continued into the Pentagon at an angle consistent with its impacting Column 9B as shown in Figure 20.

Figure 19: Path of the left engine through the gouged retaining wall.
