Metal Removal via Slag Attack of the Steel from Building 7 of the World Trade Center—Some Observations

R.D. Sisson, Jr., and R.R. Biederman

Microstructural examination of a beam from Building 7 showed that temperatures higher than 940 °C were experienced in localized regions. Concurrent examination of the beam surfaces and surface layers showed evidence of extensive metal removal, and the analysis suggests that this removal occurred while the beam was exposed to the fire in the rubble pile after the building had collapsed.

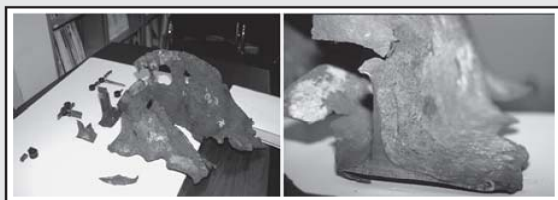
the “pile of rubble” that had been burning for many days. The samples had been exposed to the fires in the building while it remained standing as well as the fires in the rubble on the ground after the building collapsed. In this sample beam, extensive metal removal was observed with thickness decreases up to ½ in. and very localized regions of total metal loss. A photograph of the steel beam sample is presented in Fig. 1. A photograph of a metallurgical mount of a beam section is seen in Fig. 2.

Fig. 1 Severely eroded ½ in. wide flange beam from WTC 7. Nominal composition (%) of the A36 steel plate is 0.29C max, 0.80–1.2Mn, 0.04P, 0.05S, 0.15–0.3Si, bal Fe.

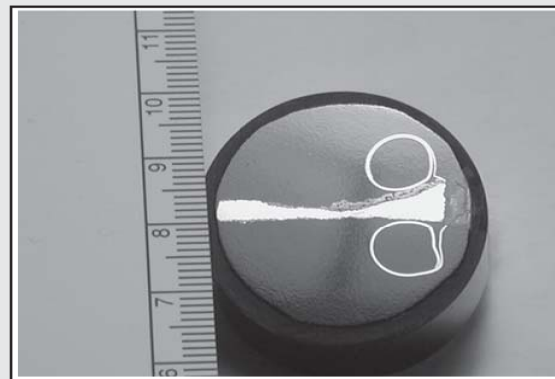
Fig. 2 Cross-sectional metallurgical mount

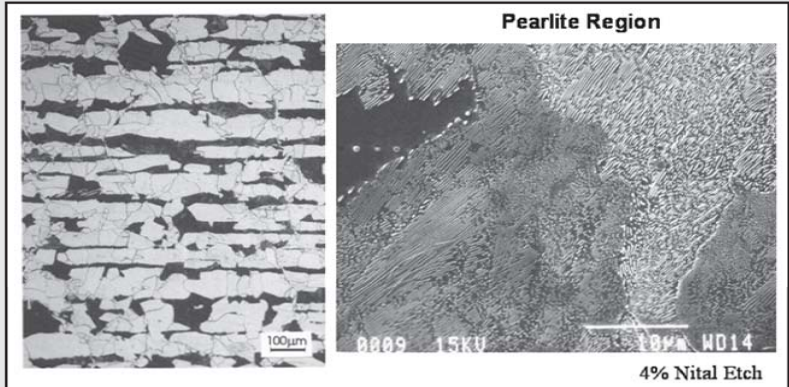
The microstructure of the steel from Building 7 is typical of a structural steel such as ASTM A36. The wide flange beam displayed a microstructure that consisted of a banded hot worked mixture of ferrite and pearlite (Fig. 3). The microstructures in these regions displayed no effects of excessive heat or metal loss.

Fig. 3 Microstructure of unaffected A36 steel. White—ferrite; dark—banded pearlite. Pearlite forms in bands due to manganese segregation and prior hot working. 4% nital etch

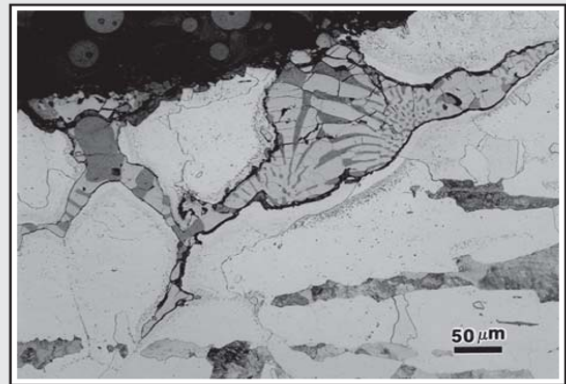
In the regions of the beam that exhibited extensive metal removal, an intergranular liquid slag attack was observed (Fig. 4). Scanning electron microscopy (SEM) with energy-dispersive X-ray spectroscopy (EDS) identified the slag to be comprised of Fe, O, and S (Fig. 5). Chemical reactions including oxidation, sulfidation, and decarburization occurred, as well as the usually observed phase transformations in the steel.

Fig. 4 Optical micrograph of near-surface region showing iron oxide-iron sulfide eutectic structure, grain-boundary attack, and decarburization

and sulfur. Assuming these phases are FeO and FeS, their phase diagram^[4] is a simple eutectic with the eutectic composition of approximately 55 mol.% FeS at 940 °C. The microstructure of the slag is composed of primary FeO and the eutectic structure (Fig. 4, 5, and 9).

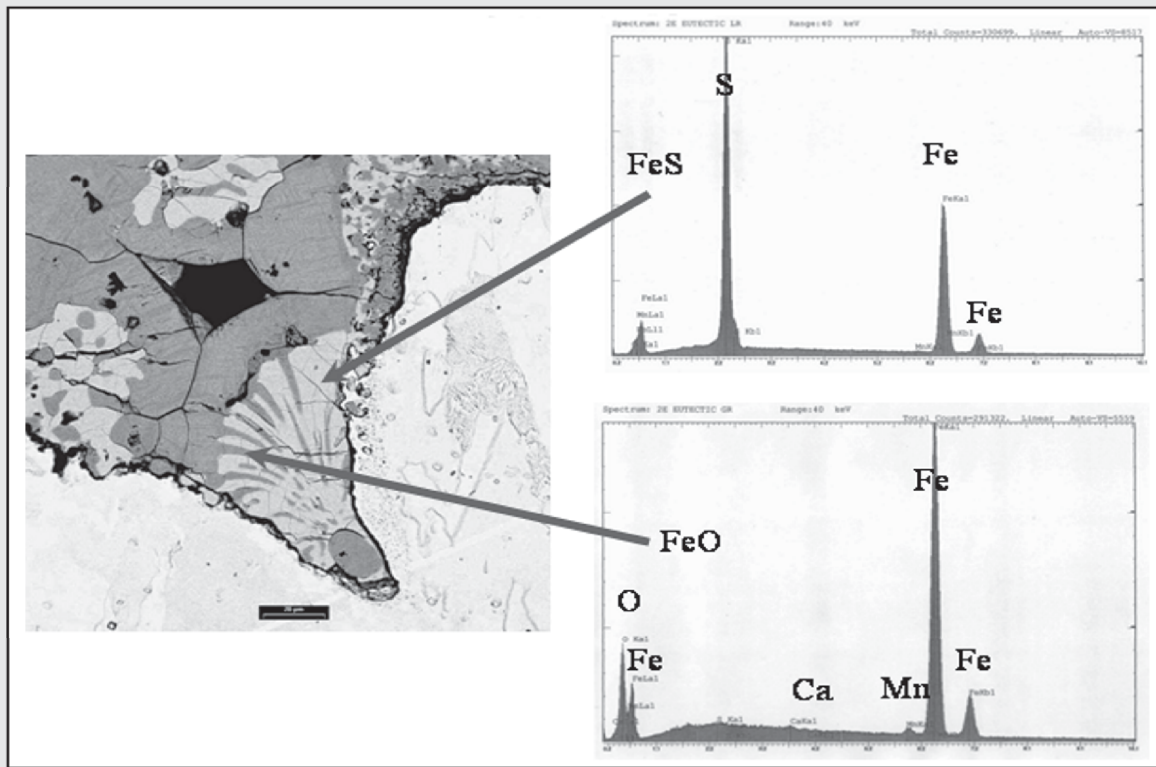
Using EDS with SEM, it was determined that the slag contained iron, oxygen, and sulfur (Fig. 5). The reaction of this slag with the steel resulted

Fig. 5 Energy dispersive X-ray spectroscopy (EDS) analysis of eutectic region

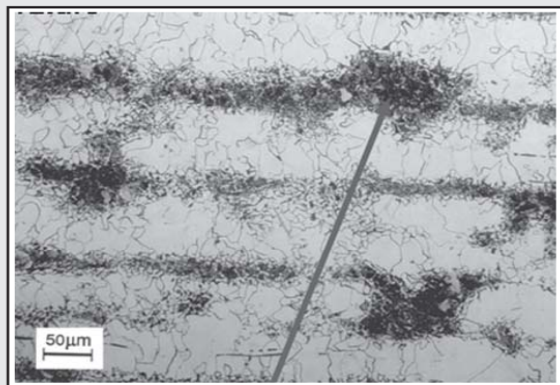
As the temperature increases, several microstructural changes^[3] normally occur within the steel. Two important intermediate temperature transformation reactions that occur soften the steel. These are the pearlite spheroidization reaction at temperatures below the A1 temperature, and the conversion from ferrite and pearlite to austenite at temperatures above the A1 temperature and above the A3 temperature, followed by transformation back to pearlite and ferrite on cooling. Typical examples of these transformations are presented in Fig. 6 and 7, within the pearlite banded regions near the bottom of Fig. 4. In Fig. 6, the Fe₃C in the pearlite had started to spheroidize. Also, some pearlite bands have areas where a re-austenitization had occurred and new finer-grained regions of pearlite and ferrite formed on cooling (Fig. 7). These observations indicate that the steel in this region

Fig. 6 Typical microstructural changes that occur when A36 steel is heated to the vicinity of the eutectoid reaction $\sim 727^\circ\text{C}$ (1340°F), held for a short time, and cooled to ambient temperature. Arrow indicates partial carbide spheroidization.

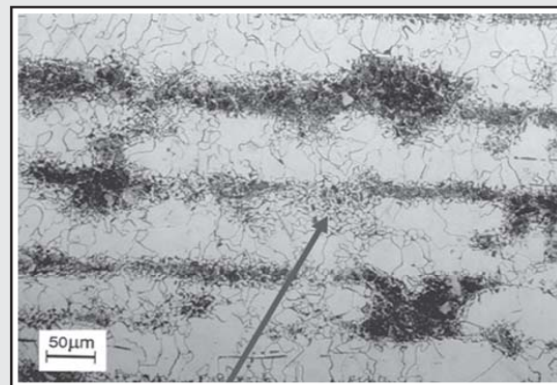
had experienced temperatures in the range of 550 to 850 °C.

Fig. 7 Typical microstructural changes that occur when A36 steel is heated to above the eutectoid temperature $\sim 727^\circ\text{C}$ (1340°F) and cooled to ambient temperature. Arrow indicates a typical region where conversion to an austenite matrix (on heating) occurred followed by a retransformation to a ferrite matrix on cooling.

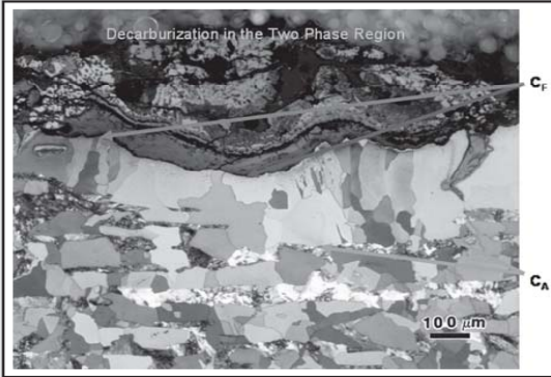
An example of a typical near-surface microstructure is shown in Fig. 8. This microstructure shows the scale and slag reaction effects at the top of the micrograph and the normal metallurgical reactions that occurred in this steel on heating and cooling toward the bottom. As the temperature increased, some changes in the microstructure of the steel occurred as a result of heating and cooling. However, as higher temperatures occurred, microstructural as well as chemistry changes occurred due to the reactions with the environment. The interaction of heat in a corrosive fire environment resulted in exposing the steel to sulfidation, oxidation, and reductions in thickness.

in several metallurgical effects. First, the surface of the steel was decarburized in this environment (Fig. 8). Second, the slag preferentially attacked the grain

Fig. 8 Decarburization in the two-phase region. Courtesy of George Vander Voort

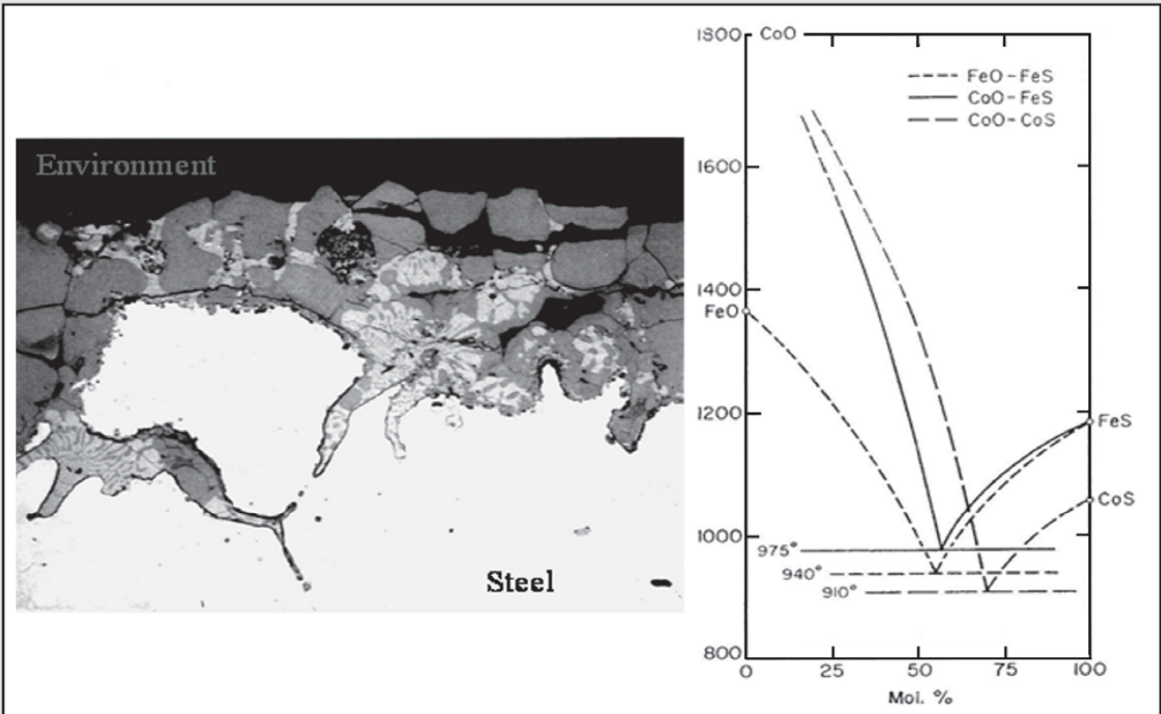
boundaries (Fig. 9). This grain-boundary attack and metal dissolution was the cause of the severe metal removal in some sections of the beam.

The microstructure of the slag with the eutectic structure and the primary FeO indicates temperatures in this region above 940 °C and maybe up to 1100 °C, as indicated by the phase diagram.^[4]

Fig. 9 Optical micrograph of near-surface region showing iron oxide-iron sulfide eutectic structure, grain boundary attack, and decarburization and the FeO-FeS phase diagram. Source: Ref 4
