Rebuttal to Identification of The Plane Model That Impacted the Pentagon

Appendix B: Trajectory during the last quarter second
of a Boeing 757 Impact into the Pentagon

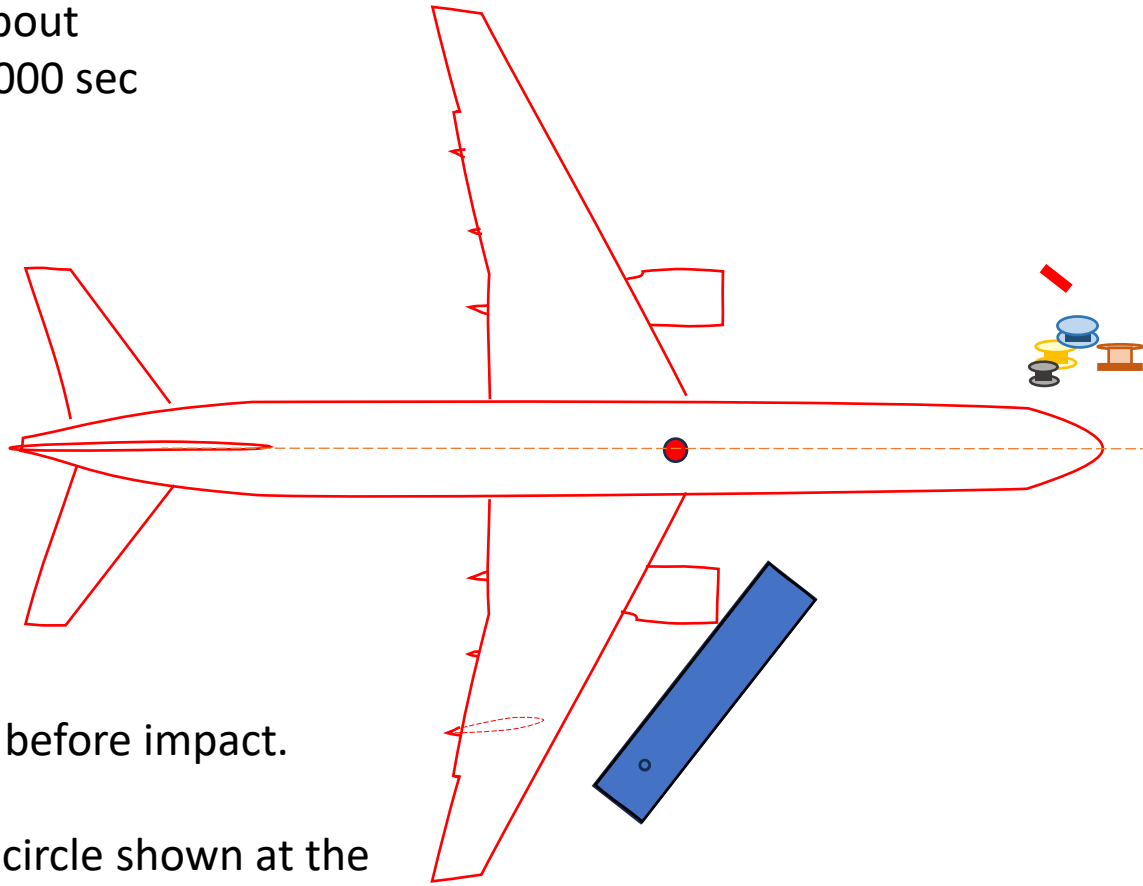
Boeing 757
at about
 $t=0.000$ sec

Just before impact.

The circle shown at the center of the plane is the assumed center of mass for rotation.

NOTE: The movement of wire spools #4 and #7 are estimated based on the assumed impact dynamics and the final resting locations seen in the Scott Boatright photo.

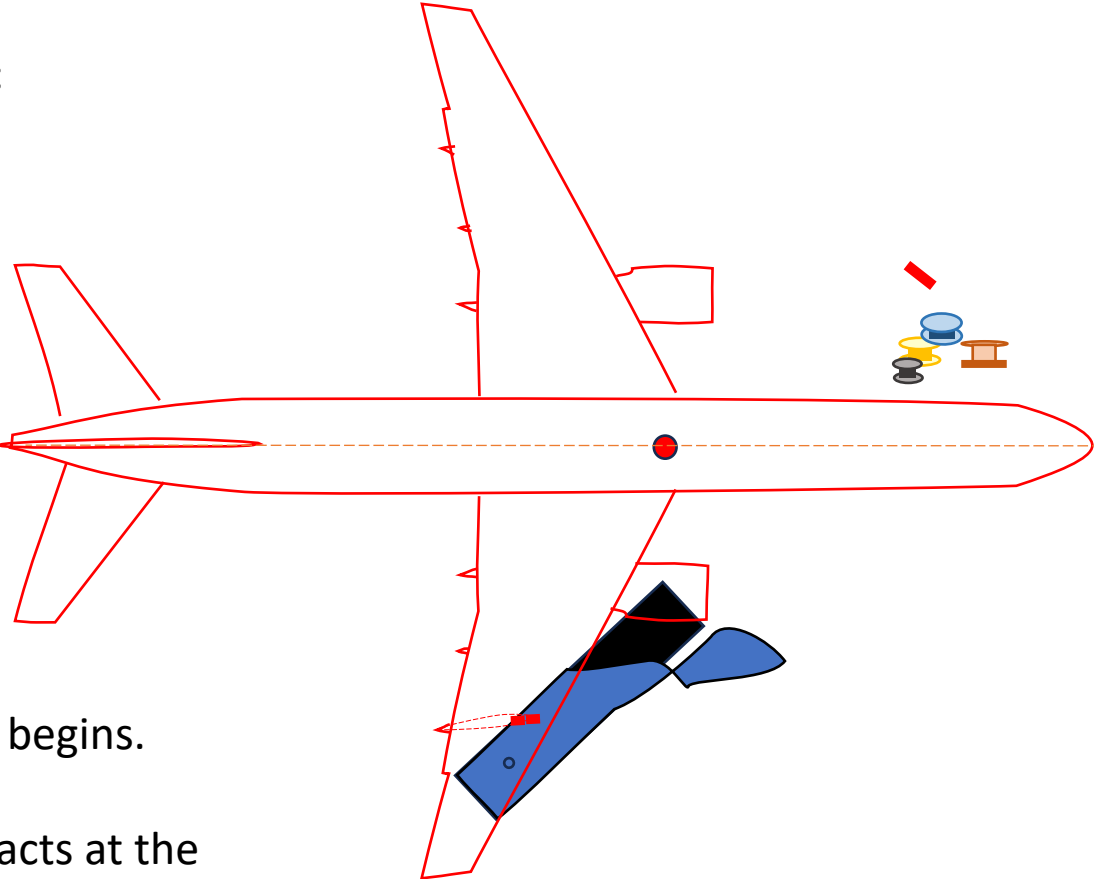
Boeing 757
at about
 $t=0.017$ sec

The impact begins.

Engine impacts at the
'bullseye' where the corrugated cabin
siding is hammered smooth.

The trailer's cabin is destroyed.

Both the aircraft and trailer begin rotating.

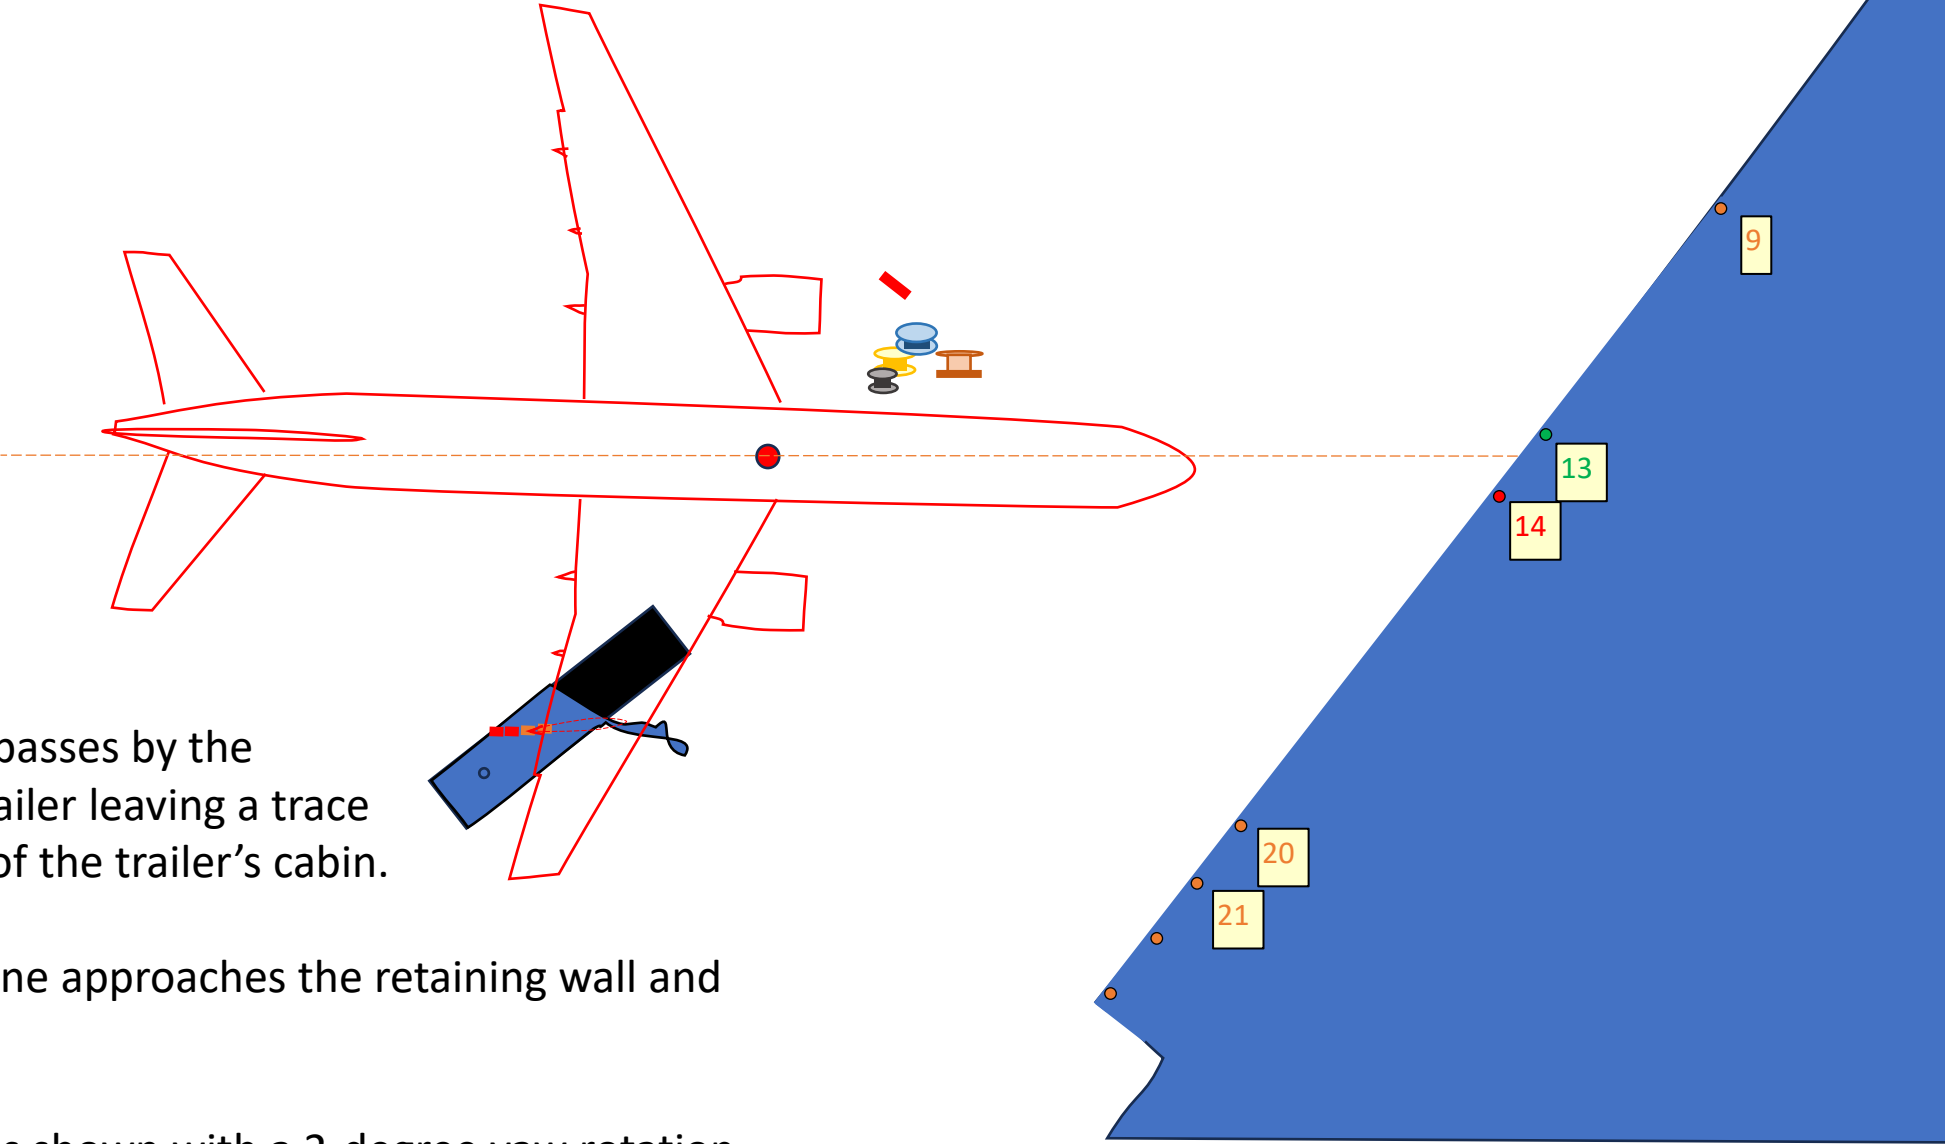
Boeing 757
at about
 $t=0.034$ sec

The aircraft passes by the generator trailer leaving a trace on the roof of the trailer's cabin.

The left engine approaches the retaining wall and wire spools.

The aircraft is shown with a 2-degree yaw rotation.

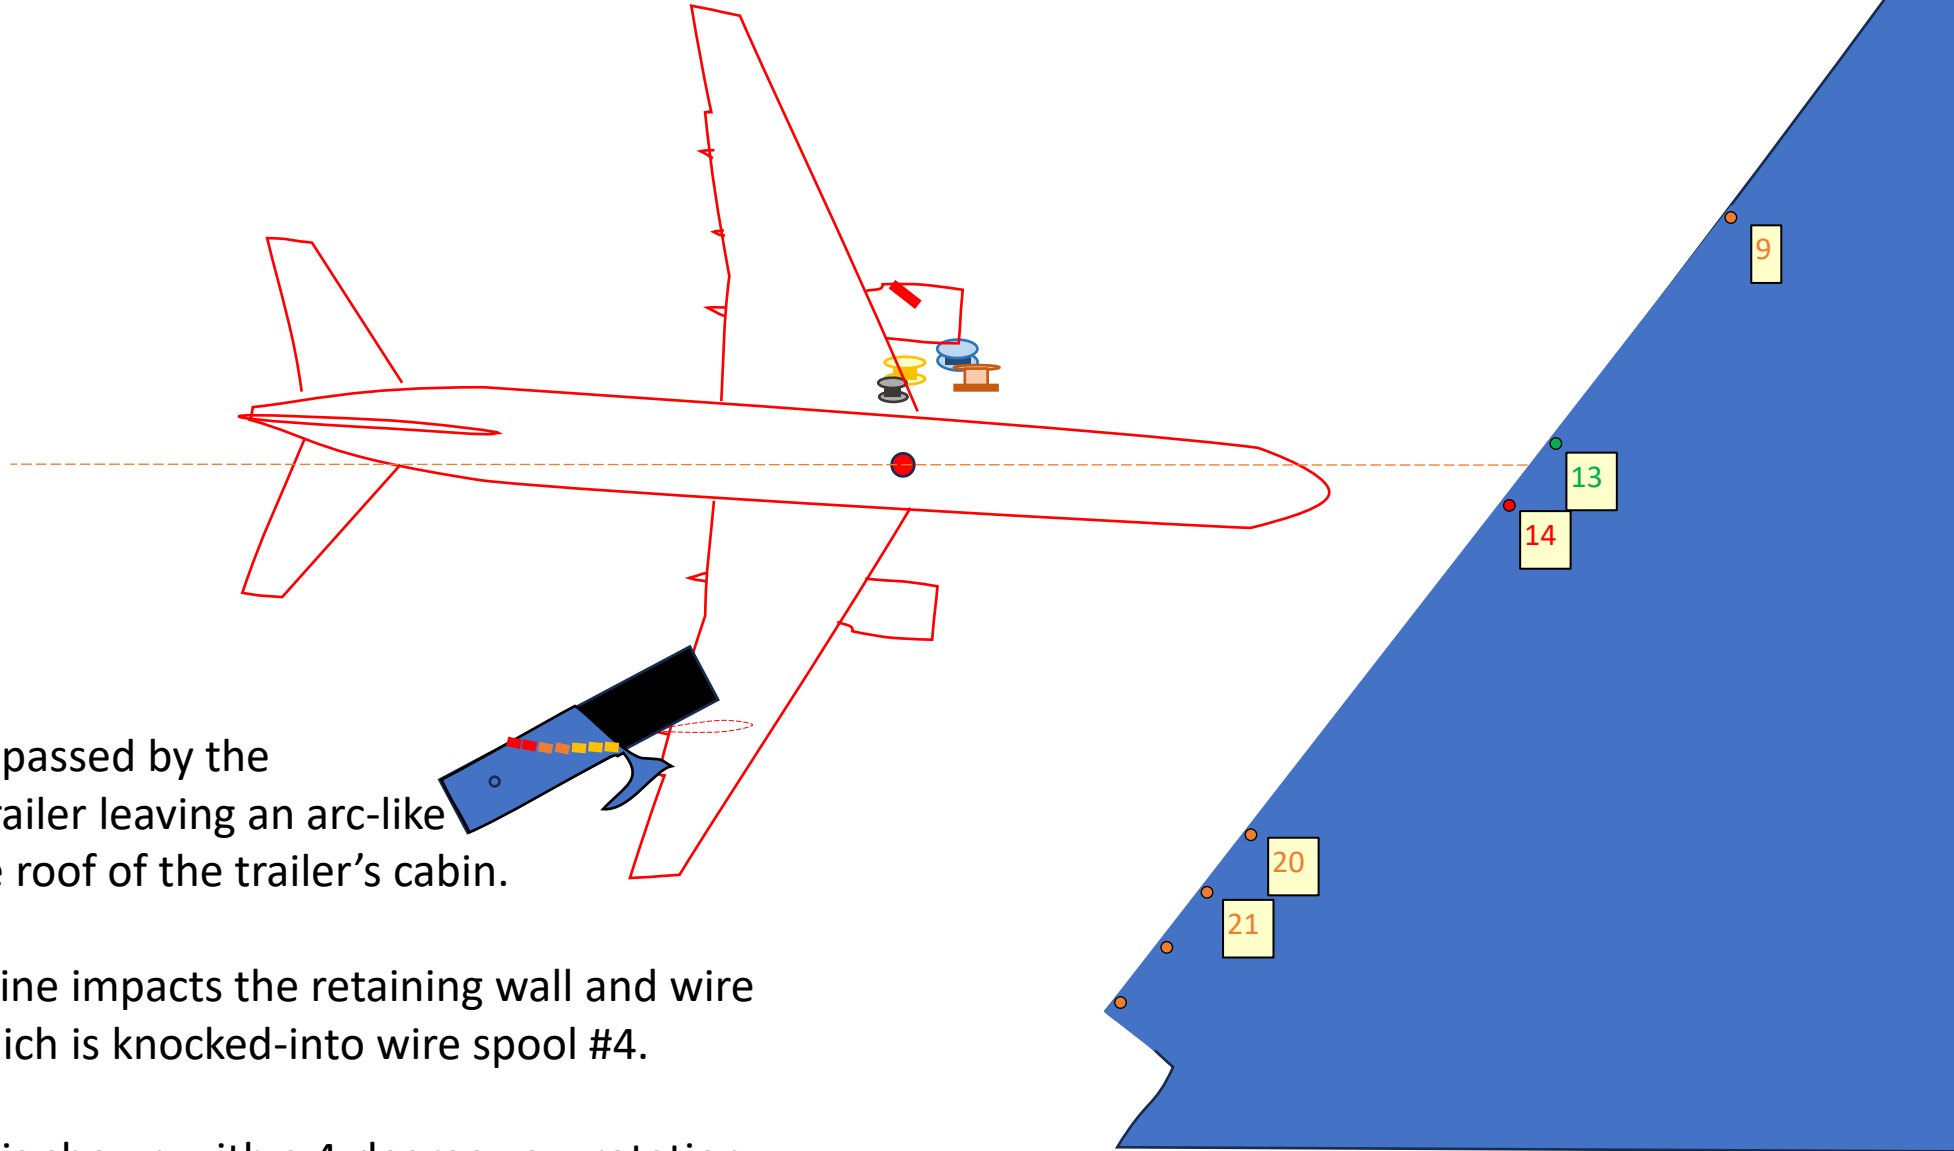
Boeing 757
at about
 $t=0.051$

The aircraft passed by the generator trailer leaving an arc-like trace on the roof of the trailer's cabin.

The left engine impacts the retaining wall and wire spool #7 which is knocked-into wire spool #4.

The aircraft is shown with a 4-degree yaw rotation.

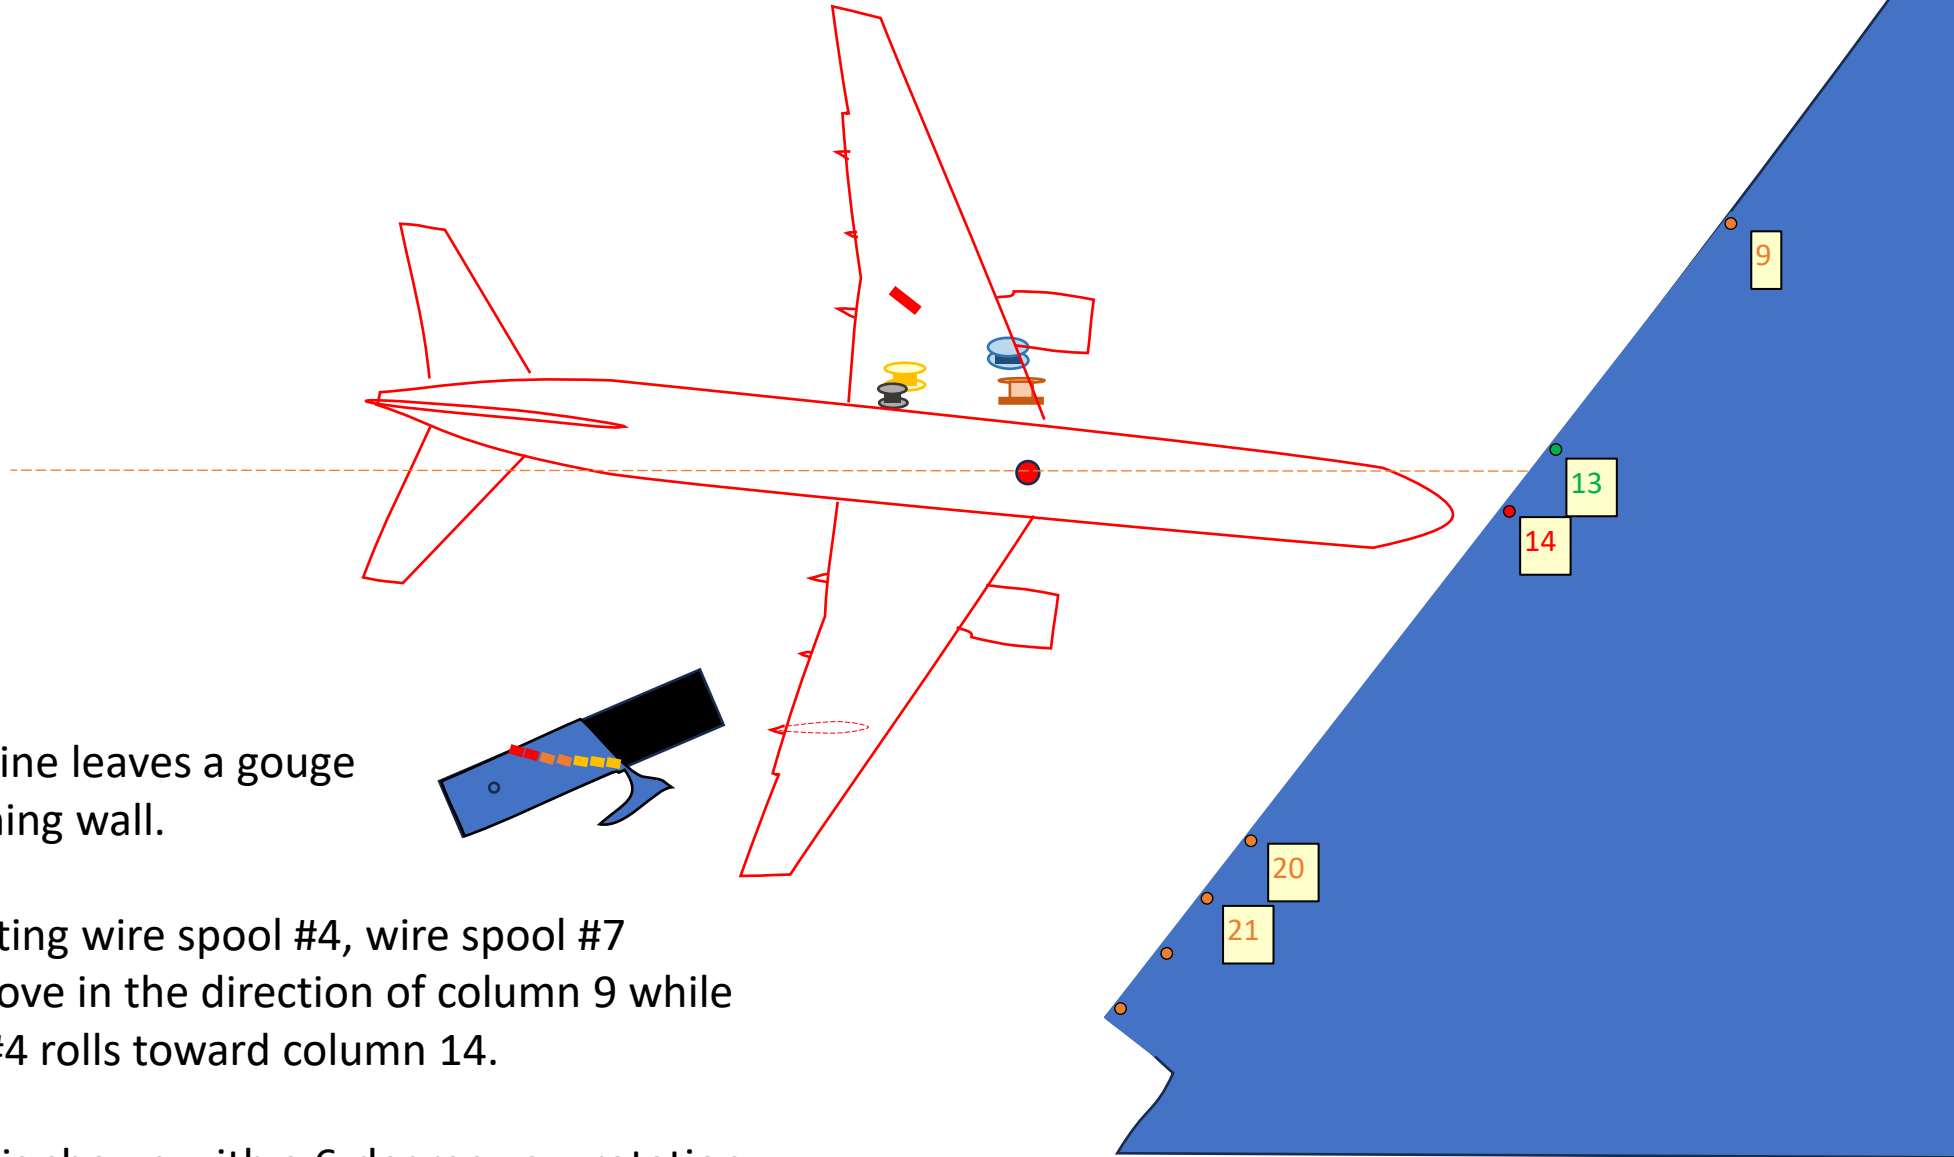
Boeing 757
at about
 $t=0.068$ sec

The left engine leaves a gouge
in the retaining wall.

After impacting wire spool #4, wire spool #7
begins to move in the direction of column 9 while
wire spool #4 rolls toward column 14.

The aircraft is shown with a 6-degree yaw rotation.

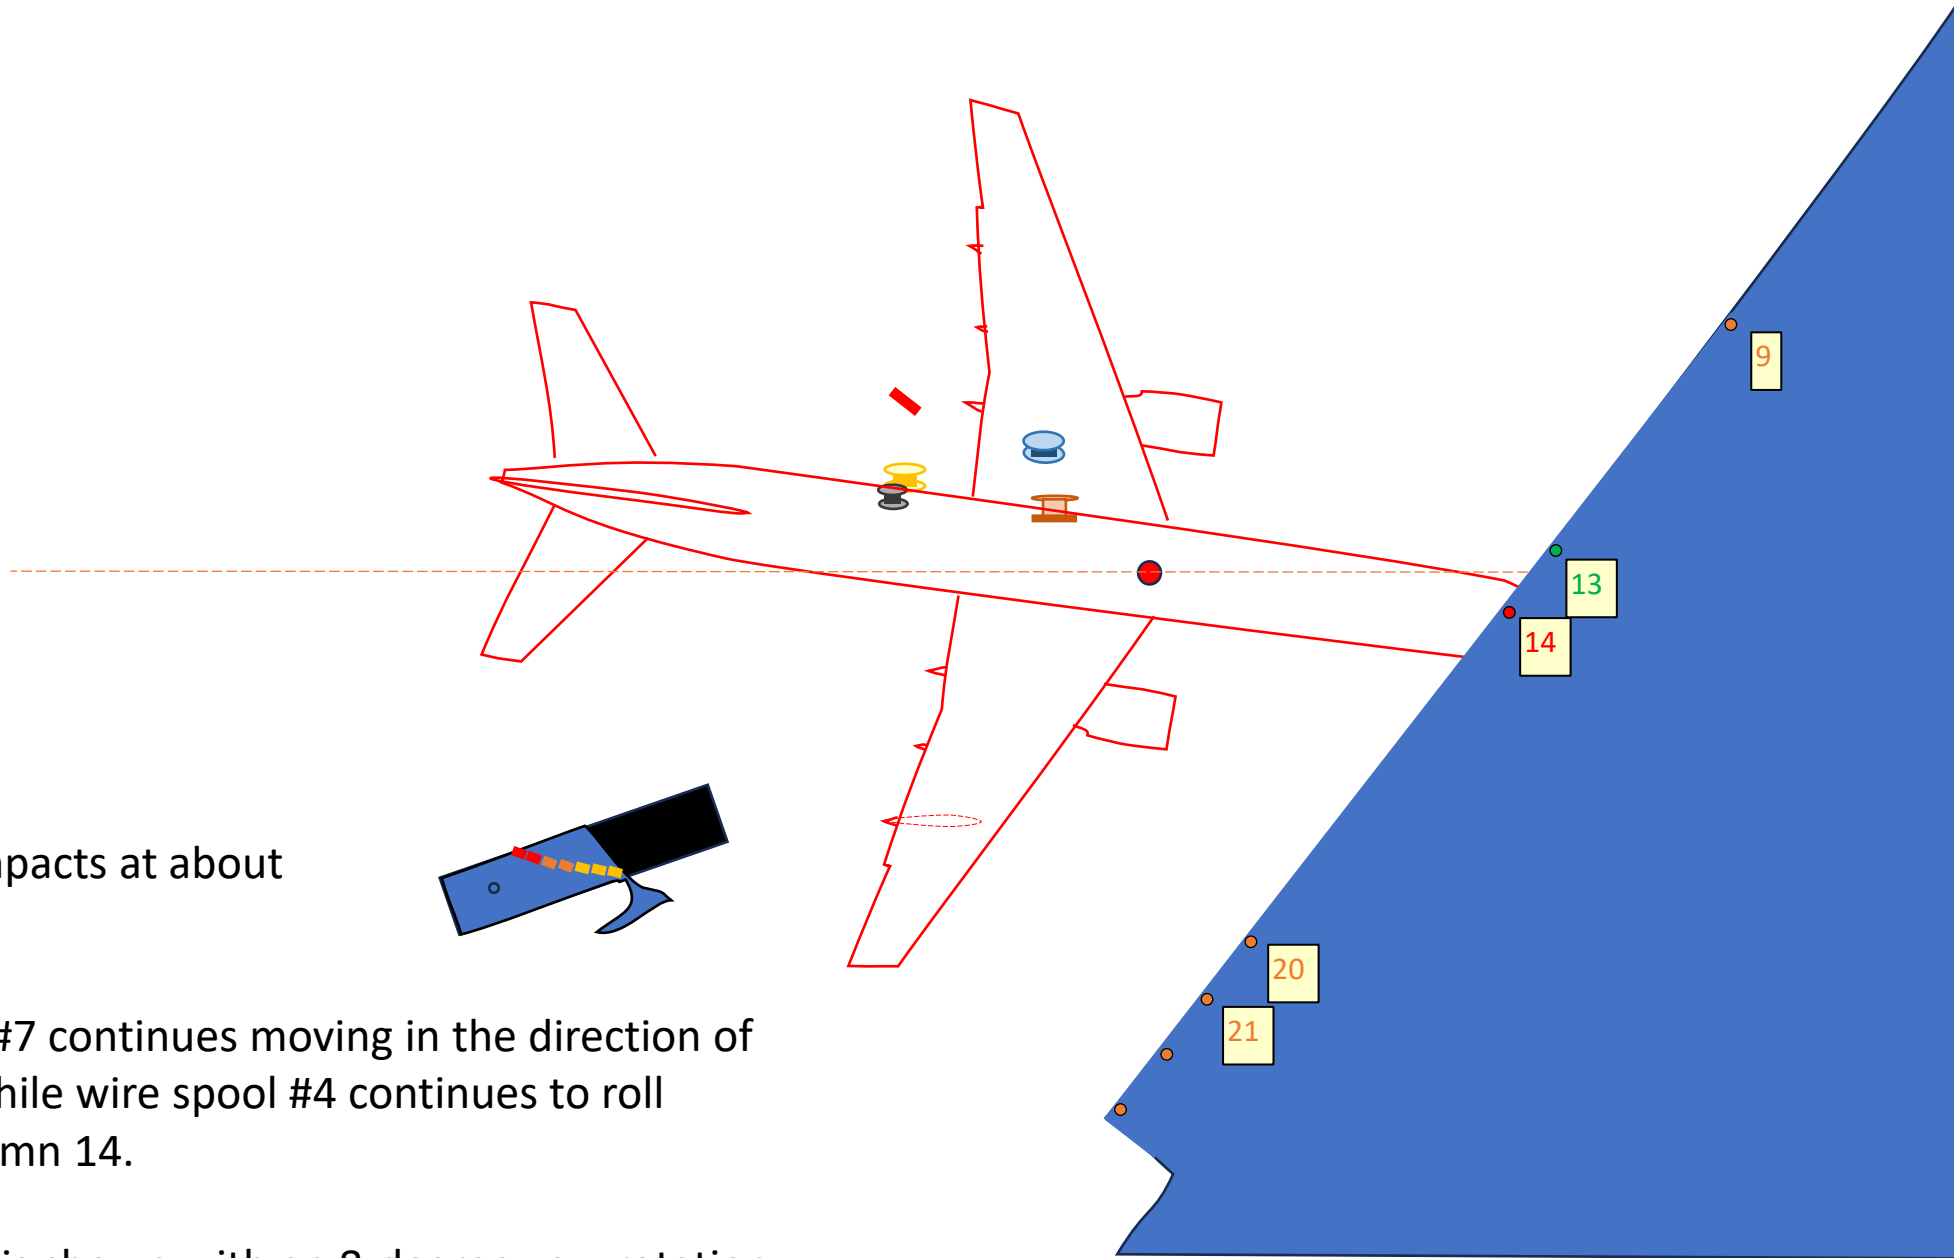
Boeing 757
at about
 $t=0.085$ sec

The nose impacts at about
column 14.

Wire spool #7 continues moving in the direction of
column 9 while wire spool #4 continues to roll
toward column 14.

The aircraft is shown with an 8-degree yaw rotation.

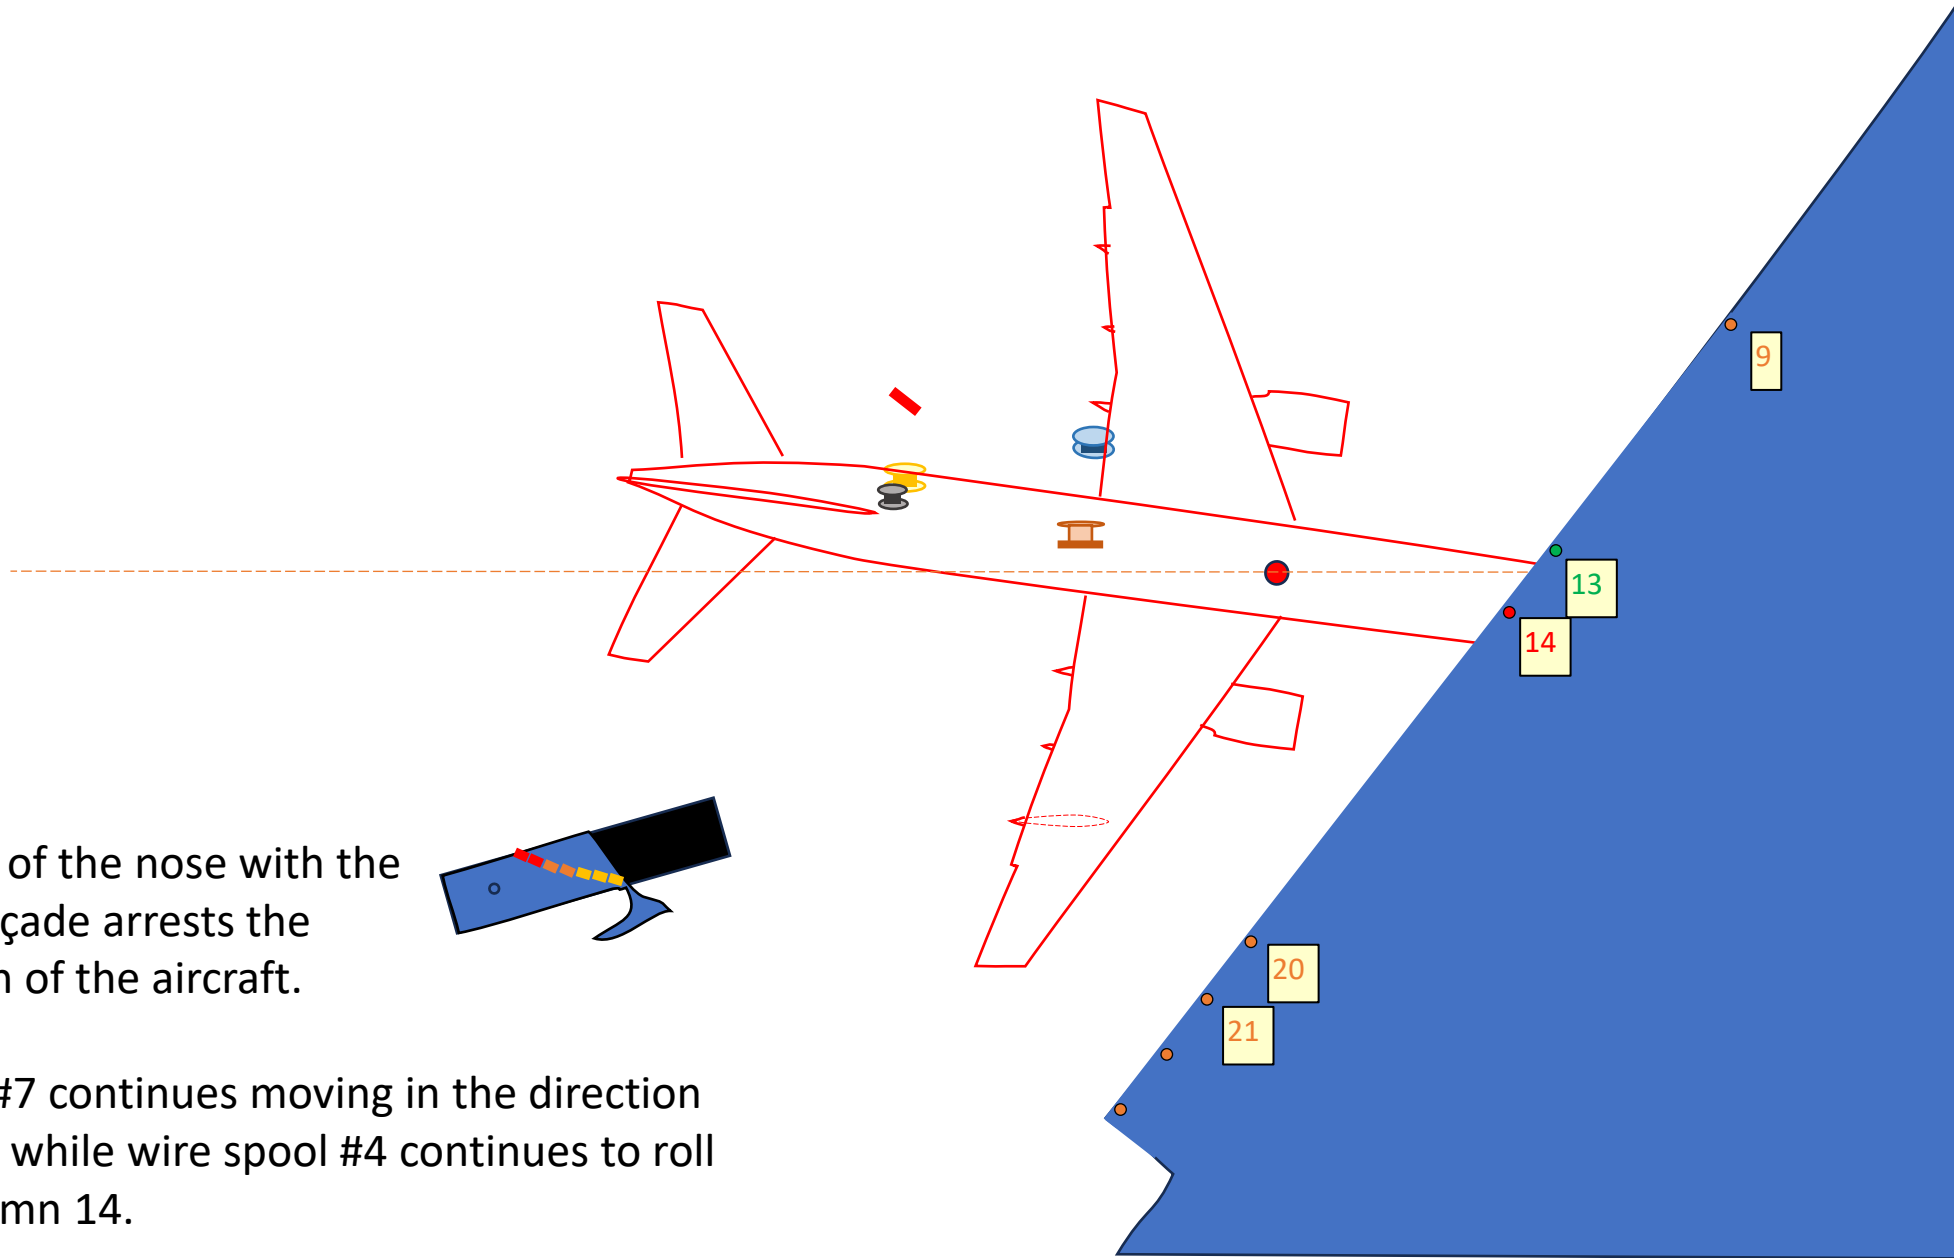
Boeing 757
at about
 $t=0.102$ sec

The contact of the nose with the Pentagon façade arrests the yaw rotation of the aircraft.

Wire spool #7 continues moving in the direction of column 9 while wire spool #4 continues to roll toward column 14.

The aircraft maintains its 8-degree yaw rotation.

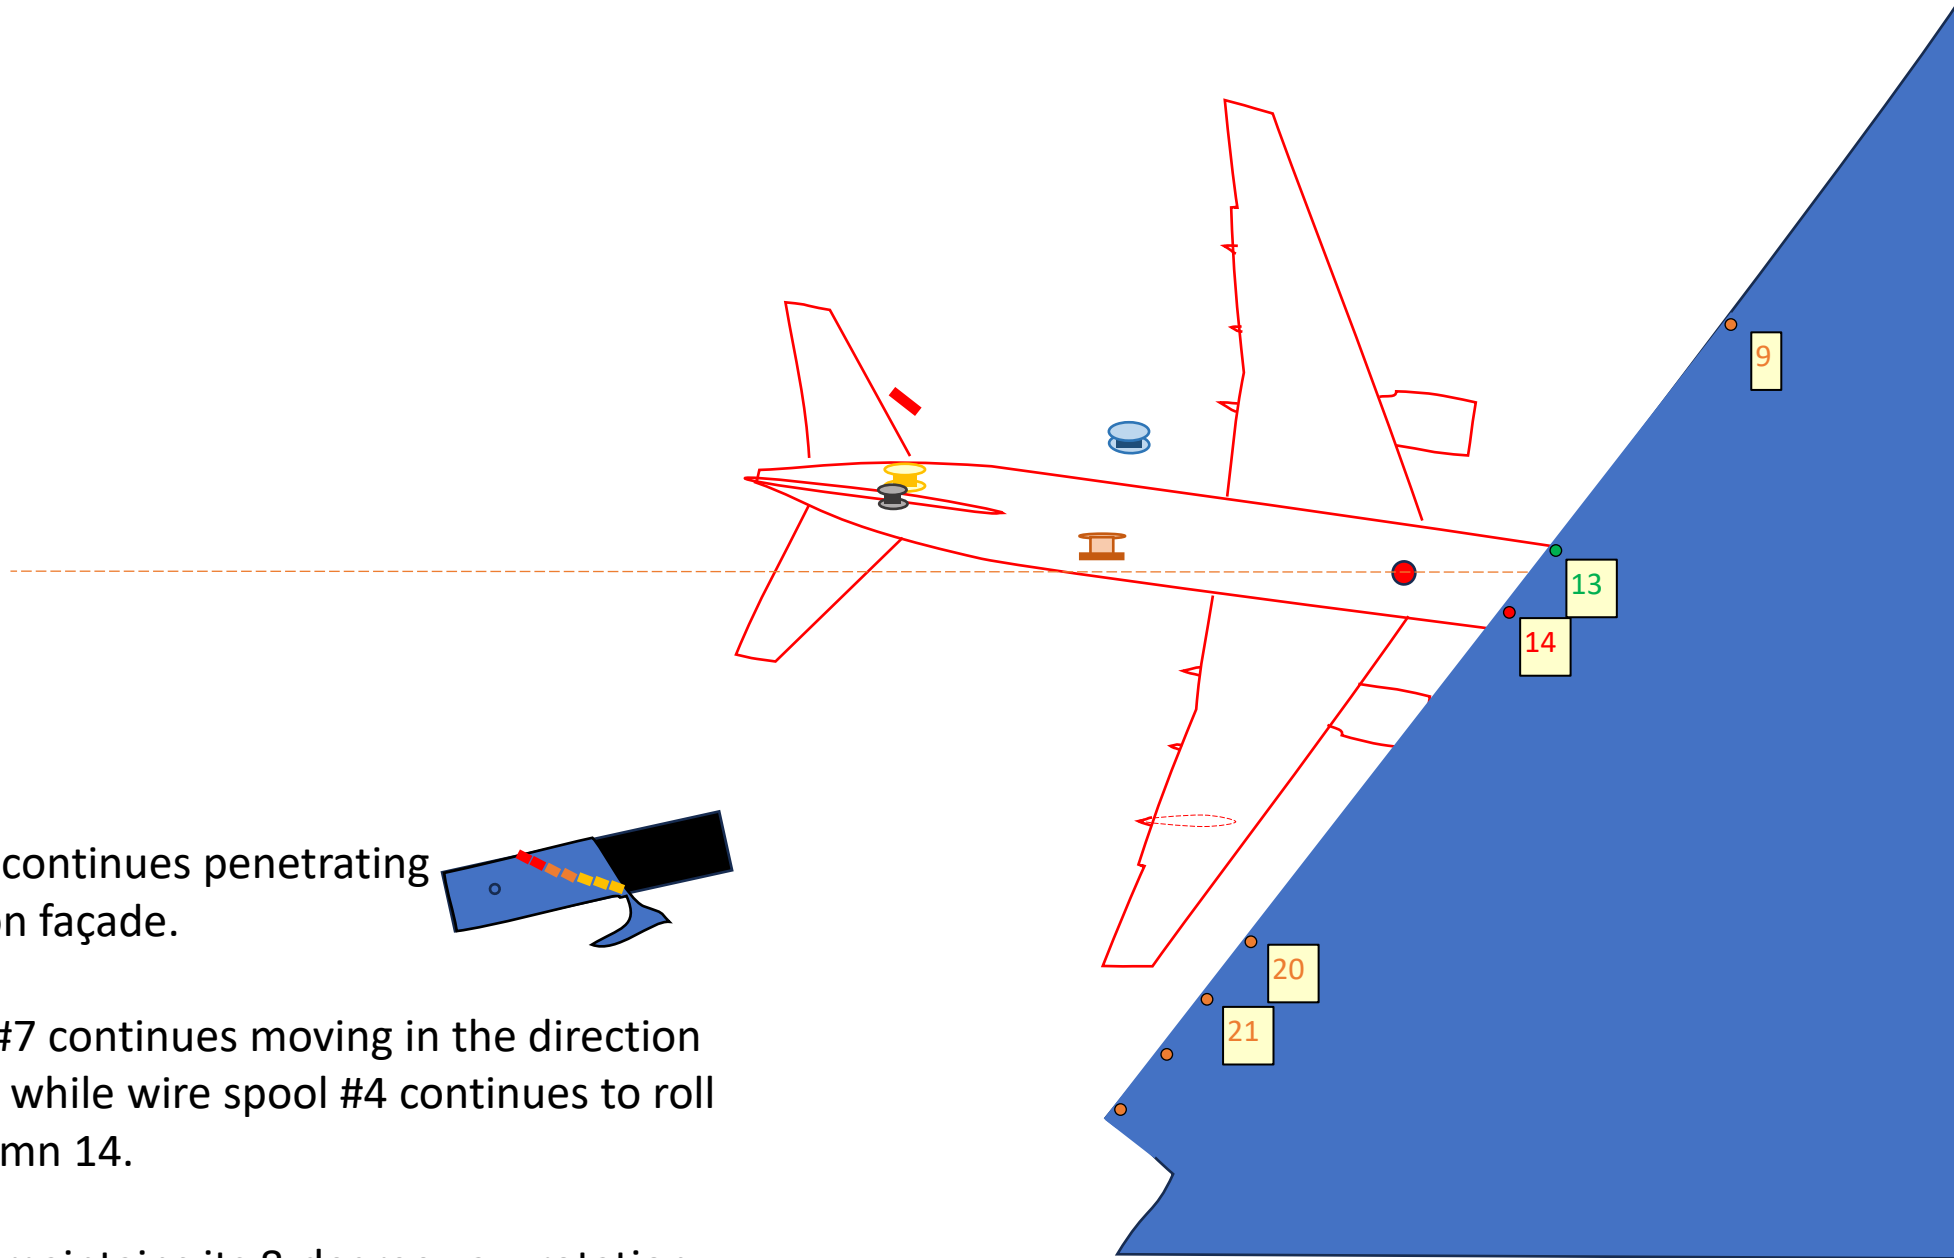
Boeing 757
at about
 $t=0.119$ sec

The aircraft continues penetrating
the Pentagon façade.

Wire spool #7 continues moving in the direction
of column 9 while wire spool #4 continues to roll
toward column 14.

The aircraft maintains its 8-degree yaw rotation.

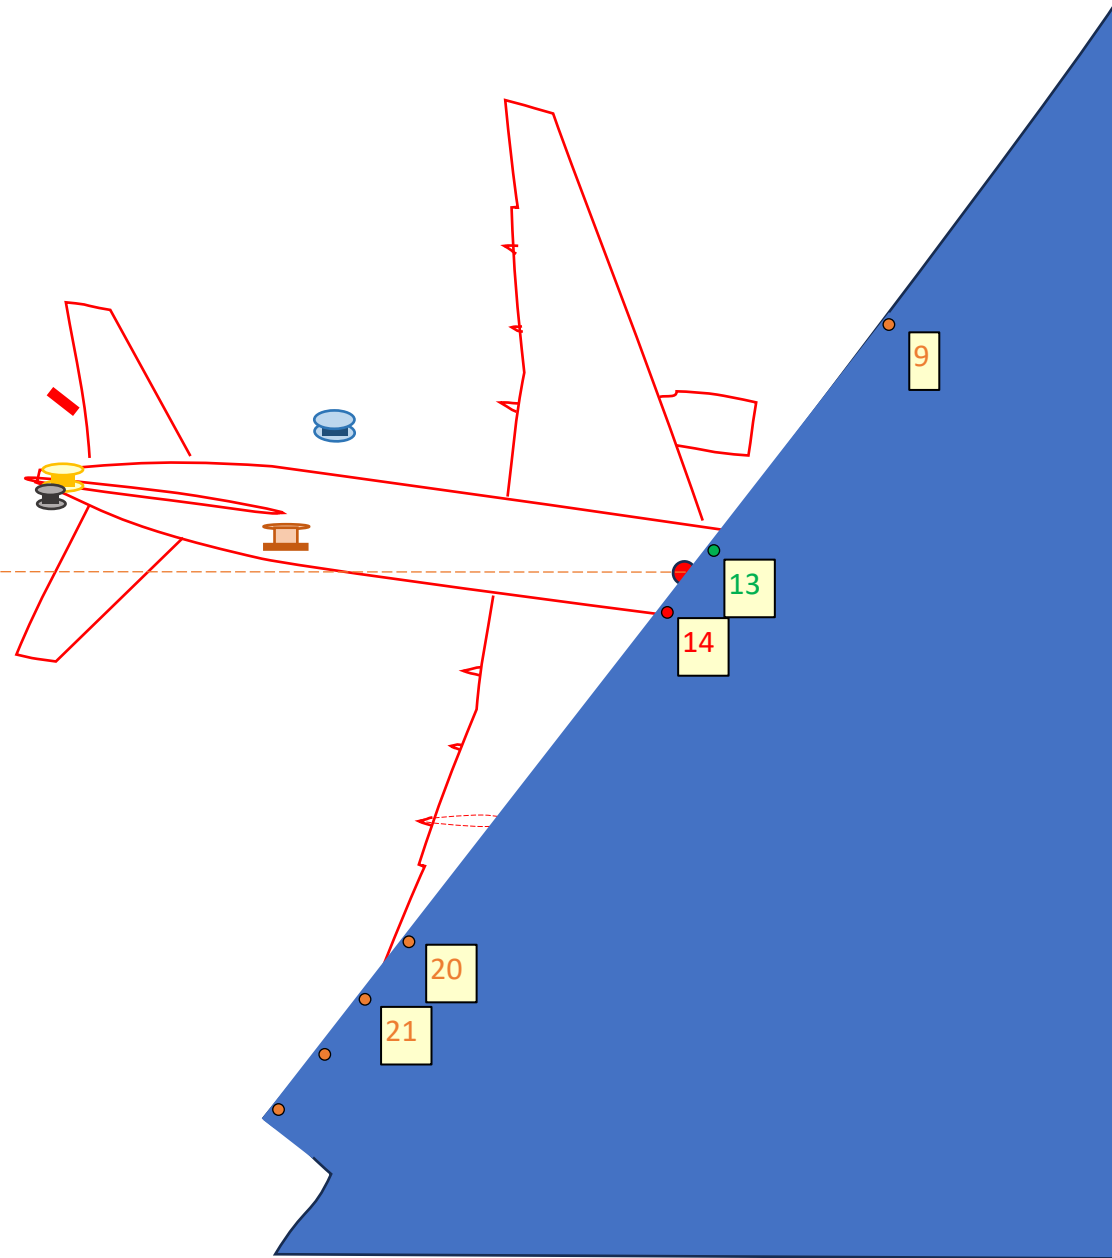
Boeing 757
at about
 $t=0.136$

The aircraft continues penetrating
the Pentagon façade.

Wire spool #7 continues moving in the direction
of column 9 while wire spool #4 now begins to
roll toward column 9.

The aircraft maintains its 8-degree yaw rotation.

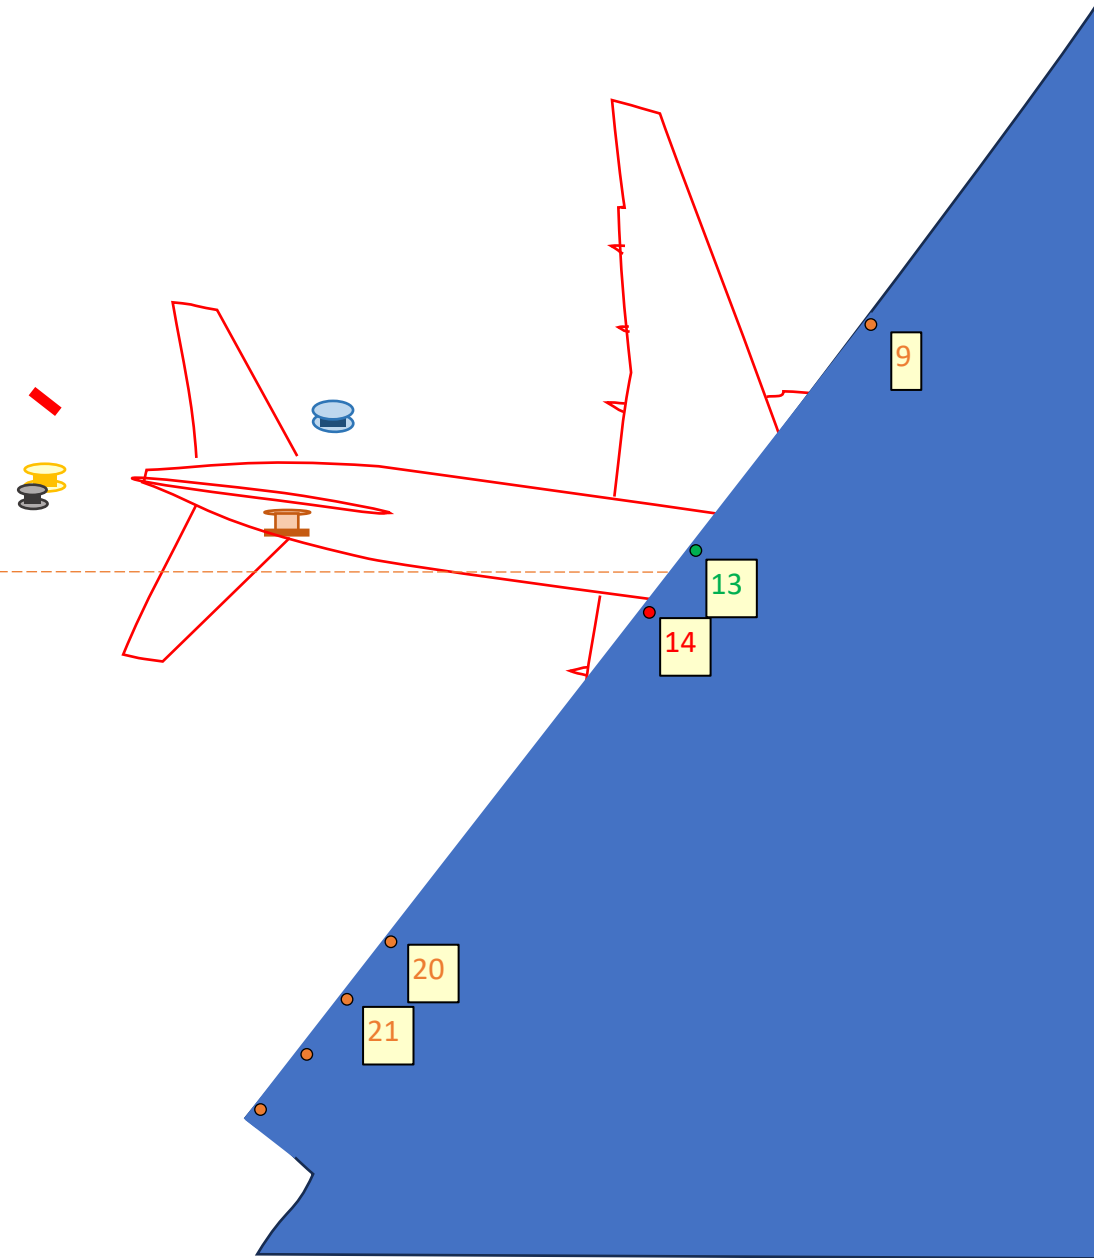
Boeing 757
at about
 $t=0.153$

The aircraft continues penetrating
the Pentagon façade.

Wire spool #7 continues moving in the direction
of column 9 while wire spool #4 continues to roll
toward column 9.

The aircraft maintains its 8-degree yaw rotation.

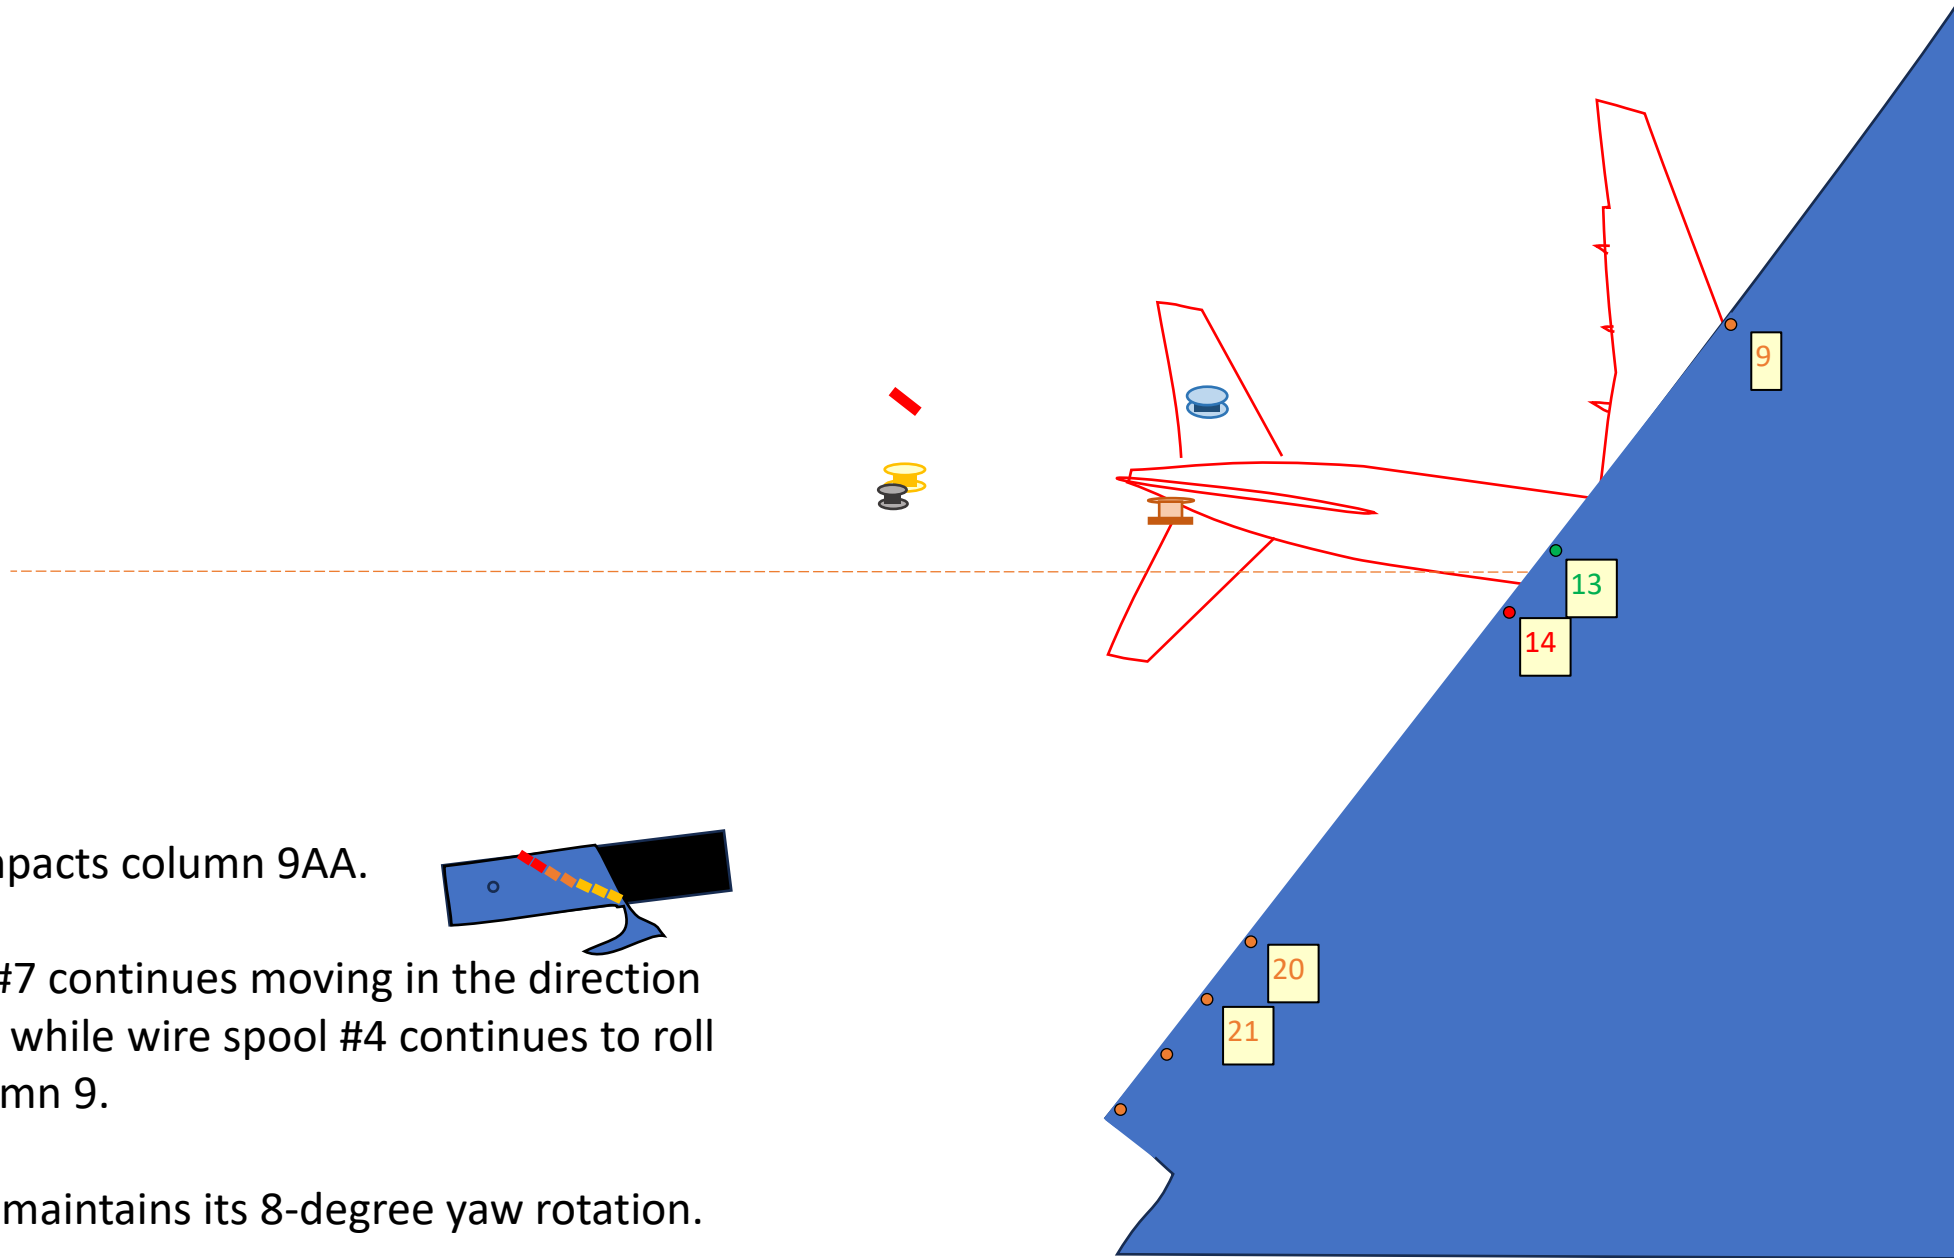
Boeing 757
at about
 $t=0.170$ sec

Left wing impacts column 9AA.

Wire spool #7 continues moving in the direction
of column 9 while wire spool #4 continues to roll
toward column 9.

The aircraft maintains its 8-degree yaw rotation.
