Rebuttal to Identification of The Plane Model That Impacted the Pentagon

Appendix B: Trajectory during the last quarter second
of a Boeing 757 Impact into the Pentagon

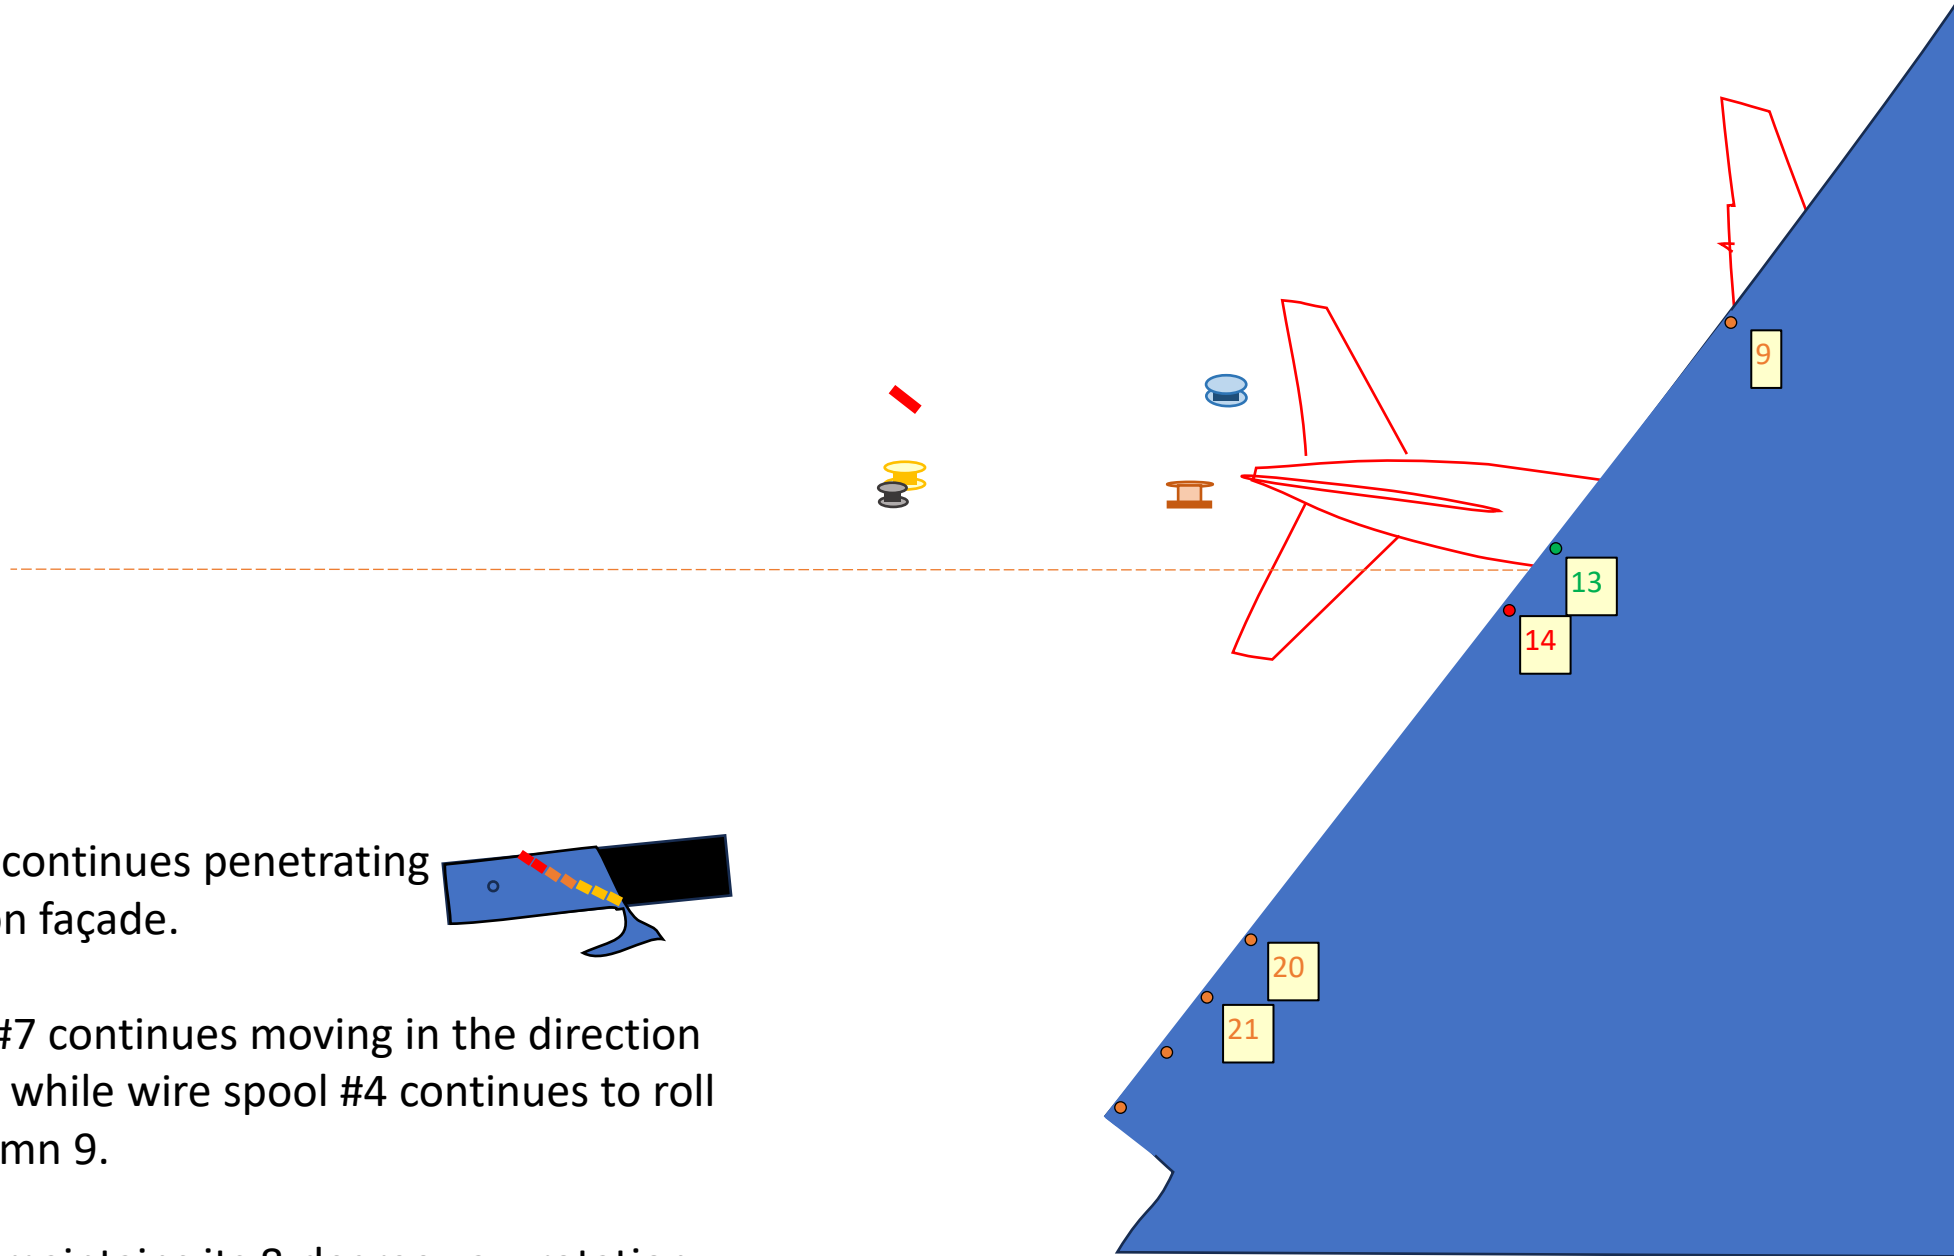
Boeing 757
at about
 $t=0.187$ sec

The aircraft continues penetrating
the Pentagon façade.

Wire spool #7 continues moving in the direction
of column 9 while wire spool #4 continues to roll
toward column 9.

The aircraft maintains its 8-degree yaw rotation.

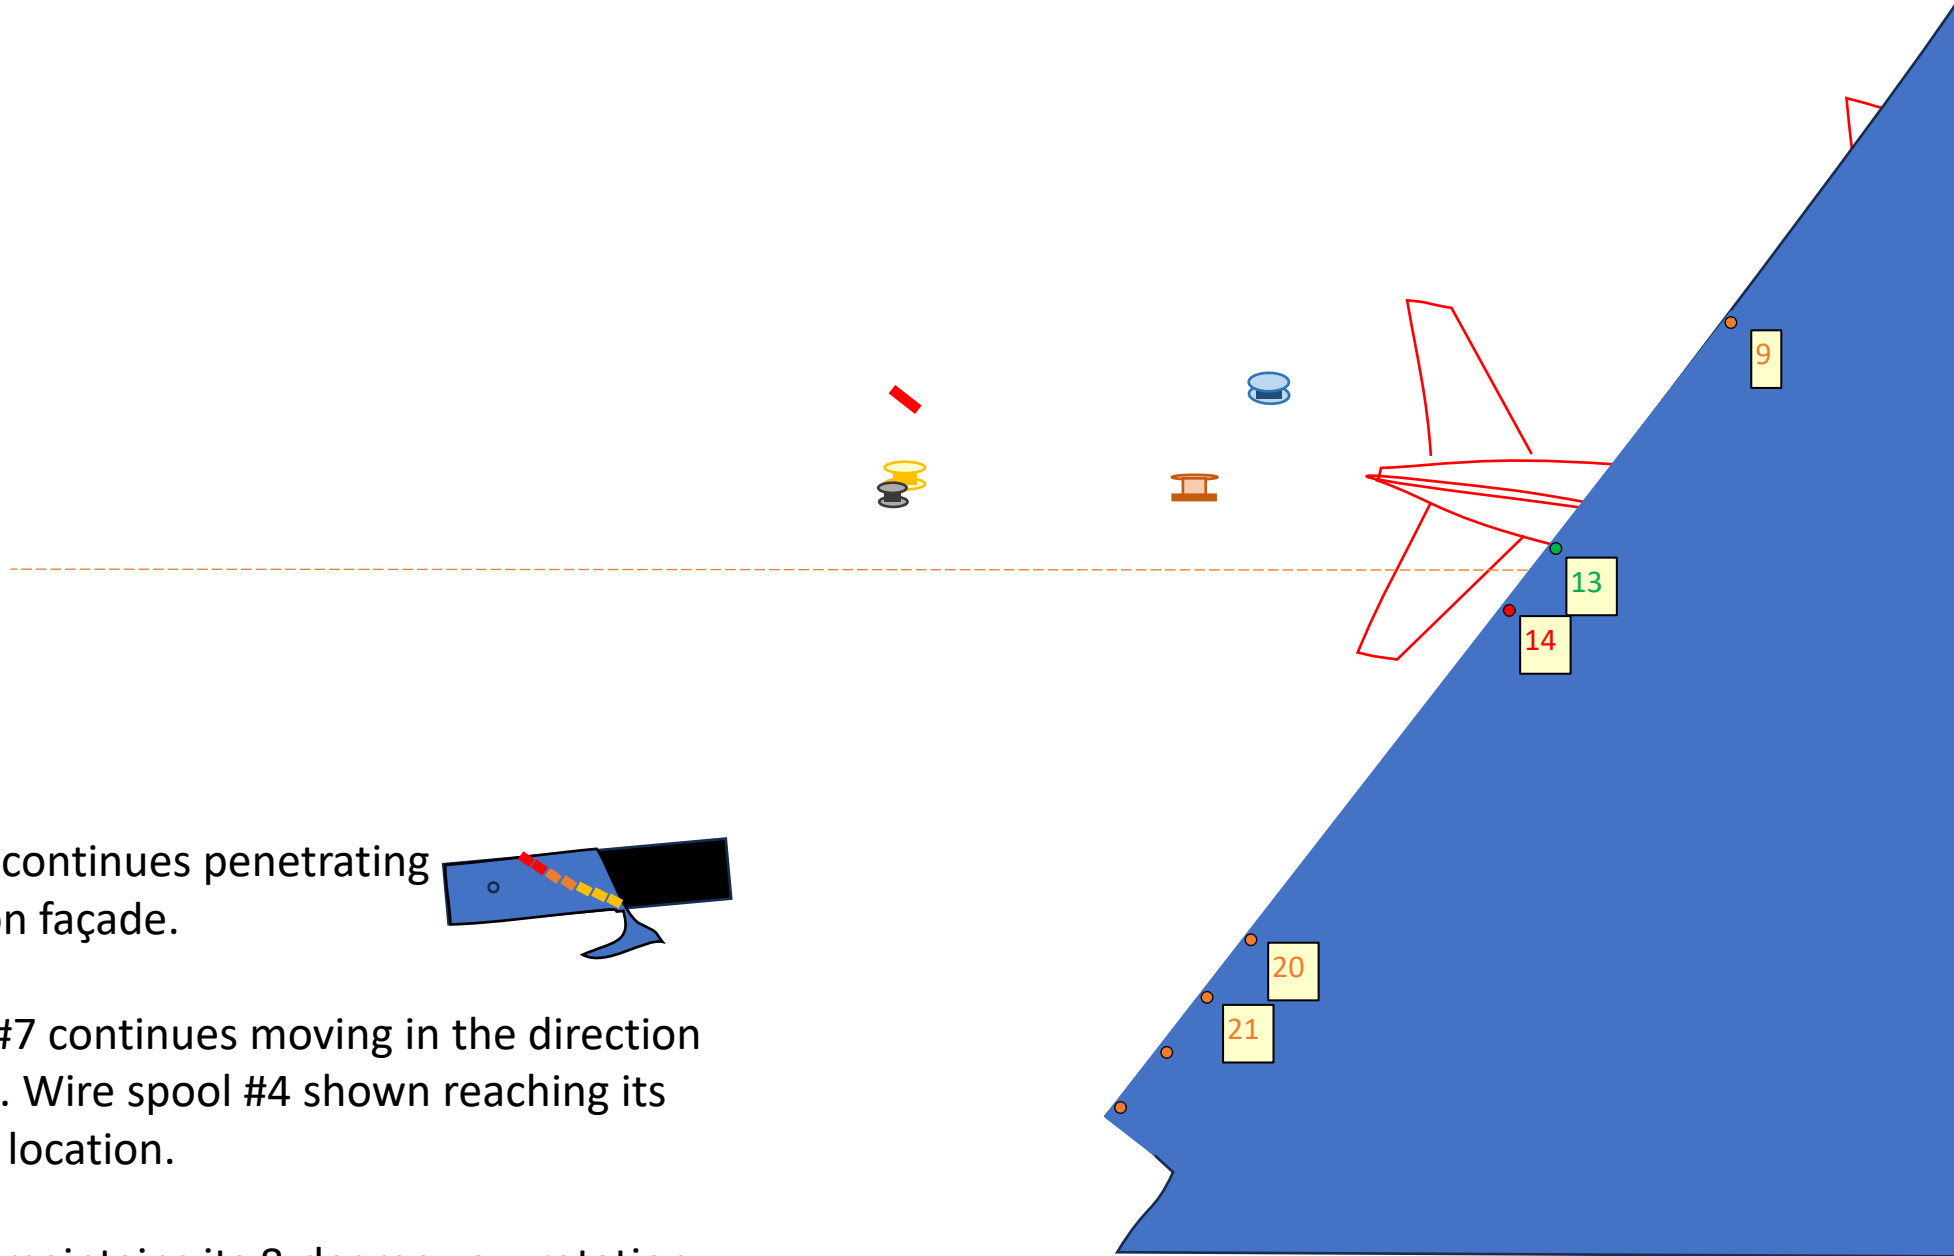
Boeing 757
at about
 $t=0.204$

The aircraft continues penetrating
the Pentagon façade.

Wire spool #7 continues moving in the direction
of column 9. Wire spool #4 shown reaching its
final resting location.

The aircraft maintains its 8-degree yaw rotation.

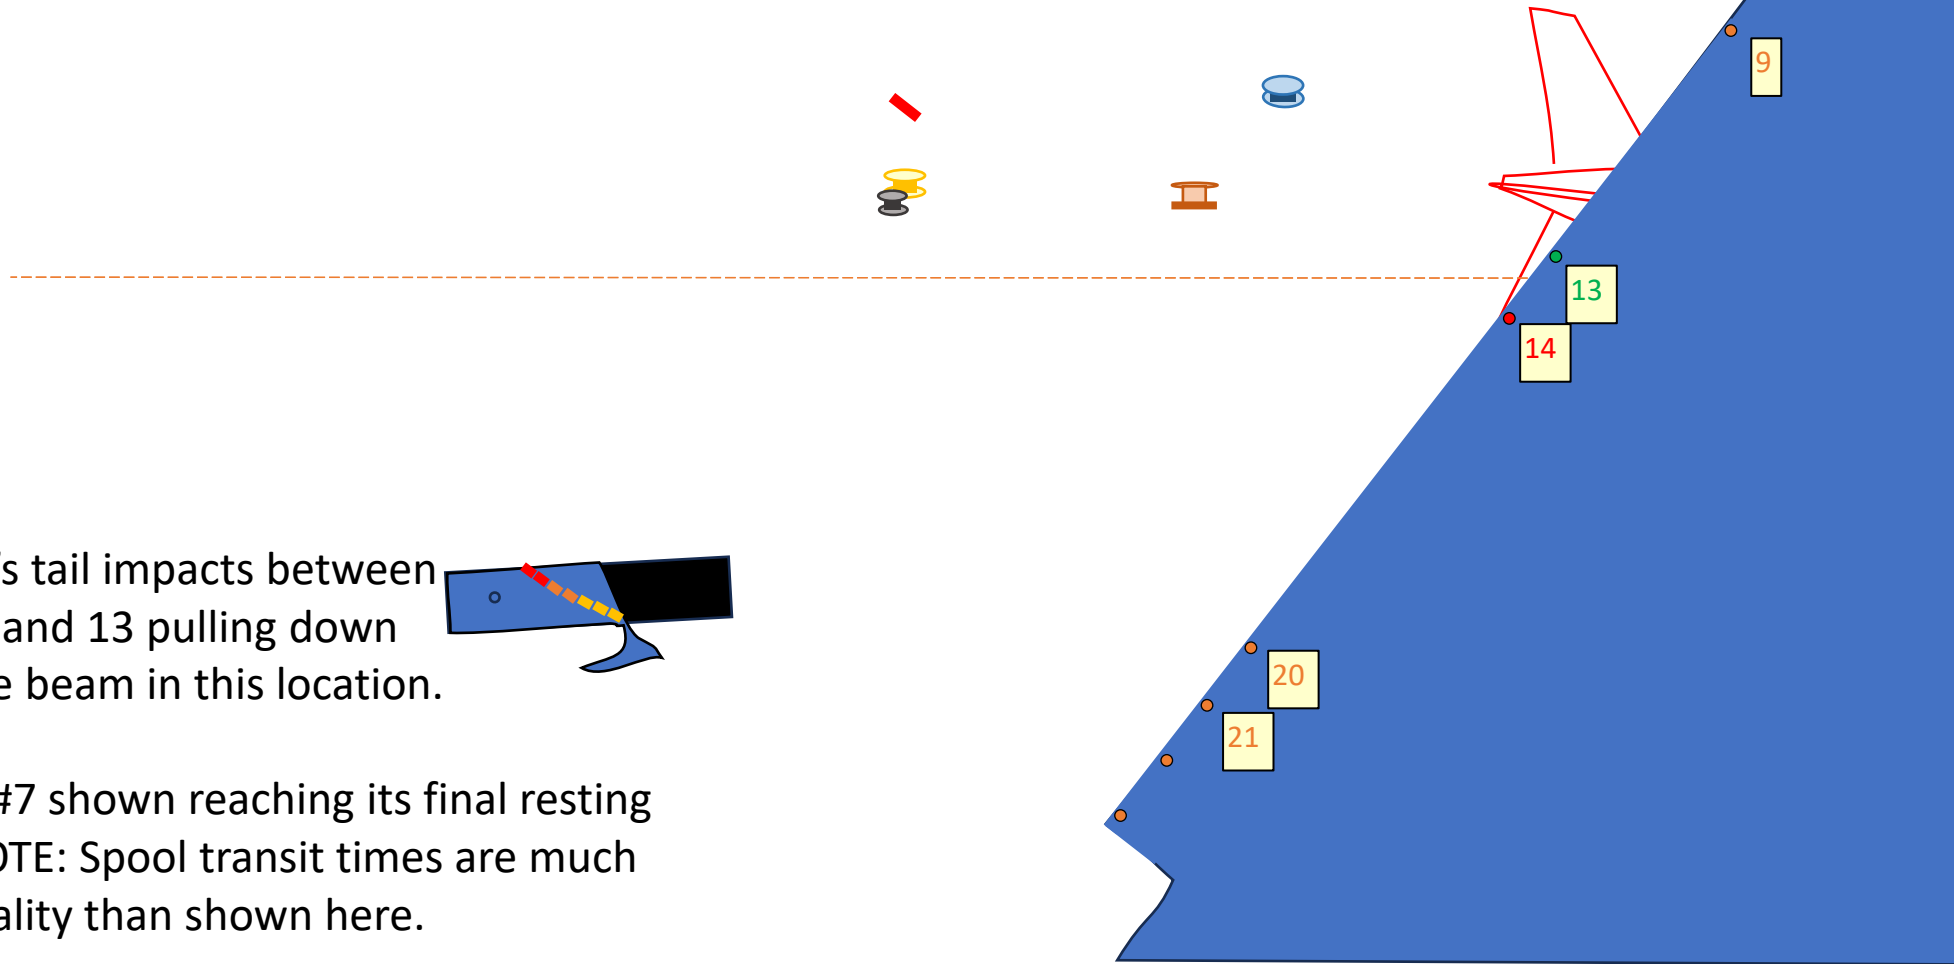
Boeing 757
at about
 $t=0.221$

The aircraft's tail impacts between columns 12 and 13 pulling down the concrete beam in this location.

Wire spool #7 shown reaching its final resting location. NOTE: Spool transit times are much longer in reality than shown here.

The aircraft maintains its 8-degree yaw rotation.
