# Rebuttal to Identification of The Plane Model That Impacted the Pentagon

Appendix C: Creation of the flap-track fairing trace on the cabin roof of  
the generator trailer

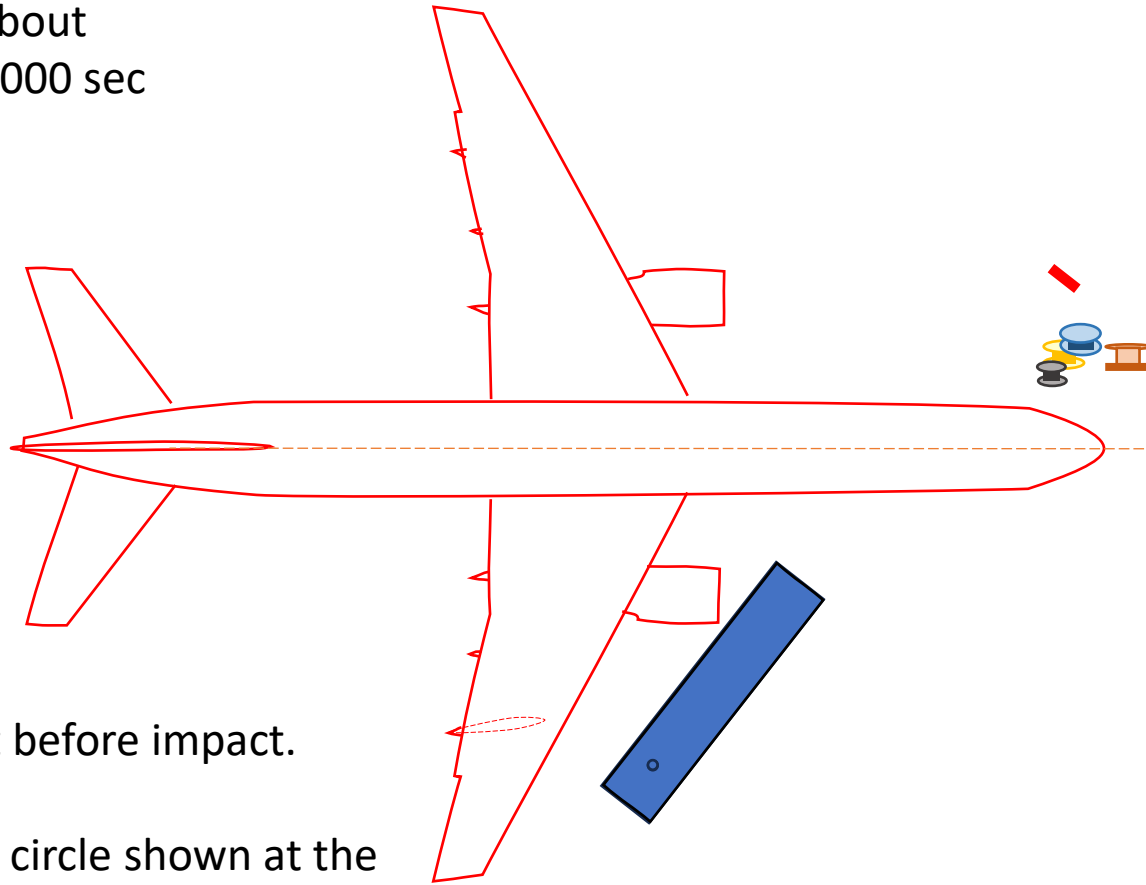
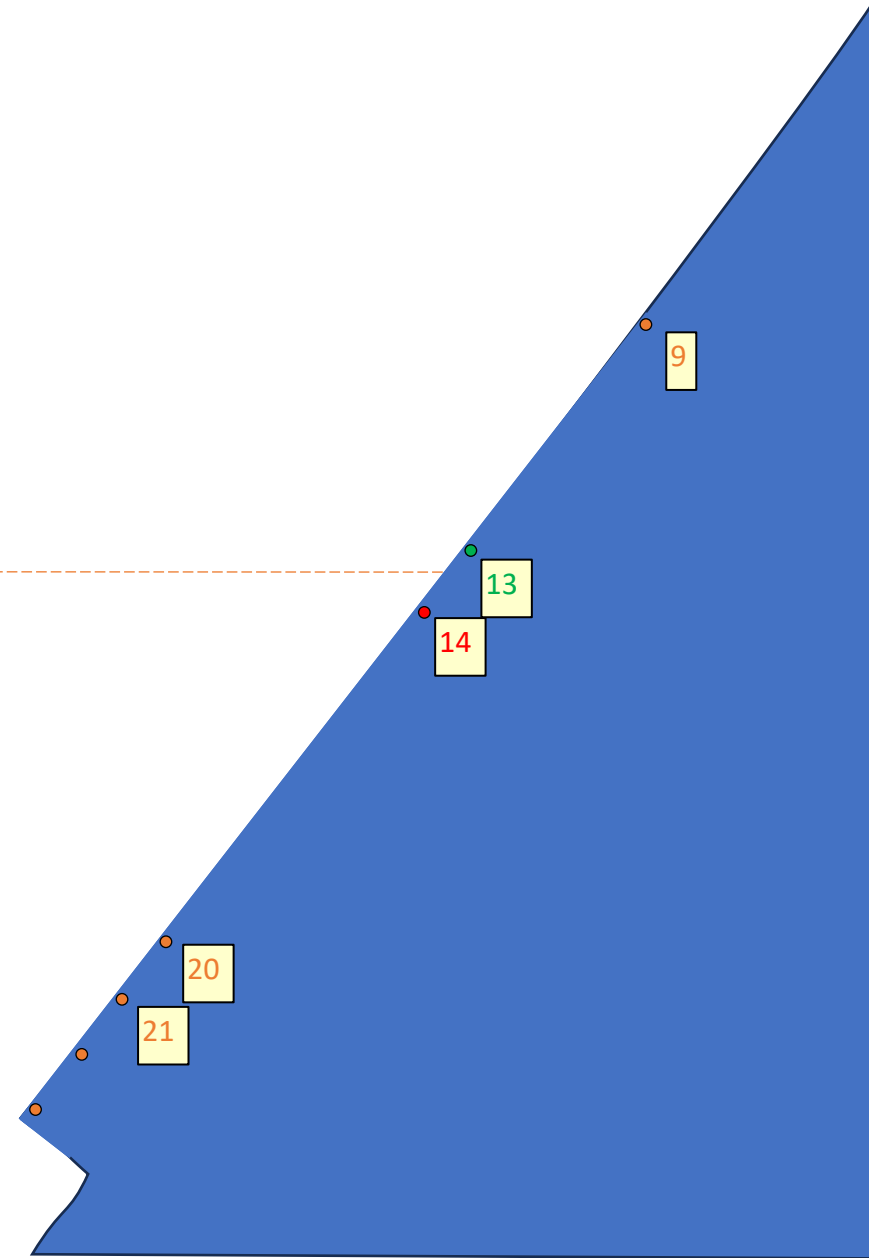
Boeing 757  
at about  
 $t=0.000$  sec

Just before impact.

The circle shown at the rear of the trailer is assumed to be the center of mass for rotation.

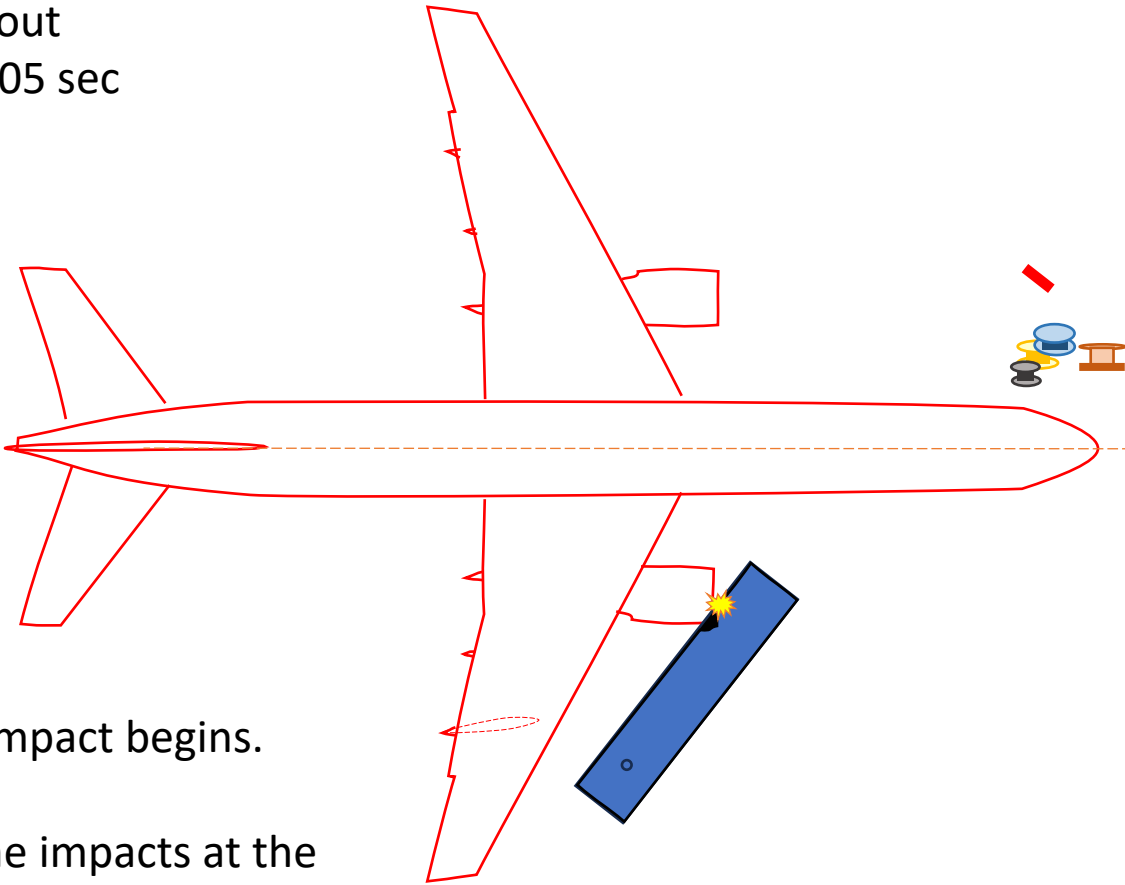
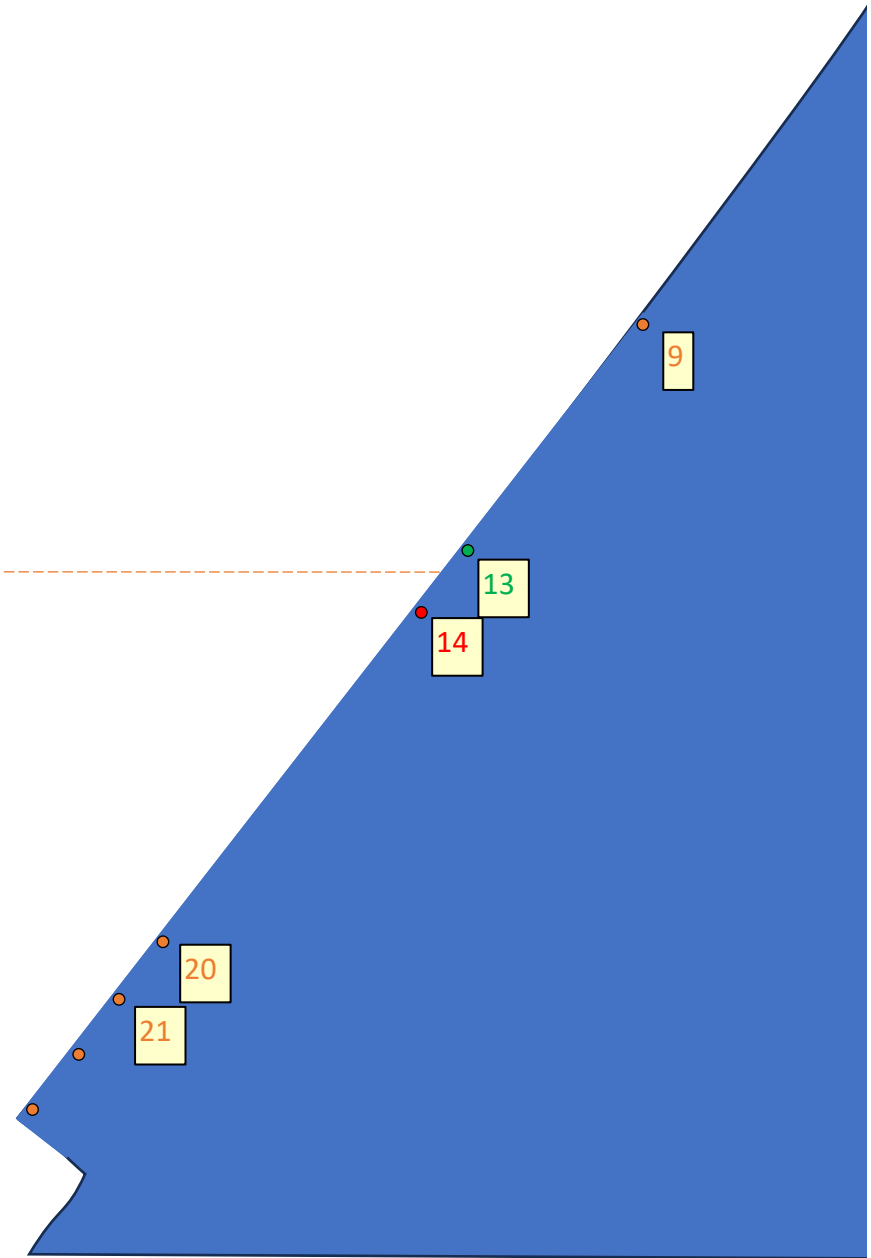
Boeing 757  
at about  
 $t=0.005$  sec

The impact begins.

Engine impacts at the  
'bullseye' where the corrugated cabin  
siding is hammered smooth.

The trailer's cabin begins to be  
destroyed.

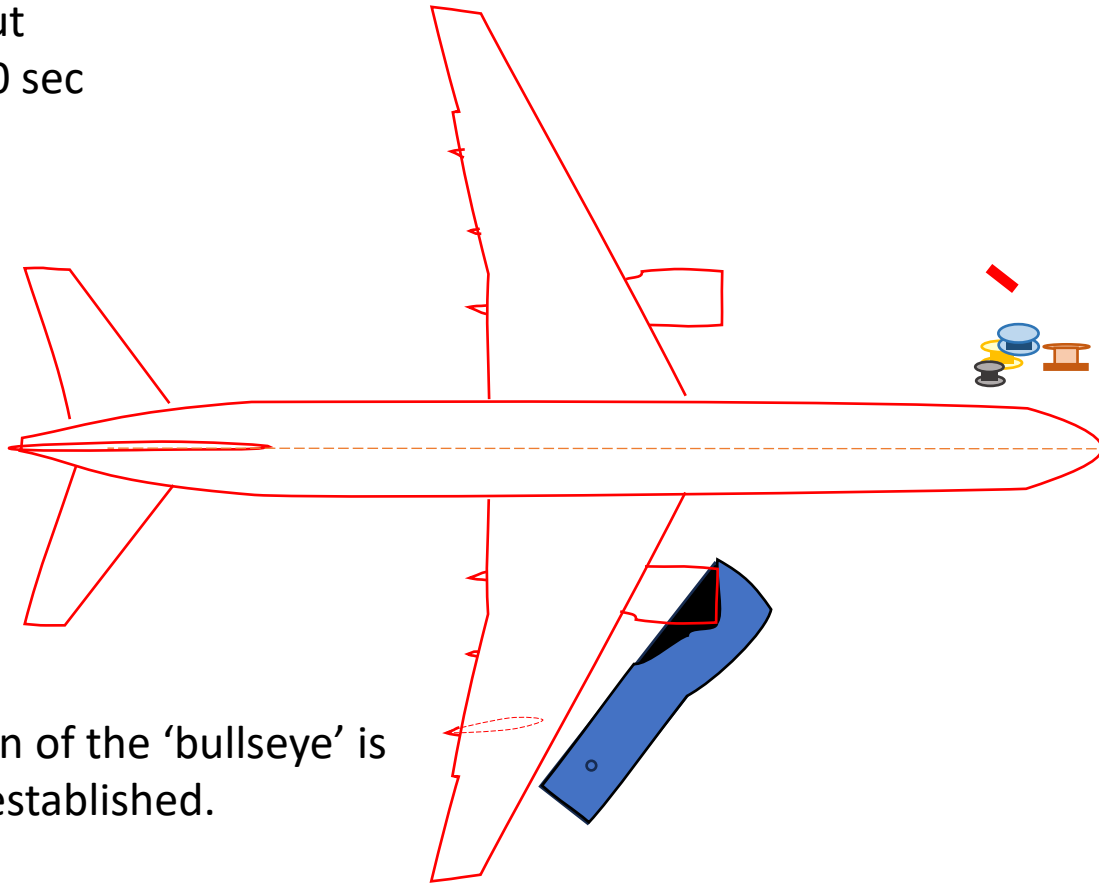
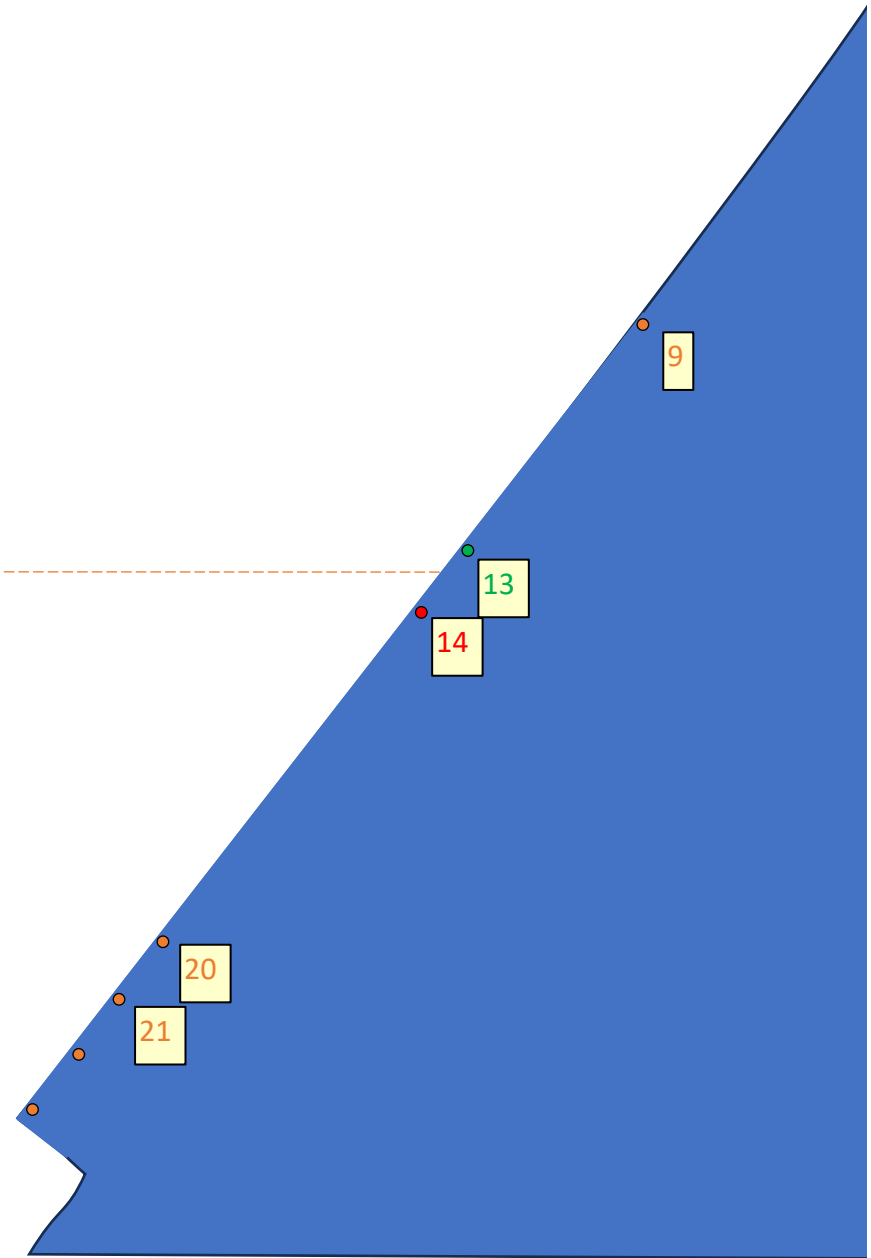
Boeing 757  
at about  
 $t=0.010$  sec

Location of the 'bullseye' is firmly established.

Heavy steel components of engine impacts the trailer's frame.

Trailer frame is then pushed rightward and downward – to begin the trailer's rotation.

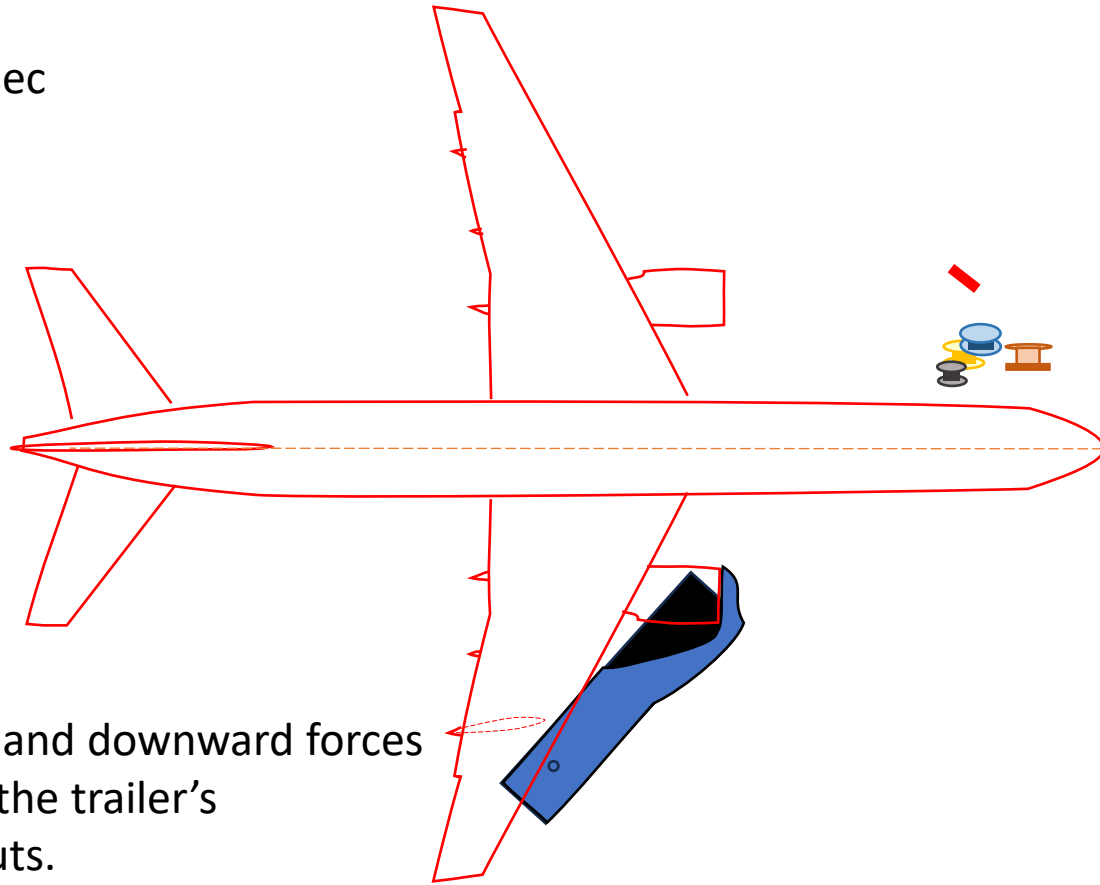
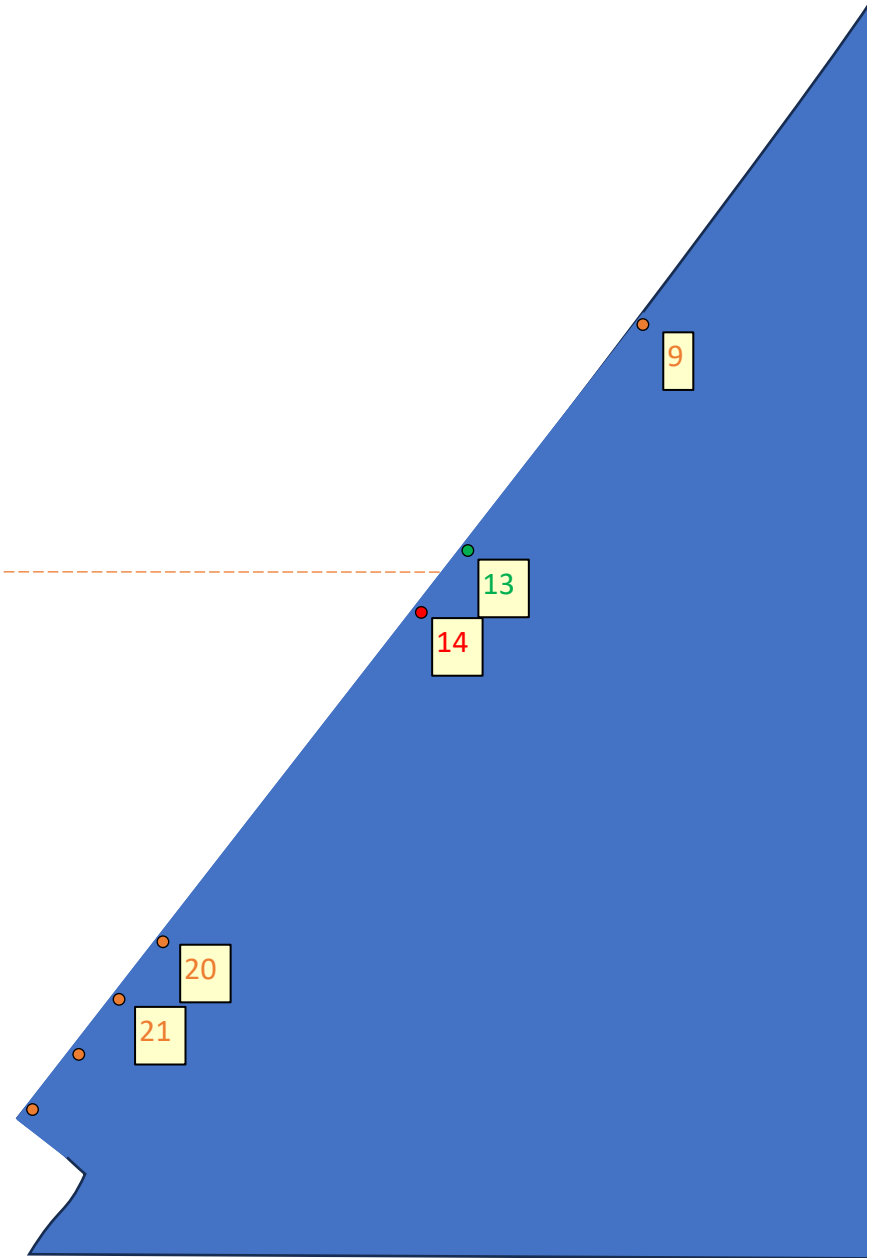
Boeing 757  
at about  
 $t=0.015$  sec

Rotation and downward forces  
collapse the trailer's  
front struts.

The trailer's cabin continues to be  
destroyed.

Large rectangular box (tool lockers)  
seen in the post-event photo is knocked over.

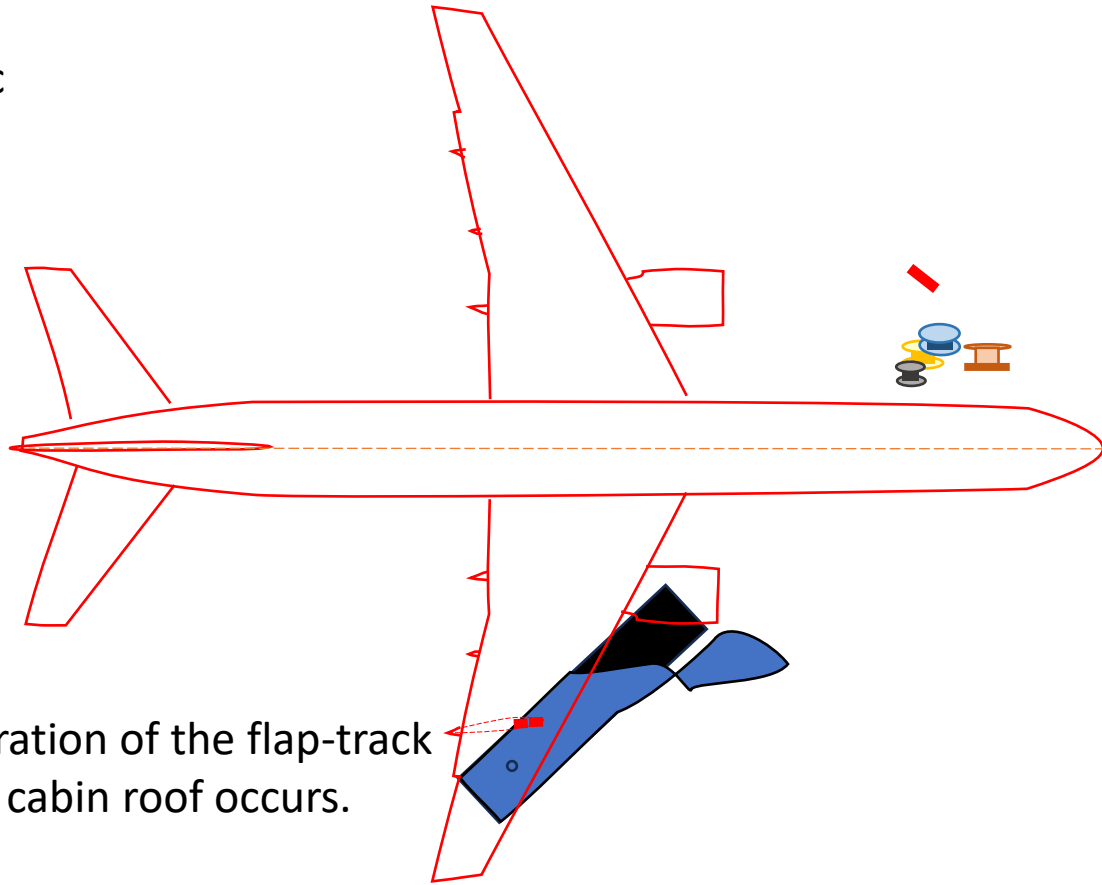
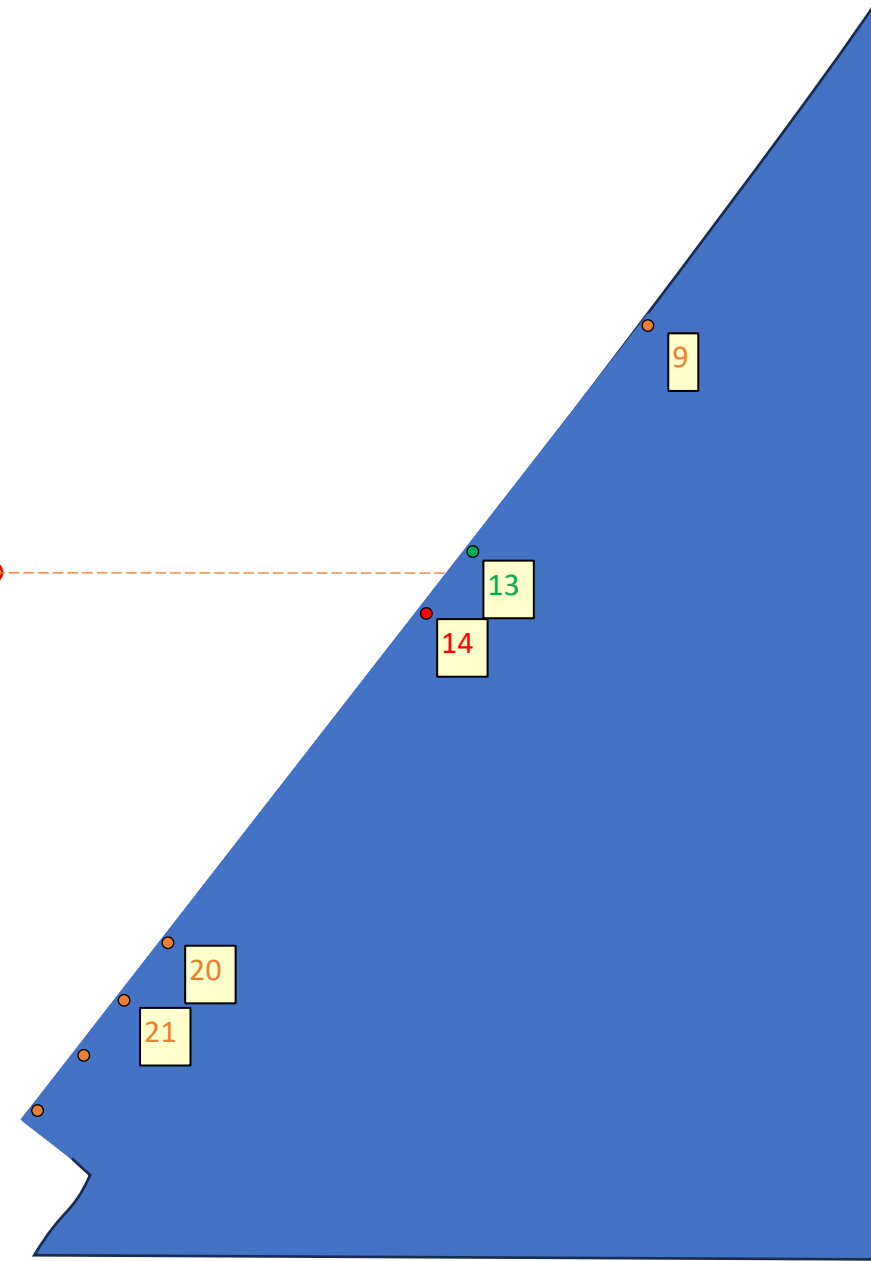
Boeing 757  
at about  
 $t=0.020$  sec

First penetration of the flap-track fairing into cabin roof occurs.

Collapse of the front struts due to the trailer's rotation, downward pressure and probable induced forward motion.

Engine is deflected toward the fuselage which accelerates the aircraft sideways.

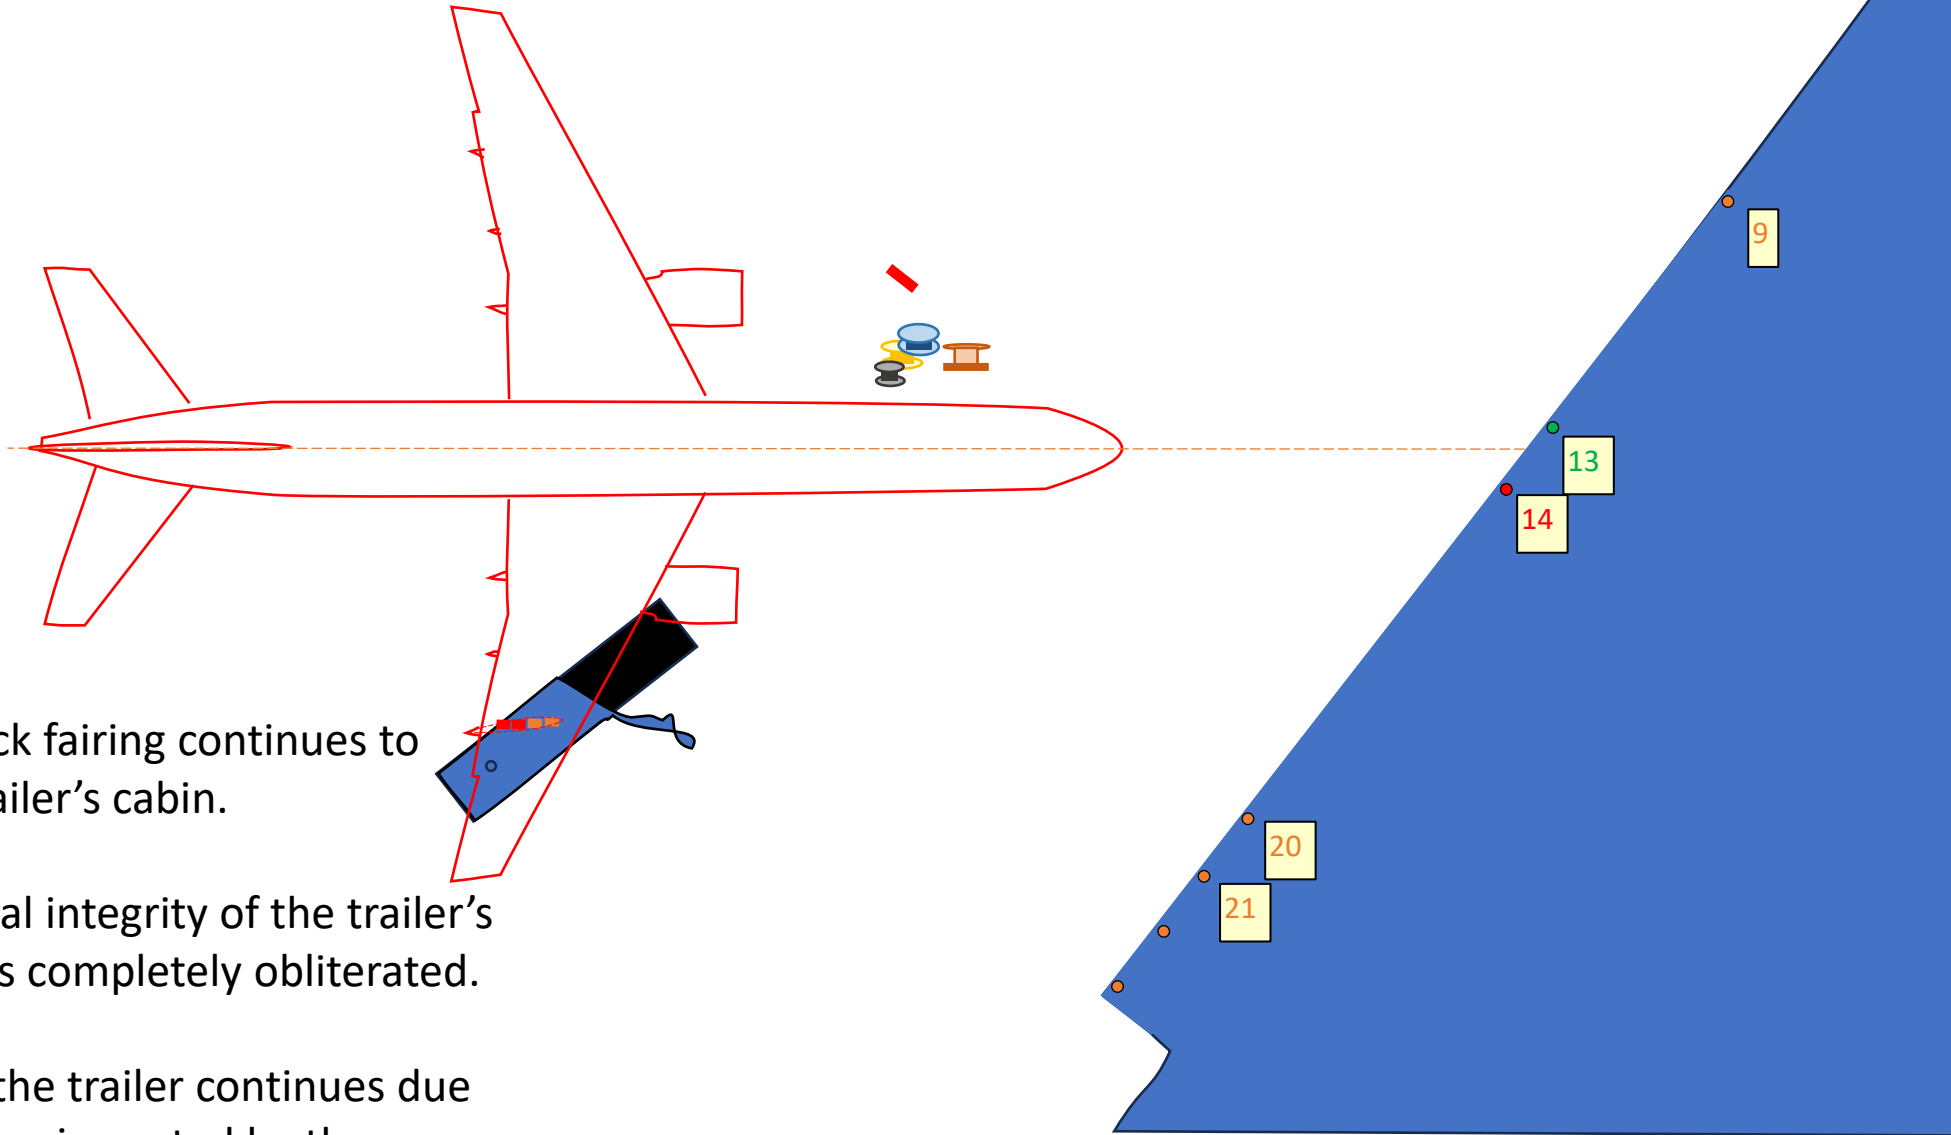
Boeing 757  
at about  
 $t=0.025$  sec

The flap-track fairing continues to score the trailer's cabin.

The structural integrity of the trailer's front cabin is completely obliterated.

Rotation of the trailer continues due to momentum imparted by the impacting right engine.

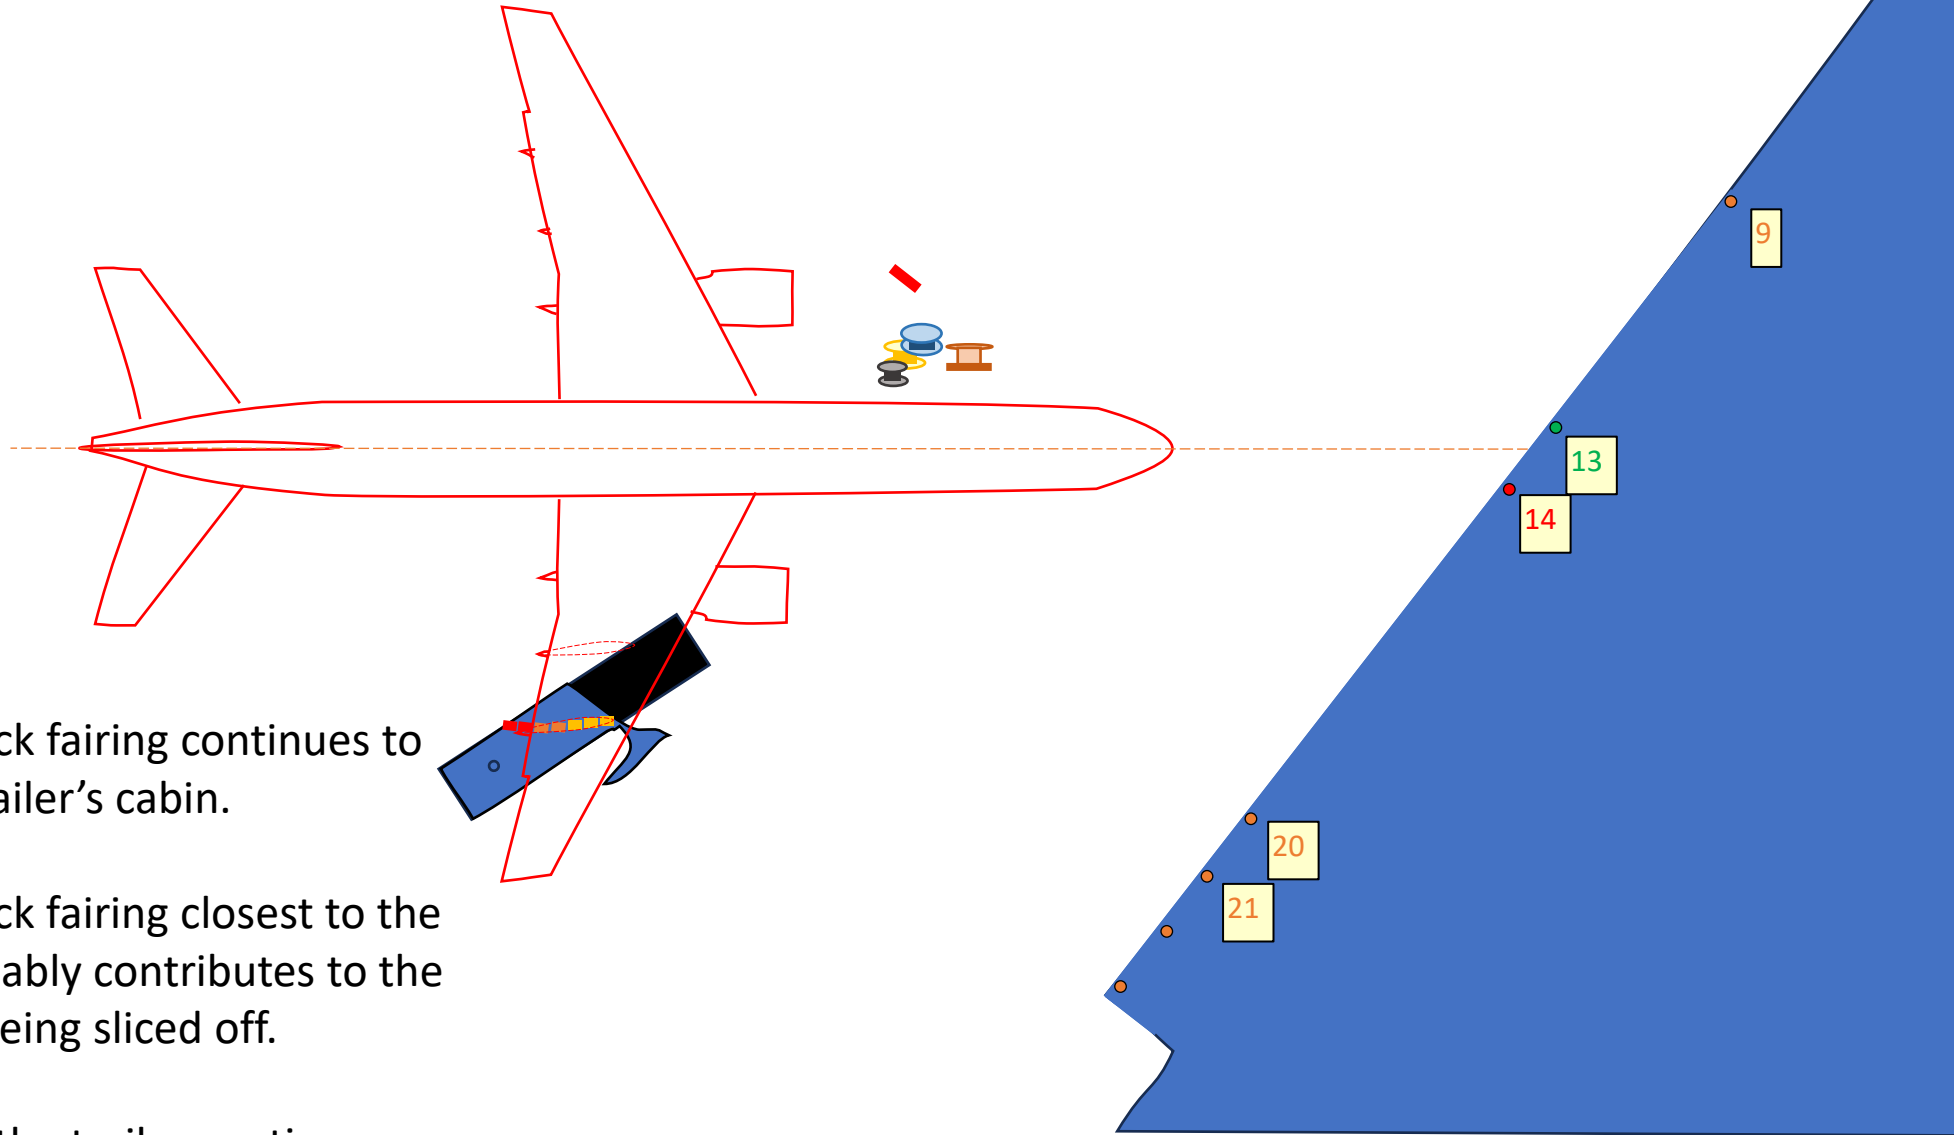
Boeing 757  
at about  
 $t=0.030$  sec

The flap-track fairing continues to score the trailer's cabin.

The flap-track fairing closest to the engine probably contributes to the cabin roof being sliced off.

Rotation of the trailer continues.

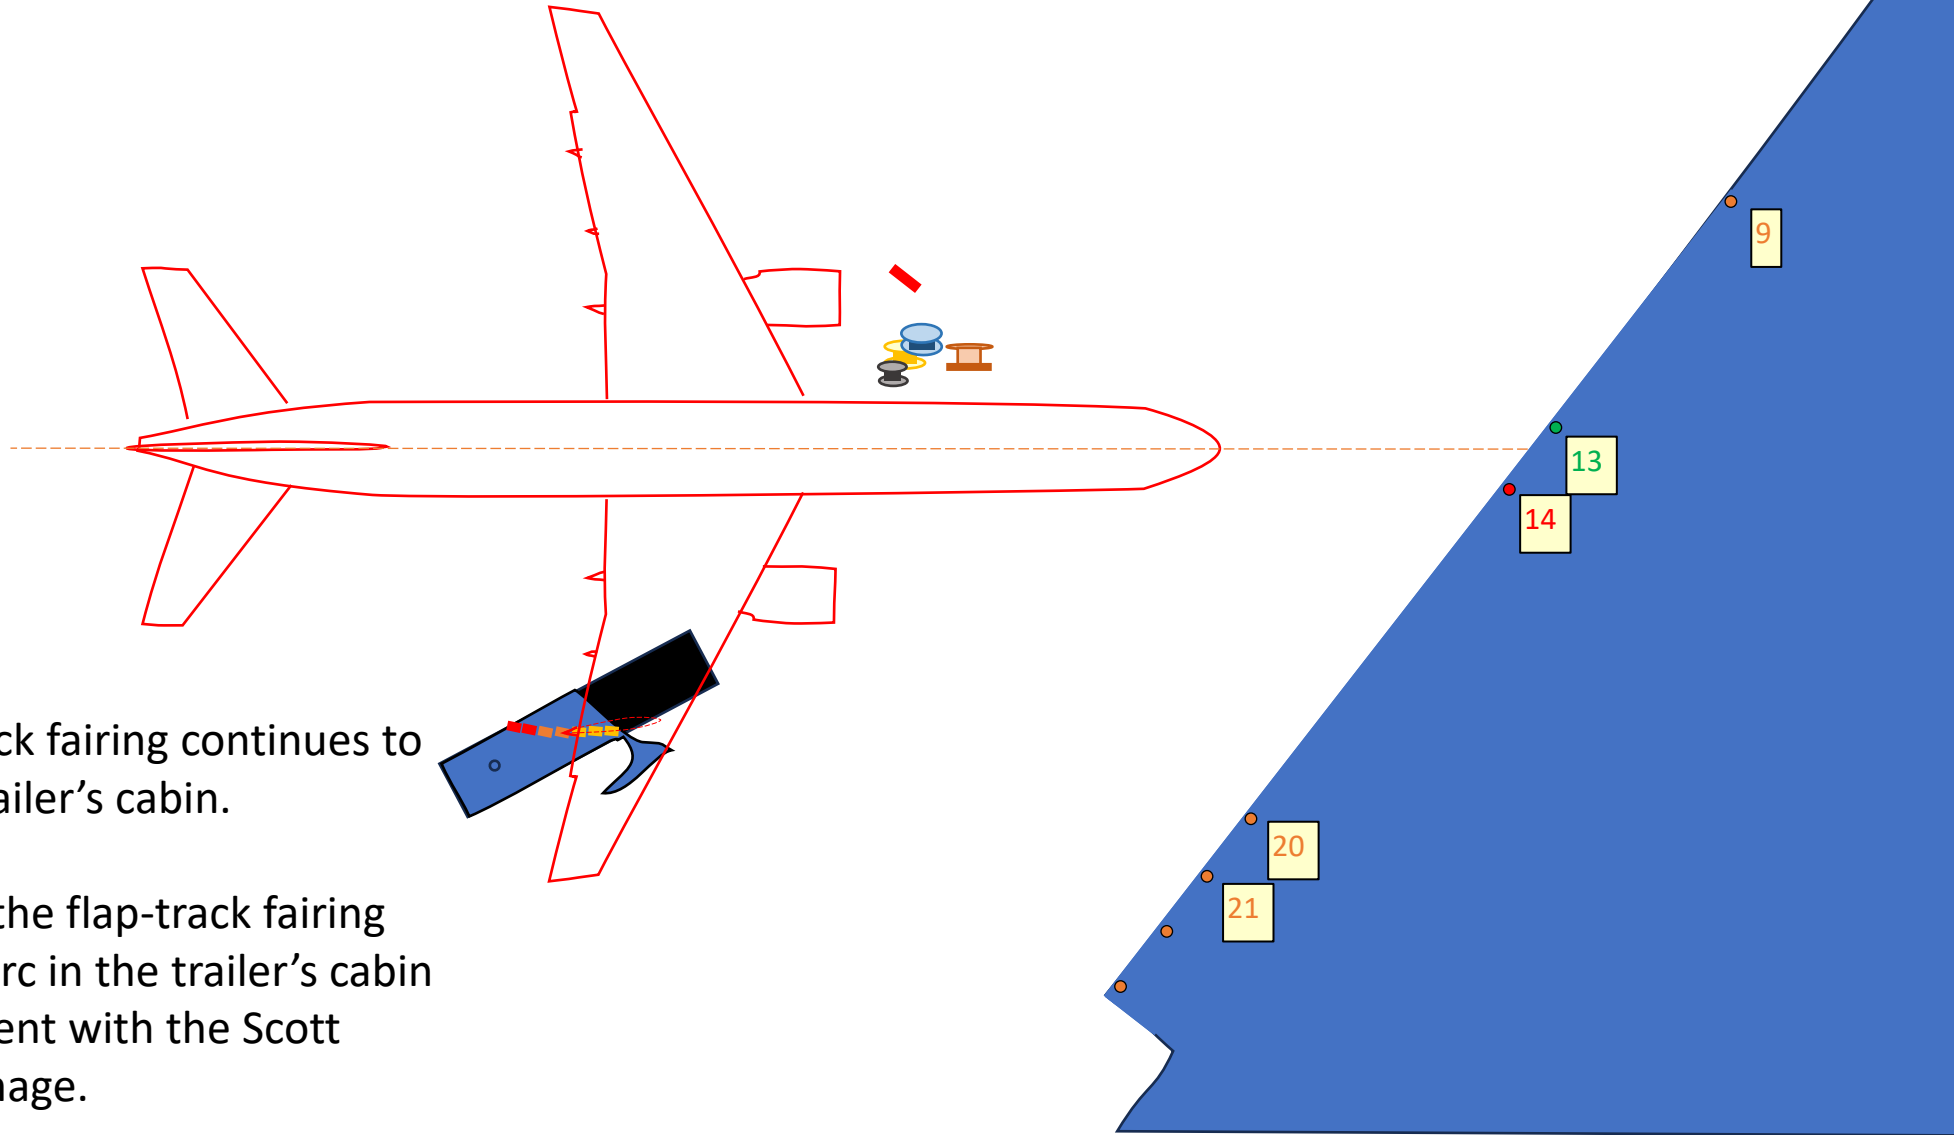
Boeing 757  
at about  
 $t=0.035$  sec

The flap-track fairing continues to score the trailer's cabin.

The scar of the flap-track fairing creates an arc in the trailer's cabin roof consistent with the Scott Boatright image.

Rotation of the trailer continues.

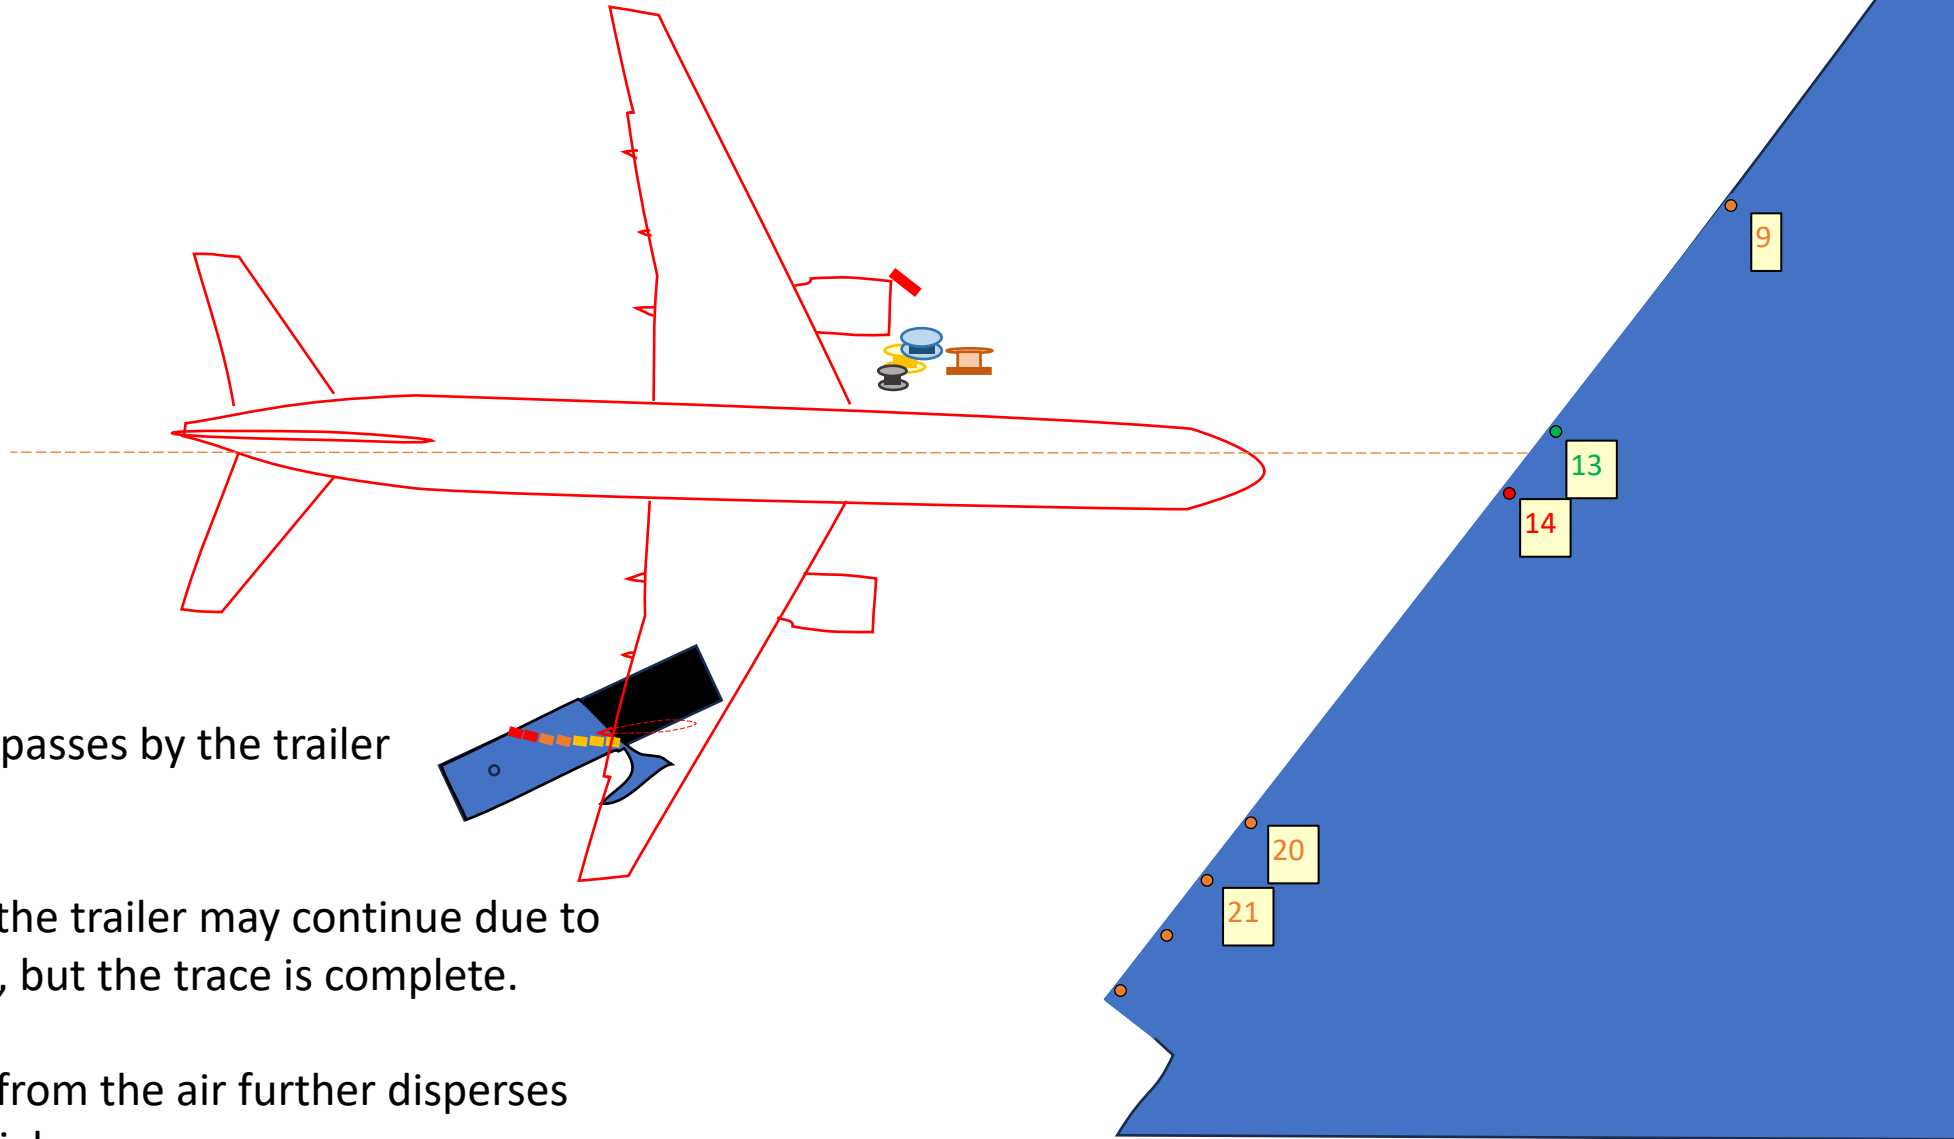
Boeing 757  
at about  
 $t=0.040$  sec

The aircraft passes by the trailer completely.

Rotation of the trailer may continue due to momentum, but the trace is complete.

Turbulence from the air further disperses loose material.
