**Rebuttal to ‘Identification of The Plane Model That Impacted the Pentagon’**

Wayne Coste, PE

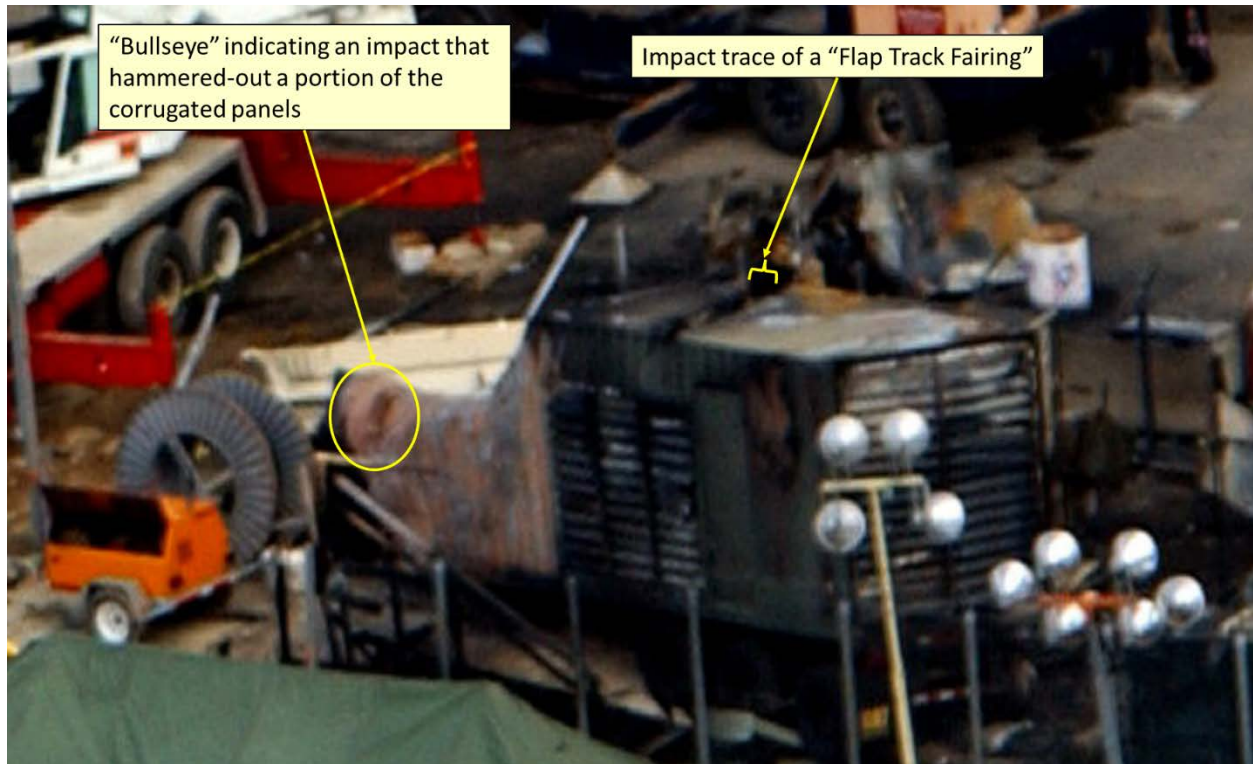
Figure 6 shows the trace of one of these fairing through the top of the generator trailer [4]. The trailer was rotated to the right as the side of the impacting right engine impacted the front-half of the left side of the generator trailer. At the appropriate height, this 52-degree impact would not only rotate the trailer out-of-the-way and toward the right, it would also collapse the front struts of the trailer allowing the trailer to be collapsed downward. This would allow sufficient rotation and descent of the trailer to allow the engine to pass alongside. This impact also created a 'bullseye' on the corrugated side of the folded-over forward portion of the trailer's steel cabin where the corrugated siding was hammered-out smooth. The 'bullseye' appears to be approximately 5 ft from the front of the trailer. This marks the exact location where the engine began impacting the trailer. The trace of the Flap Track Fairing on the top of the trailer can be used as an unambiguous data point for the height and position of a specific identifiable aircraft component. Detailed drawings are available in the appendices.

*Figure 6: Impacted generator trailer showing "bullseye" and trace of a Flap Track Fairing.*

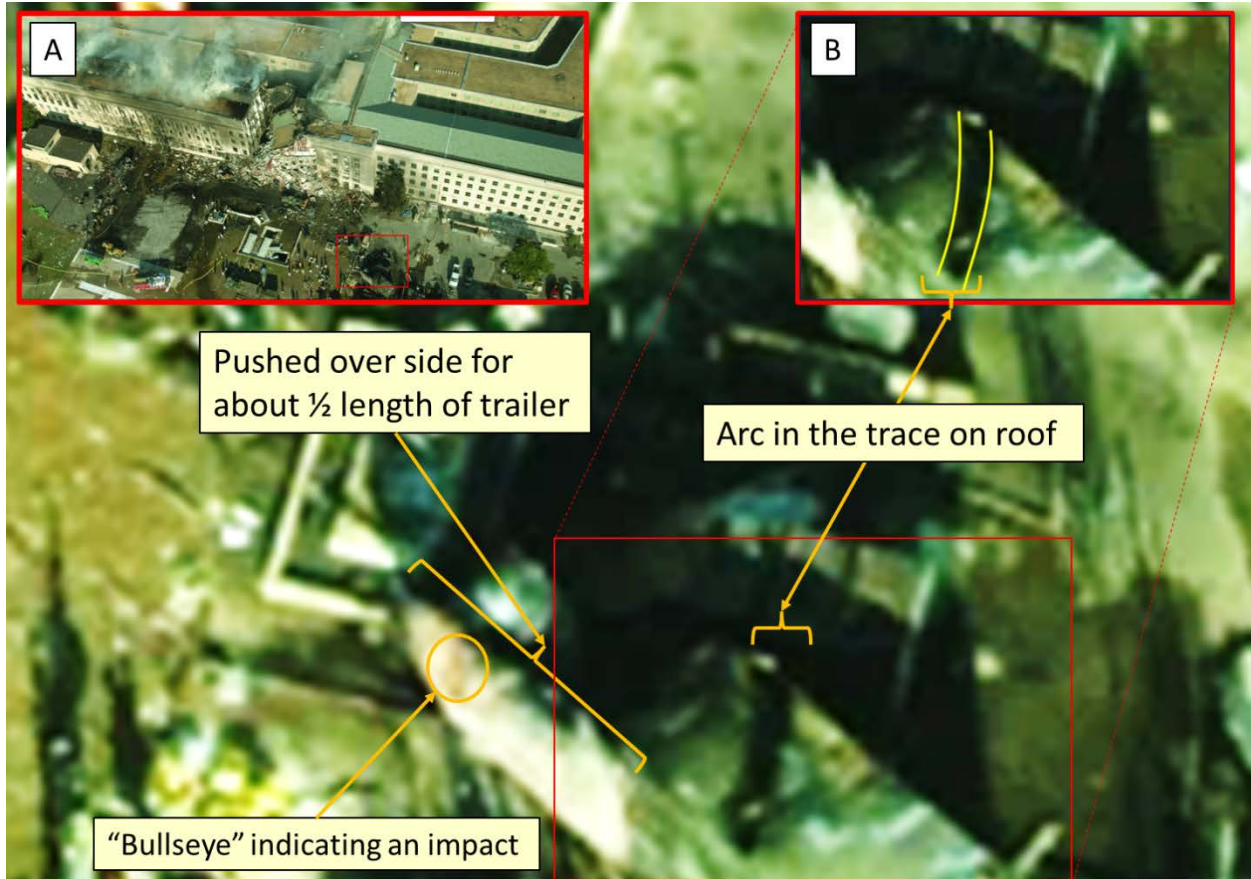
Figure 7 shows an overhead view of the trailer roof in a photo by Scott Boatwright [5]. Compared to the parallel objects on the ground, the final location of the trailer is rotated approximately 30 degrees around the rear wheels. This image shows the trace to be an arc; not a straight line. Such an arc is consistent with the generator trailer being rotated while the Flap-Track Fairing was cutting the trace. At the observed approach speed of 795 feet/sec (542 mph) [6], the contact time of the flap track fairing into the trailers roof would have been less than  $2/100^{\text{th}}$  of a second. For this arc to have been captured in the roof, the trailer would have needed a significant rotational velocity. Appendix C provides a series of drawings that illustrate this process.

Figure 7: Zoomed in section of the Scott Boatwright photograph ("A") showing the arc in the trace (highlighted in "B"). (NOTE: The full Boatwright photograph can be seen at <https://sire-media-ngcdk.fichub.com/generic/photogallery-photo/16/40972.custom.jpg>)

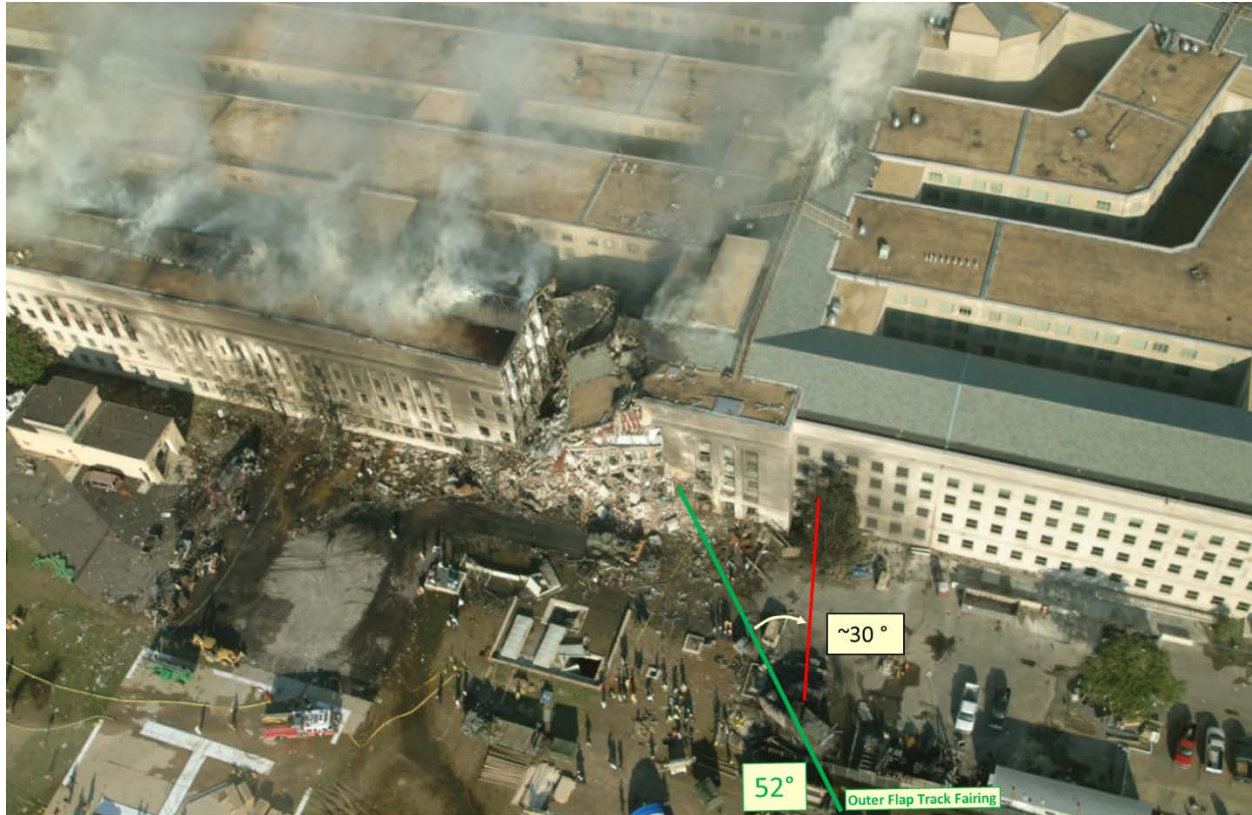
Figure 8 shows the total rotation of the trailer around its likely center of mass over the rear wheels. The total rotation is approximately 30 degrees. The imparted rotational inertia from the impact of the engine into the trailer would have caused the trailer to continue rotating after the trace was cut by the Flap Track Fairing. The axial alignment of the approaching 757 would have placed the outer right Flap Track Fairing on a path toward a point on the façade between columns 18 and 19. Once the rotation ceased, the trace is orientated in the direction of column 26 or 27. This suggests a total period of rotation of about 2 seconds before the trailer came to rest at its post impact orientation with its front support struts collapsed.

Figure 8: Due to impact and imparted energy, the trailer was rotated approximately 30 degrees around its rear wheels.

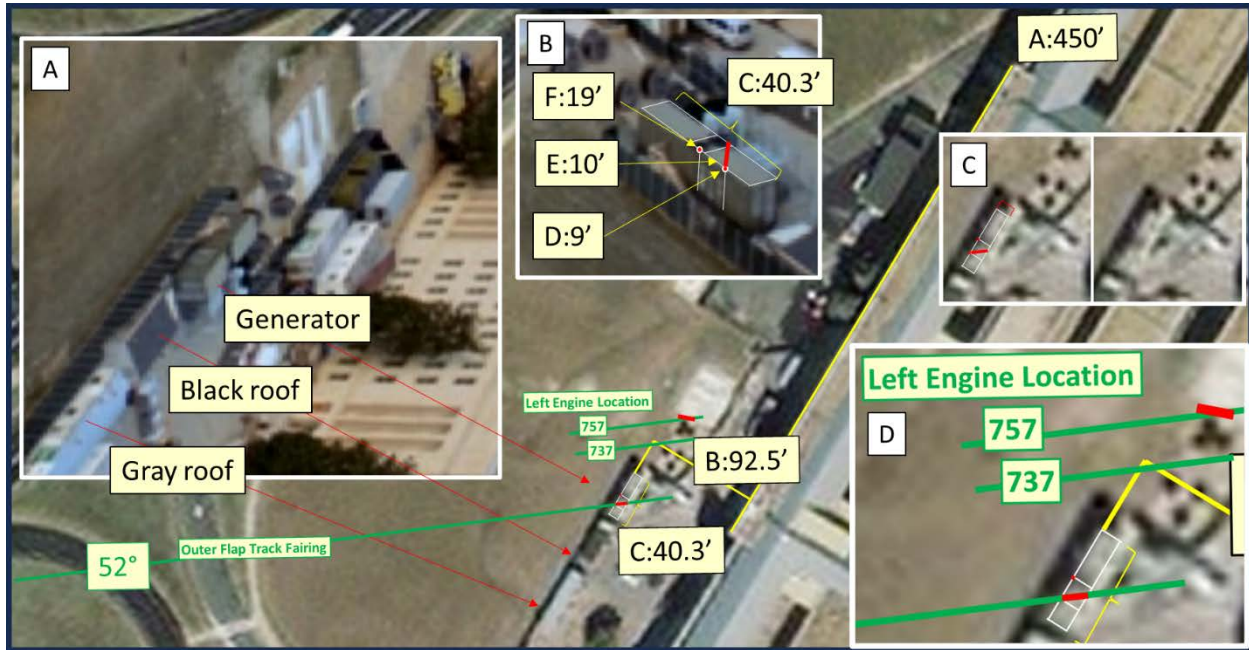
Figure 11 shows the relevant section of the satellite image along with dimensions and other information. The first inset, “A,” shows a rotated version of Figure 5 which identifies the generator trailer and two other adjacent buildings. The second inset, “B,” shows a detail of the generator trailer with dimensions that can be estimated once its length has been determined from the satellite image. The area between the white lines topped with red dots locate the side air intake vents. The third inset, “C,” shows the trailer with and without outlines. The outline of the trailer is bounded by the consistent light color of the roof with the only deviation being the area in the center that was discolored by diesel soot. While the soot can be seen discolored the center of the trailer roof, there is no hint of the trace in this image. The fourth inset, “D,” provides a larger view of the trailer in the satellite image.

Figure 11: Zoom-in of satellite image taken September 7, 2001 with insets to provide additional context and detail.

- A. Length of window bay. This is 450 feet long and provides the primary basis for all dimensions
- B. Distance from facade to the far side of generator trailer is about 92.5 feet
- C. Length of generator trailer is about 40.3 feet
- D. Distance from back of the generator trailer to the beginning of the first vent is about 9 feet
- E. Distance from back of the generator trailer to the Flap Track Fairing scar is about 10 feet
- F. Distance from back of the generator trailer to the end of the third vent is about 19 feet

The green lines are important because they establish the location of the outer Flap Track Fairing that impacted at 52 degrees as well as the location of the opposite engine in relation to it. The location of the opposite engine is shown by two short parallel green lines. These two additional green lines are associated with either a 757-200 or a 737-400. The green line identified as the “737” is separated from the fairing trace by 46.1 feet while the green line identified by the “757” is separated by 63.1 feet. The “757” line intersects with a red line segment that locates a gouge in the retaining wall that has been associated with the impact of an aircraft’s left engine.

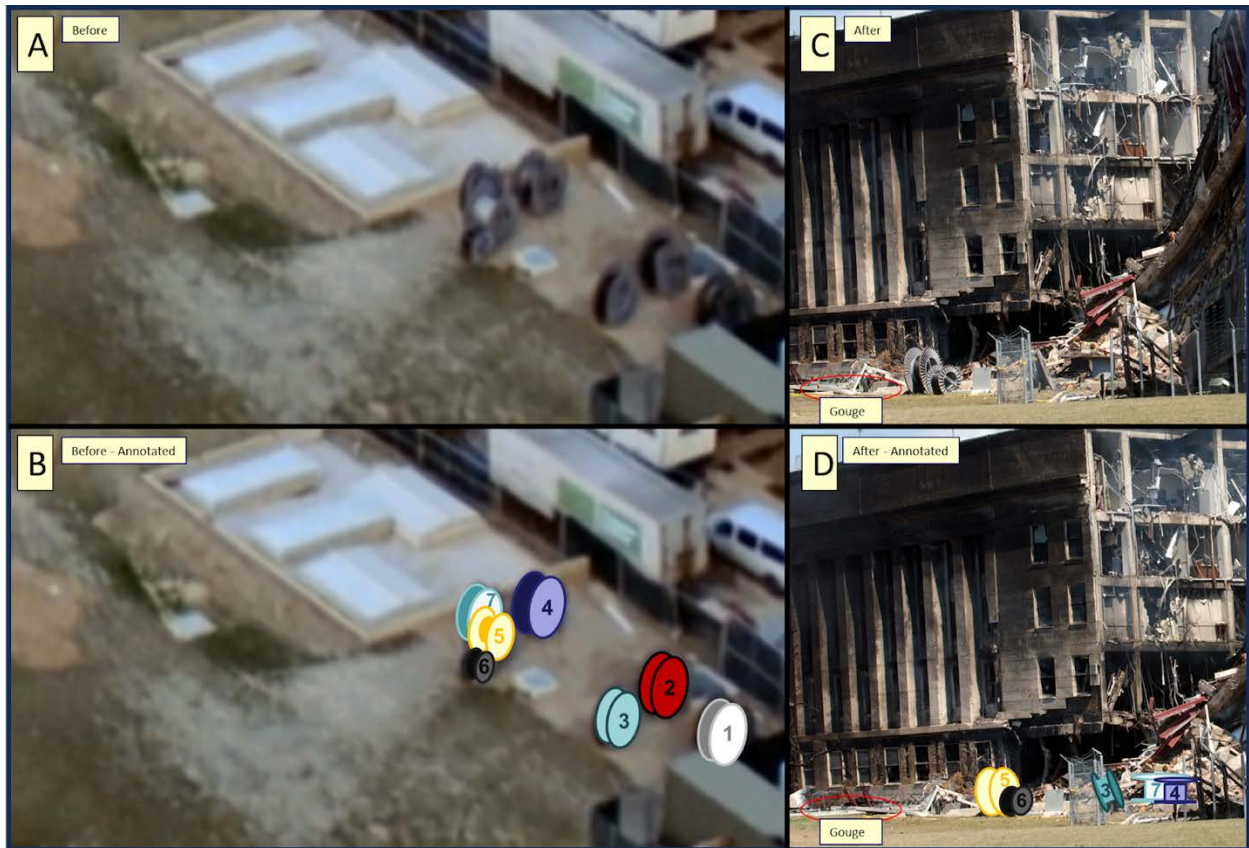
Figure 12 shows before and after images near the gouged retaining wall where the red line segment was drawn. Figure 12A shows seven wire spools from a photo taken prior to September 11. These spools are in locations consistent with the satellite images in Figures 10 and 11. The shadows do not have sufficient resolution to discern the location and size of each spool. Figure 12B provides an identification using colors and numbers. Spools 1, 2 and 3 are near the generator trailer, while spools 6, 5, 4 and 7 are seen close to the retaining wall. The spool labeled 4 is near the retaining wall and closest to the Pentagon facade.

Figures 12C and 12D show the location of the remaining spools after impact. Spools 5 and 6 are in the same location as shown in Figure 12B while spools 7 and 4 are knocked toward the facade. Figure 13 shows Scott Boatright’s overhead photo, cropped to show the post impact location of the spools more clearly.

Figure 12: Location of wire spools before and after impact.

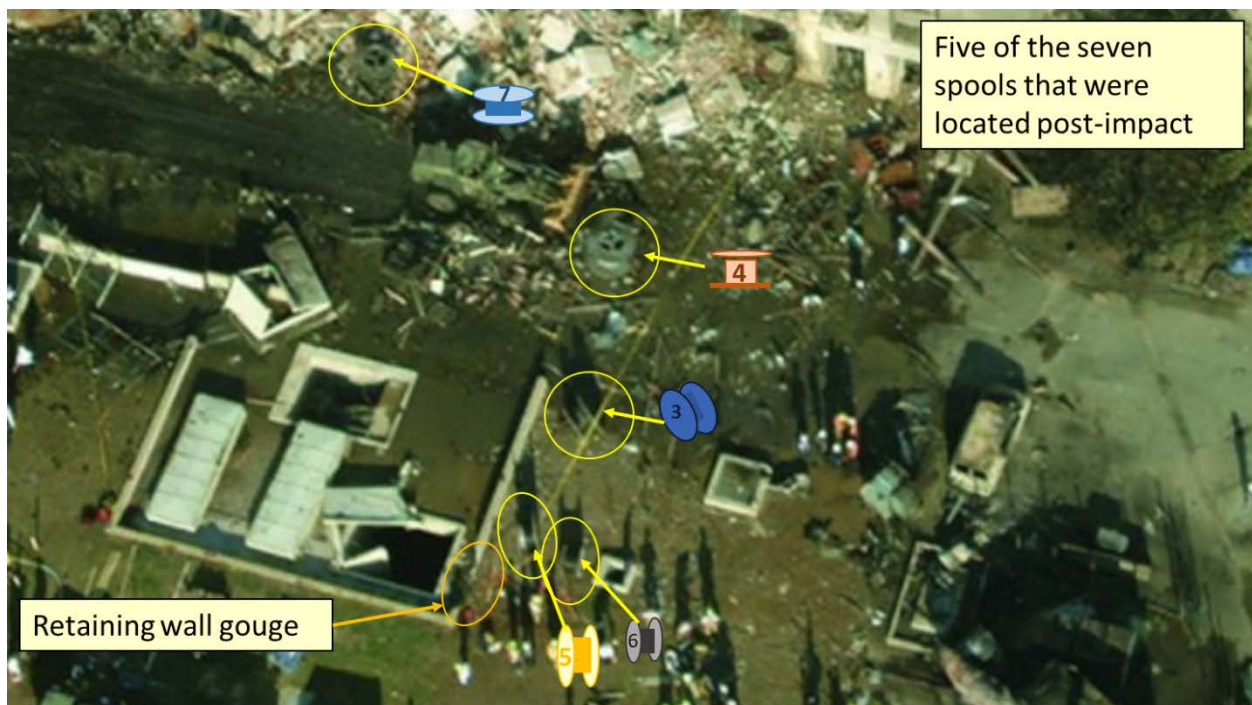
Figure 13: Overhead view of the location of the wire spools after the impact.

These resulting spool locations are consistent with the bottom of the left engine of a 757 impacting the retaining wall while the front/right side of the engine impacted spool 7 which knocked it into spool 4 sending both traveling rightward toward the facade. Meanwhile, spools 5 and 6 remained unaffected because the engine passed to their left without striking them as the wing went above them due to the clearance between the engine and fuselage shown in Figure 1.

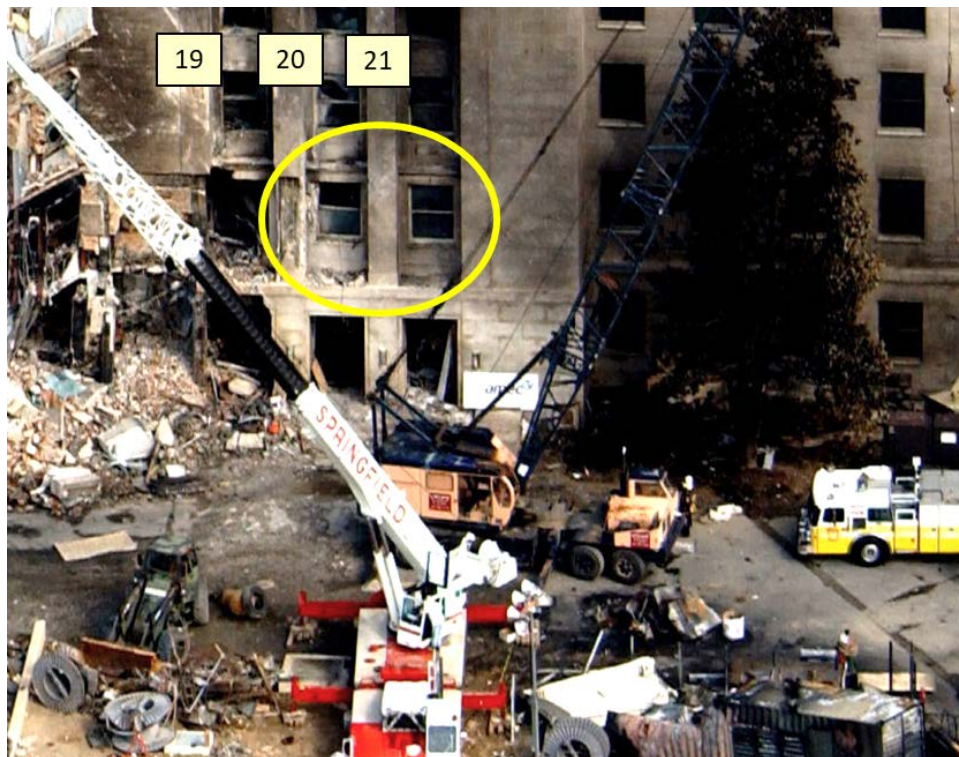
One of the key parameters for understanding the size of the impacting aircraft is the location of the right wingtip. This is a critical dimension because on a Boeing 737-400 there is about 47 feet from the centerline of the fuselage to the wingtip. This dimension for a Boeing 757-200 is about 62 feet. While there are no definitive marks that explicitly answer this positional question on the façade, there is evidence that the right wingtip very nearly reached column 21 and solidly impacted column 20. Figure 14 shows significant debris on the window sill between columns 20 and 21. This would not have been expected if the right wingtip only grazed the edge of column 20 as Inan's detailed drawings in Figures MI-11 and MI-17 show. However, careful examination of Inan's Figure MI-9 shows that the tight path through the severed light poles requires Column 20 to be missed by a more than 10 feet.

Figure 14: Debris on window sill between Columns 20 and 21.

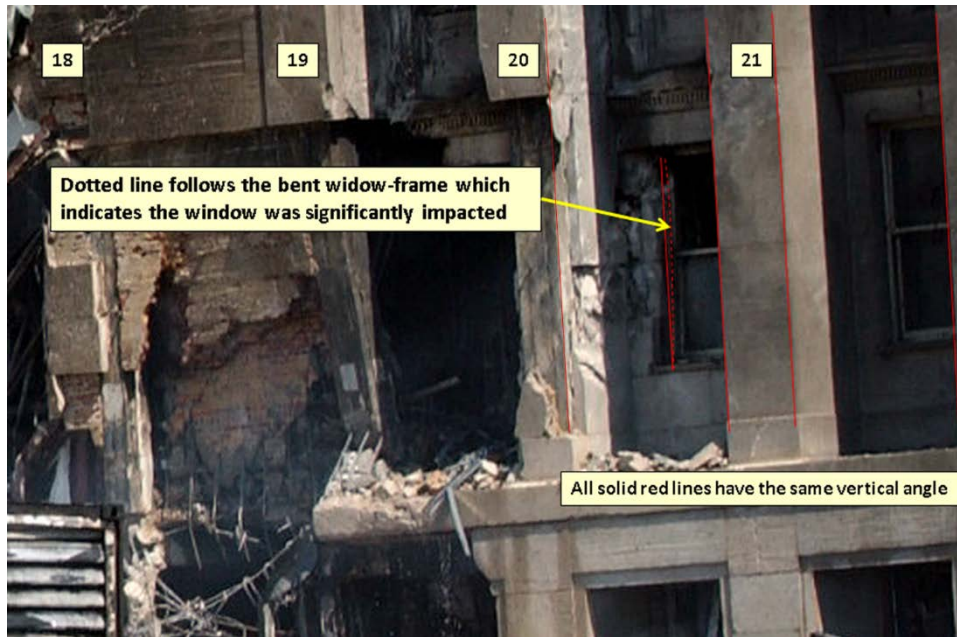
Figure 15 shows that the frame of the window between columns 20 and 21 has its left side bent. Because this window frame is constructed with 8" square steel tubing, a significant impact would have been needed to create this observed deformation. Consequently, Inan's detailed drawing (Figures MI-11 and MI-17) should have the impacting aircraft shifted at least 10 feet to the right and probably more because the right-wing tip barely touches column 20 in his analysis and cannot account for the observed damage. Detailed graphical analysis of these distances is presented in the isometric drawings in Appendix A.

Figure 15: Bent window frame between Columns 20 and 21 with significant debris on the window sill.

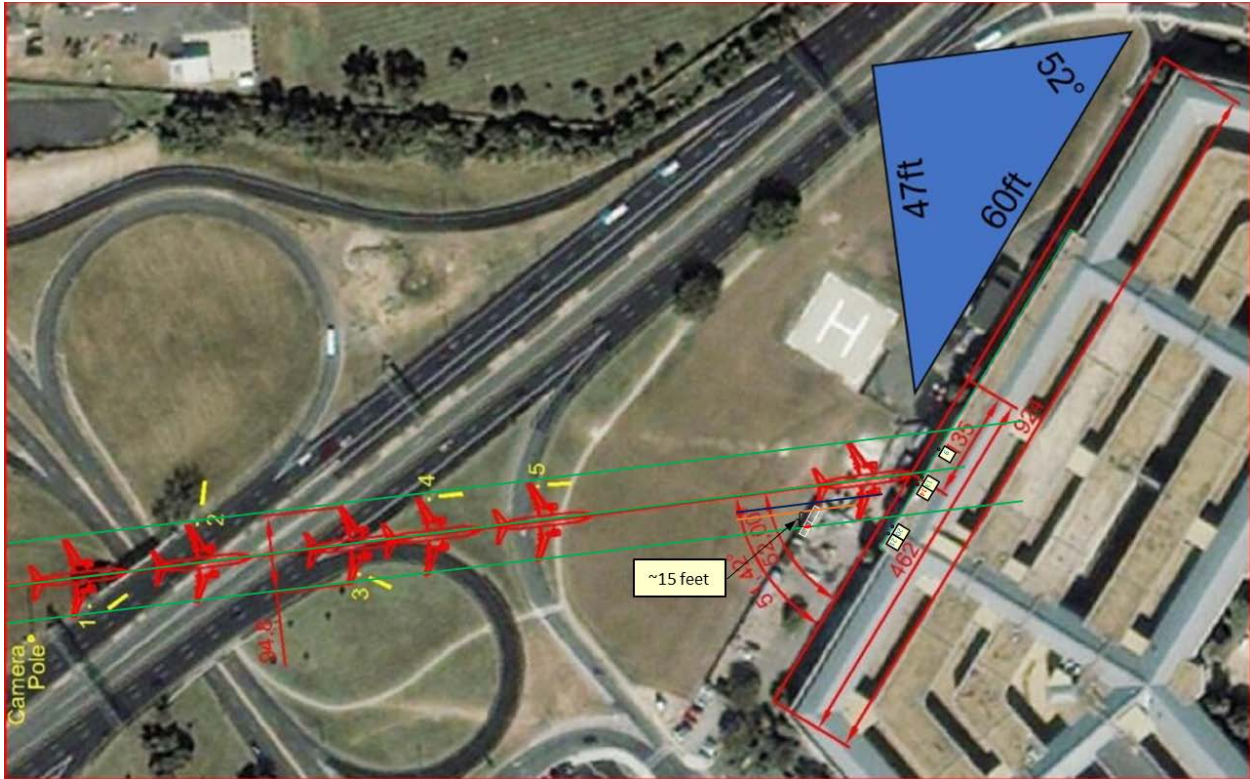
Figure 16 is an annotated version of Inan's Figure MI-9. The column locations that are added are based on actual scale drawing of the wall extracted from the Arlington Fire Department's After-Action Report [7]. Five columns of interest are marked (columns 9, 13, 14, 20 and 21) and their size is approximately shown to scale. Inan's Figures MI-16 and MI-17 rely on the sizes of the column shown in the ASCE Pentagon Performance report that are shown 3½ times larger than actual size for the purpose of color-coding amounts of damage sustained by the columns. The uncolored columns in Figure MI-11 shows the actual column sizes (e.g., see the little squares in column row 5).

Inan shows the 737-400 approaching along a straight path constrained by the need to impact all five light poles. With this axial alignment, the nose impacts the Pentagon façade to the left of columns 13 (e.g., between columns 12 and 13). The plane's dimensions are verified to be consistent with a Boeing 737-400 having a wingspan of about 94 feet. However, the right-wing tip cannot reach column 20 and the right engine does not clip the corner of the diesel generator trailer. Given the approaching aircraft is at an altitude allowing the Flap Track Fairing to create the trace through the roof of the trailer, the engine, which hangs about 6 feet below the wing, could not impact the generator trailer unless it were shifted 10 or more feet to the right. However, if the 737 is shifted to the right, then the light poles #2, #4 and #5 could not all be hit solidly enough to sever the light poles, as was observed.

Figure 16: Annotated version of Inan's Figure MI-9.

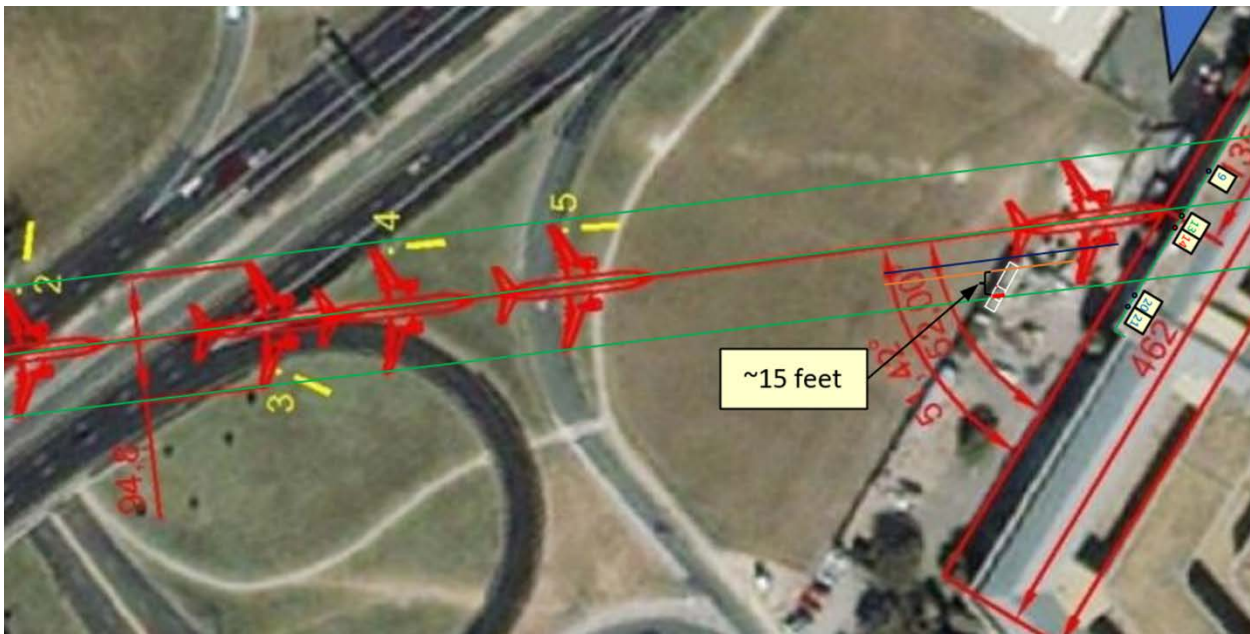
Figure 17 zooms into this image to focus on establishing the location of the Flap Track Fairing trace on the trailer in the satellite image. The green lines provide a wingtip-to-wingtip envelope of the hypothesized 737-400. The orange line shows the location of the outer Flap Track Fairing and the short blue line provides the outside limit of the right engine. The thick red line on the roofline of the generator trailer above the rear air intake vent panel shows the location of the observed trace.

Figure 17: Locating the Flap Track Fairing trace on the satellite photo.

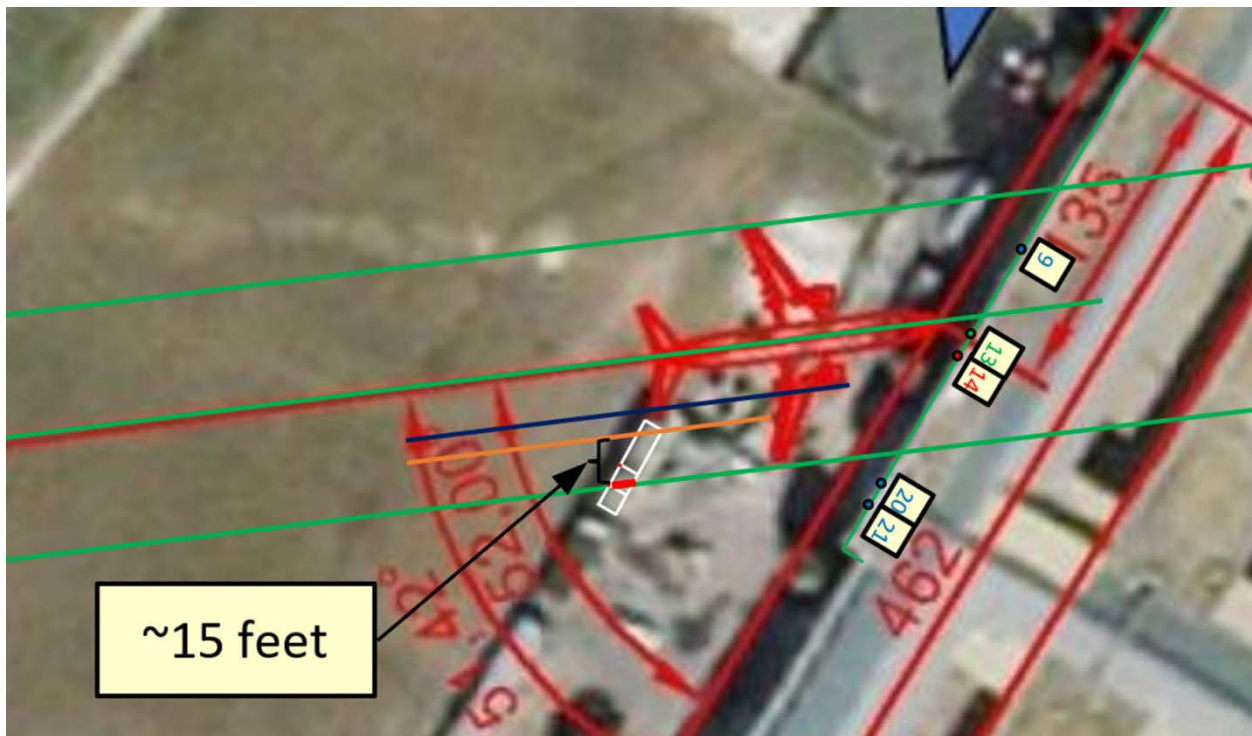
Figure 18 expands the detail of the hypothesized 737-400 approach. As shown, the nose will impact to the left of column 13. The blue line shows the position of the right engine which indicates no possibility of an impact with the generator trailer, even though this blue line is placed on the farthest outside edge of a wide, blurry red outline of the 737. The orange lines show the path of the outer Flap Track Fairing. The outer fairing is about 15 feet from the thick red line that indicates the trace on the roof of the generator trailer.

If the plane was shifted 15 feet to the south to align the Flap Track Fairing and the trace, the approach path through the light poles would likely miss both light poles #2 and #4 and the nose of the plane would impact to the right of column 14 (e.g., between columns 14 and 15).

Finally, the lower green line shows the right-wing tip does not impact column 20. The column locations along the façade are from an actual scale drawing of the wall extracted from the Arlington Fire Department's After-Action Report [7].

Figure 18: Detail of hypothesized 737-400 impact.

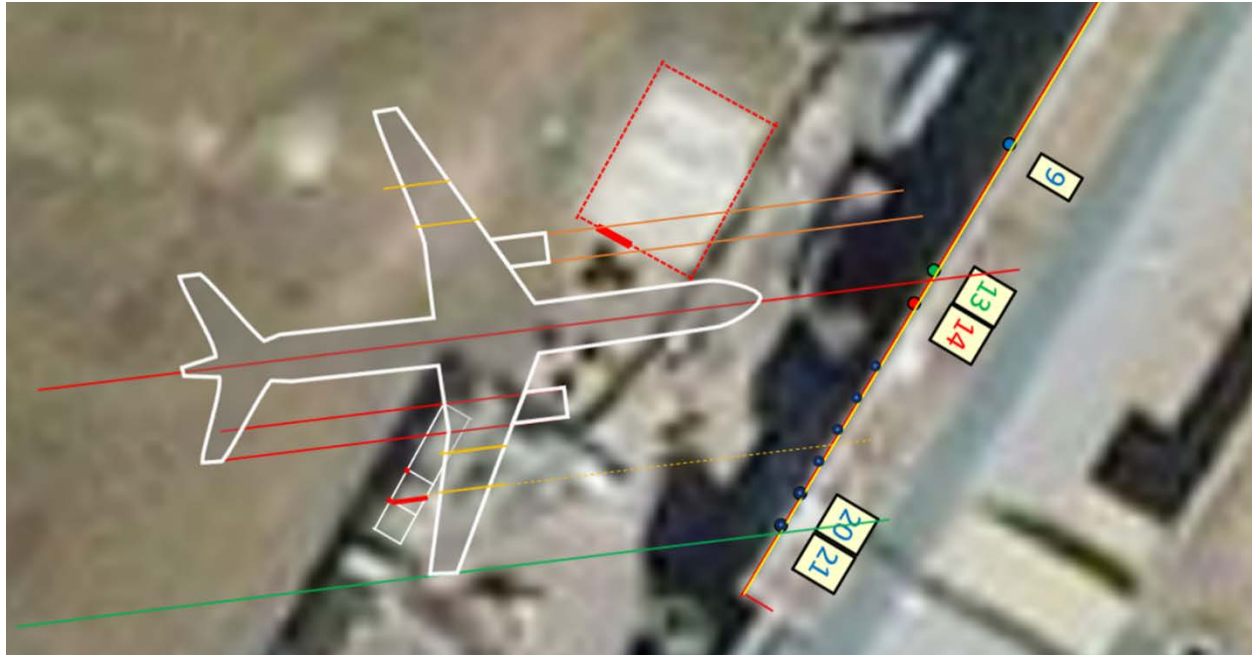
As shown in Figure 19, a Boeing 757-200 traveling along approximately the same axial path as hypothesized in Figure MI-9 almost fits the observations perfectly. With an axial alignment toward the right of column 13, the outer Flap Track Fairing aligns with the trace in the generator trailer roof. The right engine impacts the trailer at approximately the middle of the front half of the trailer where the 'bullseye' records an impact. Additionally, without considering any yaw rotation, the outer right wingtip would impact column 21. Wire spool 7 would be impacted while wire spools 6 and 5 would be underneath the left wing between the fuselage and engine. The left engine is perfectly aligned to impact, and gouge, the retaining wall section which is shown in red. While more detailed explanations about the 757 Impact can be seen at [911Speakout.org](http://911Speakout.org) [8], the measurements in this analysis are more precise.

Figure 19: Boeing 757-200 shows alignment with Flap Track Fairing.

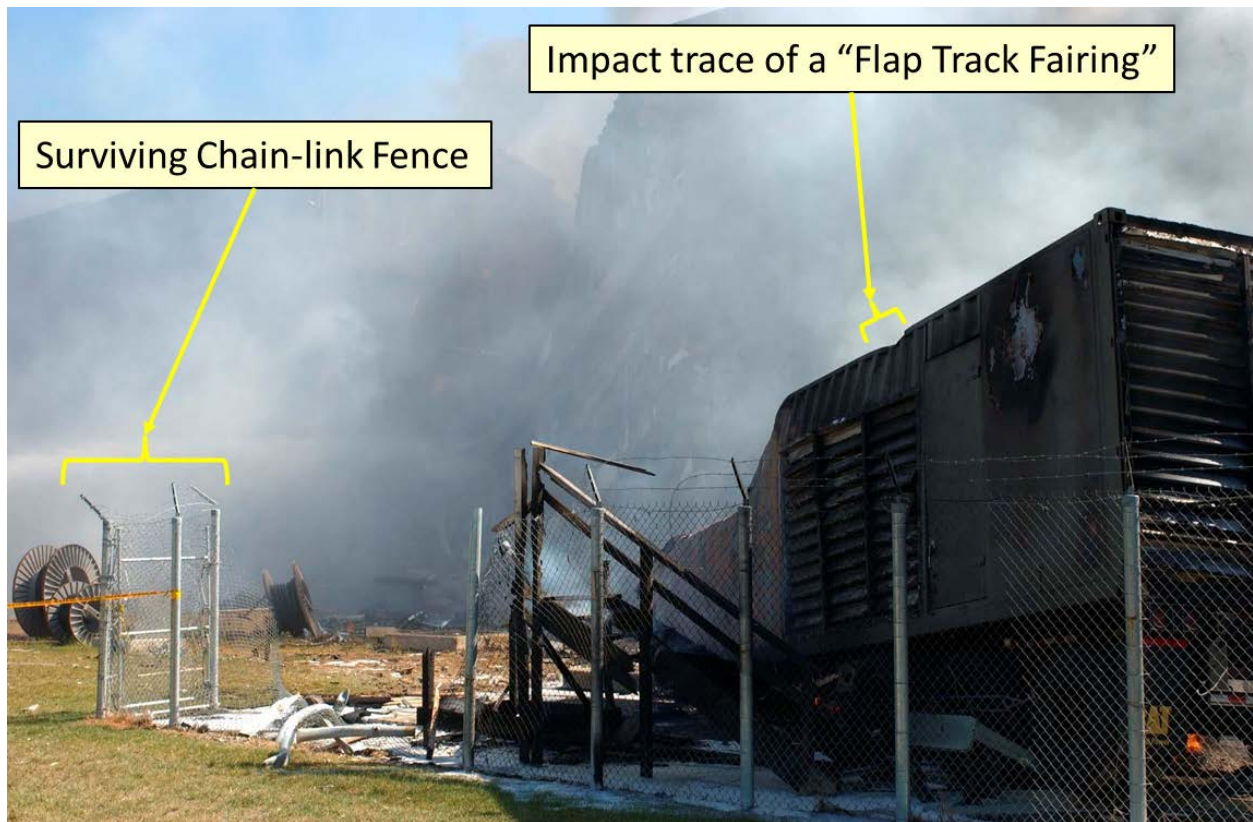
One of the minor structures that can provide insights into the dimensions of the impacting aircraft is a surviving corner segment of the chain-link fence that had surrounded the generator trailer. Figure 20 shows this surviving corner section is largely undamaged and, including the barbed-wire, it is approximately half the height of the trailer. Two sections of the fence have been knocked-down between the surviving corner segment and the continuation of the fence along the side of the trailer. As shown in Figure 18, the path of the right engine of a Boeing 737-400 would have impacted this corner fence segment. However, as shown in Figure 19, the right engine of a Boeing 757-200 would have impacted the fence at the location of the knocked-down sections while leaving the corner segment unaffected. The alignment of this fence segment can be seen in the isometric drawings in Appendix "A."

Figure 20: Generator Trailer showing surviving corner segment of the chain link fence.

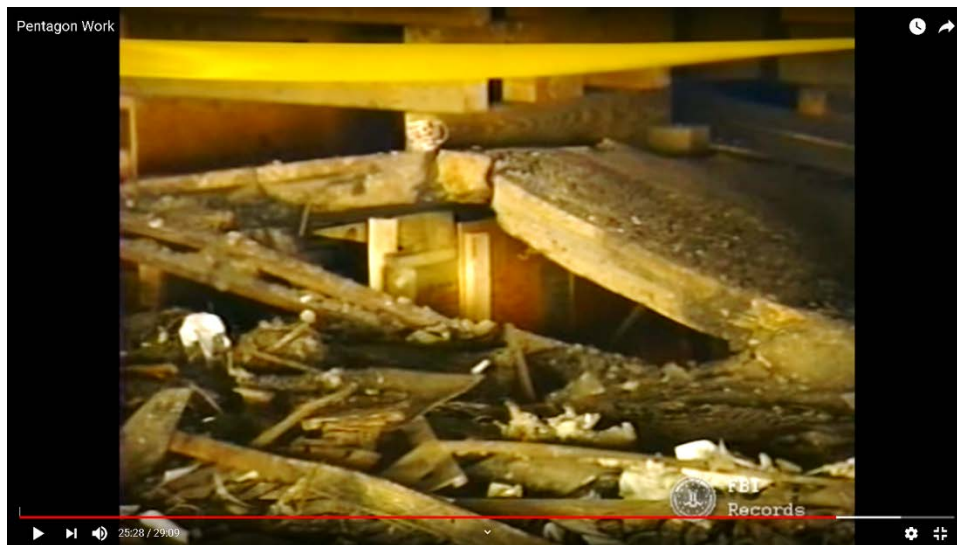
This damage to the second-floor slab was the topic of a recent Debated Topics Forum paper that identifies the source of the damage as the kinetic energy of the rapidly rotating jet engines [10] which were forced to redirect their motion chaotically due to torques from multiple impacts with columns and the dynamic effects of gyroscopic precession. Analysis of the aircraft approach and impact provides an explanation of how the left engine of the 757 entered the Pentagon, with a documented trajectory through the columns. Impacts with columns along this path would create a tumbling and bouncing 5-ton gyroscope whose trajectory would take it directly under the uplifted slab. The tenting of the slab, shown in Figure 26, reflects a mechanical snapping that would be characteristic of mechanical impact damage, not a detonation from below. Explosives of a significant scale would be very unlikely because Major David King was near the location of this alleged explosion and yet was not injured by what would have been a massive explosion.

Figure 26: Uplifted second floor slab illustrating mechanical damage, not explosive detonations.
