Rebuttal to the Hypothesis that a Boeing 737 Struck the Pentagon

By David Chandler

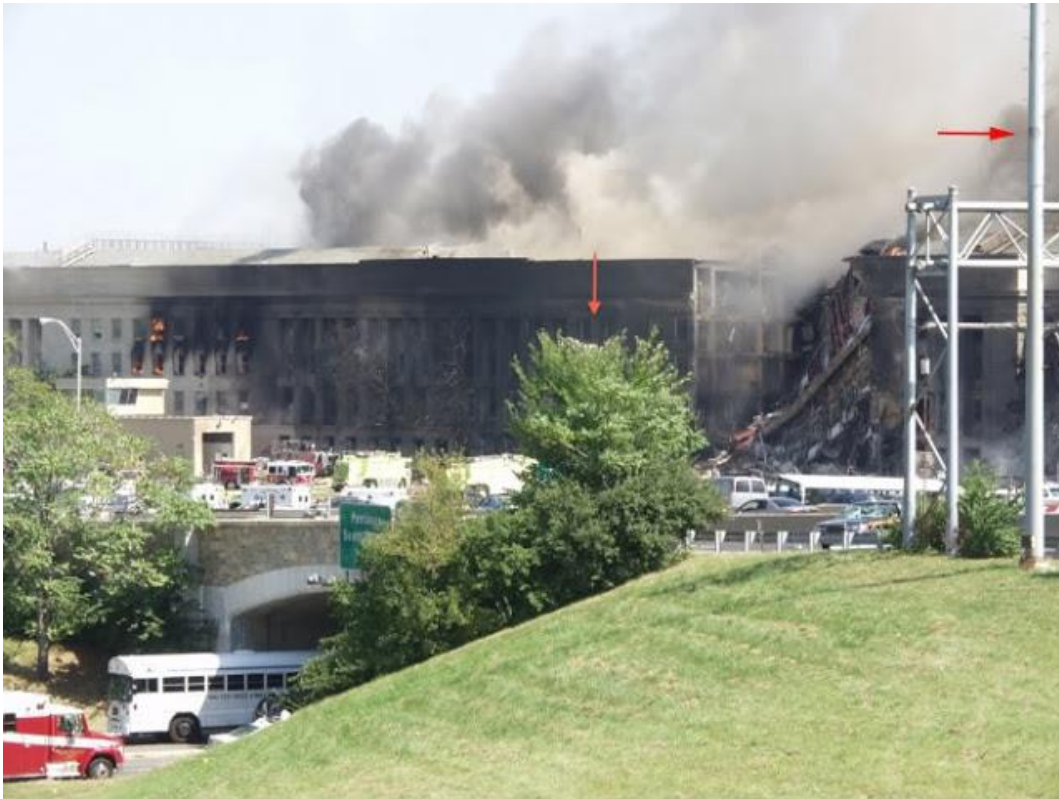
Figure 1 Notch in the top of the tree and scar and missing rung on VDOT camera pole.

- A Virginia Department of Transportation (VDOT) highway camera pole, close to the tree and the first light pole, has a surface scar and is missing a rung (Figure 1). There are no “before” pictures of the camera pole for comparison, but the positioning and the nature of

the damage are consistent with its being grazed by the right wingtip. The lateral spacing between the camera pole and second light pole is ~125 ft.

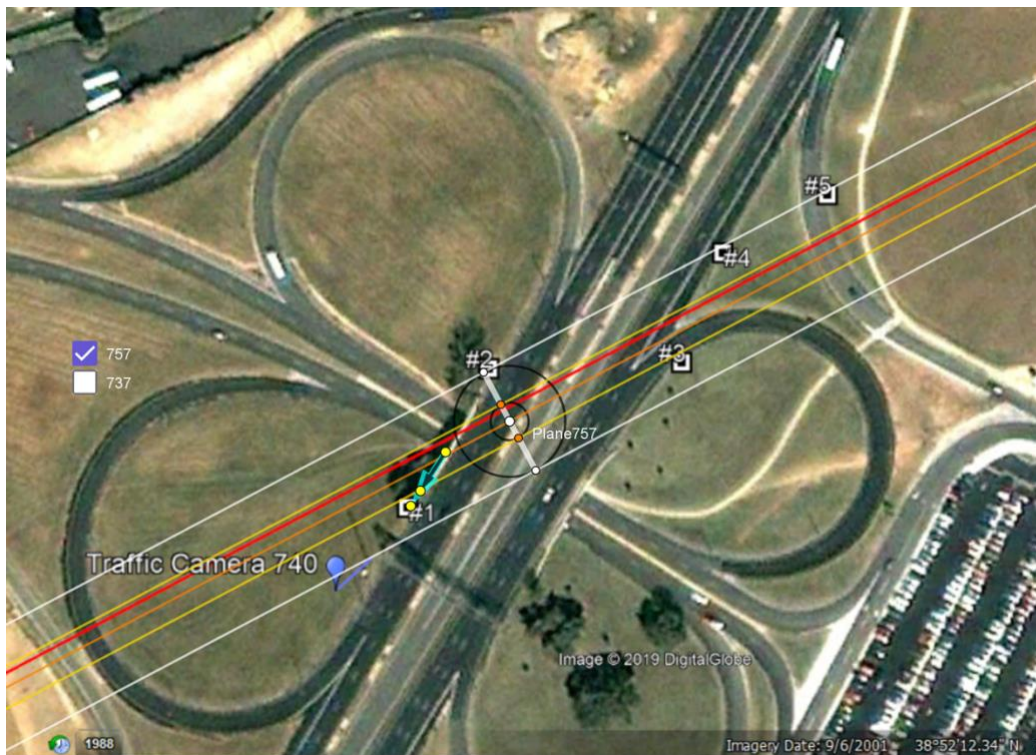
Figure 2 Tracks of the nose, the wing tips, and the engines of a 757. The near vertical linear shadow near the blue bubble near the bottom left corner of the image is the shadow of the traffic camera pole. The bottom of the shadow marks the location of the pole.

Figure 2 shows the flight path of the Pentagon plane using the wingspan and “engine span” of a 757 and the direction of motion (red line) given by the flight data recorder (FDR) whose data module was recovered in the Pentagon debris. The 757 wingspan is 124 ft 10 in, as documented in Figure 4.³

Positioning the left wingtip at light pole 2, the right engine passes directly through the notch in the tree indicated by a yellow dot at the tip of the black arrow in Figure 2⁴ and the right wingtip touches the VDOT camera pole. It is hard to imagine that this spacing is coincidental, given the other corroborating evidence. Furthermore, with this wingspan and this positioning, the 1st and 3rd light poles impact the leading right wing slat just outside the right engine. Such a double impact on the wing slat can account for its damage causing it to dislodge and drop onto the lawn.

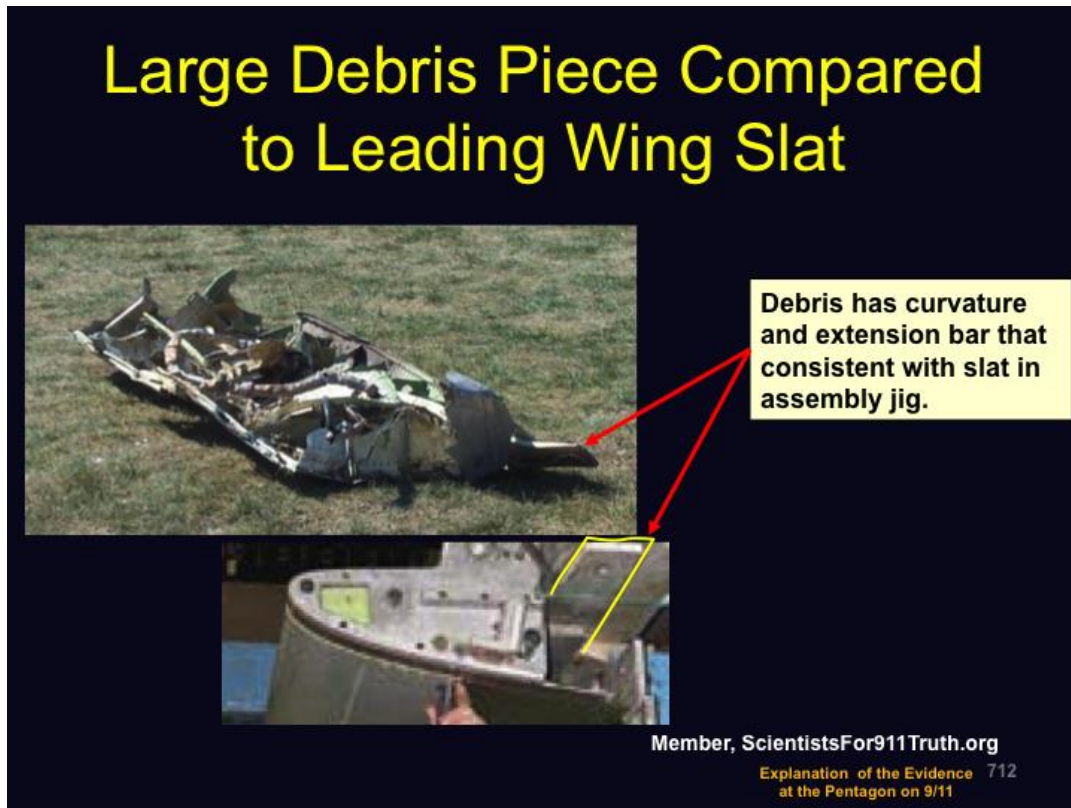
- One other piece of physical evidence of impact was the leading wing slat from the right wing of the incoming plane, Figure 3, that was dislodged and dropped onto the lawn prior to the plane hitting the Pentagon wall. For this piece to be dislodged from the wing, the impacts from light poles 1 and/or 3 would have to make solid contact with this part of the wing. This debris fragment is discussed in the video, *Chapter 12: Explanation of the Evidence at the Pentagon on 9/11* which can be found at <https://911speakout.org/wayne-coste/> or directly on YouTube at <https://youtu.be/amvxGqCmYkc?si=Nrzi0fCATIG8DLTu&t=813>.

Figure 3 Leading wing slat impacted by first and third light poles and dropped onto the lawn prior to the plane reaching the Pentagon wall.

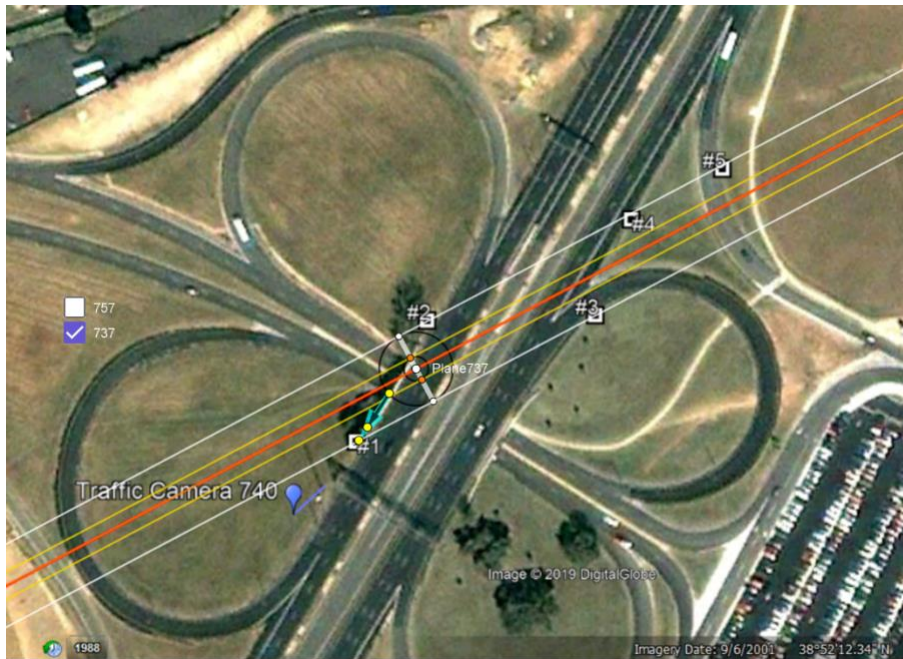
To evaluate the Boeing 737 hypothesis, I have produced a second construction (Figure 6), with the wing span and "engine span" of a 737-400 (94.75 ft and 31.6 ft respectively), as documented in Figure 5.⁵ Note in Figure 6 that if the left wingtip touches the 2nd light pole, the right wingtip misses the VDOT camera pole by a wide margin, and the right engine not only misses the notch in the tree but appears to miss the tree entirely. Furthermore, although it is possible to find a path for the wings to touch all five light poles, all of them would be grazing contacts with the wingtips. Such contacts cannot account for the fact that the vertical shafts of poles 1 and 3 were severed, and none of the impacts with the poles would have contacted or dislodged the leading wing slat of the right wing that was found on the lawn.

Figure 4 A second set of trails has been constructed to match the dimensions of a 737-400. The assembly has been positioned so the left wingtip touches the second light pole, which is an absolute requirement for any hypothetical plane flying along this path.
