## Rebuttal to the Hypothesis that a Boeing 737 Struck the Pentagon

By David Chandler

*Editor's Note: This paper is a response to the June 2024 paper by Mehmet Inan, which can be read [here](#). This paper was republished with minor revisions related to the missing rung of the camera pole near Highway 27 on January 30, 2025. The original version, published on January 23, 2025, can be found [here](#).*

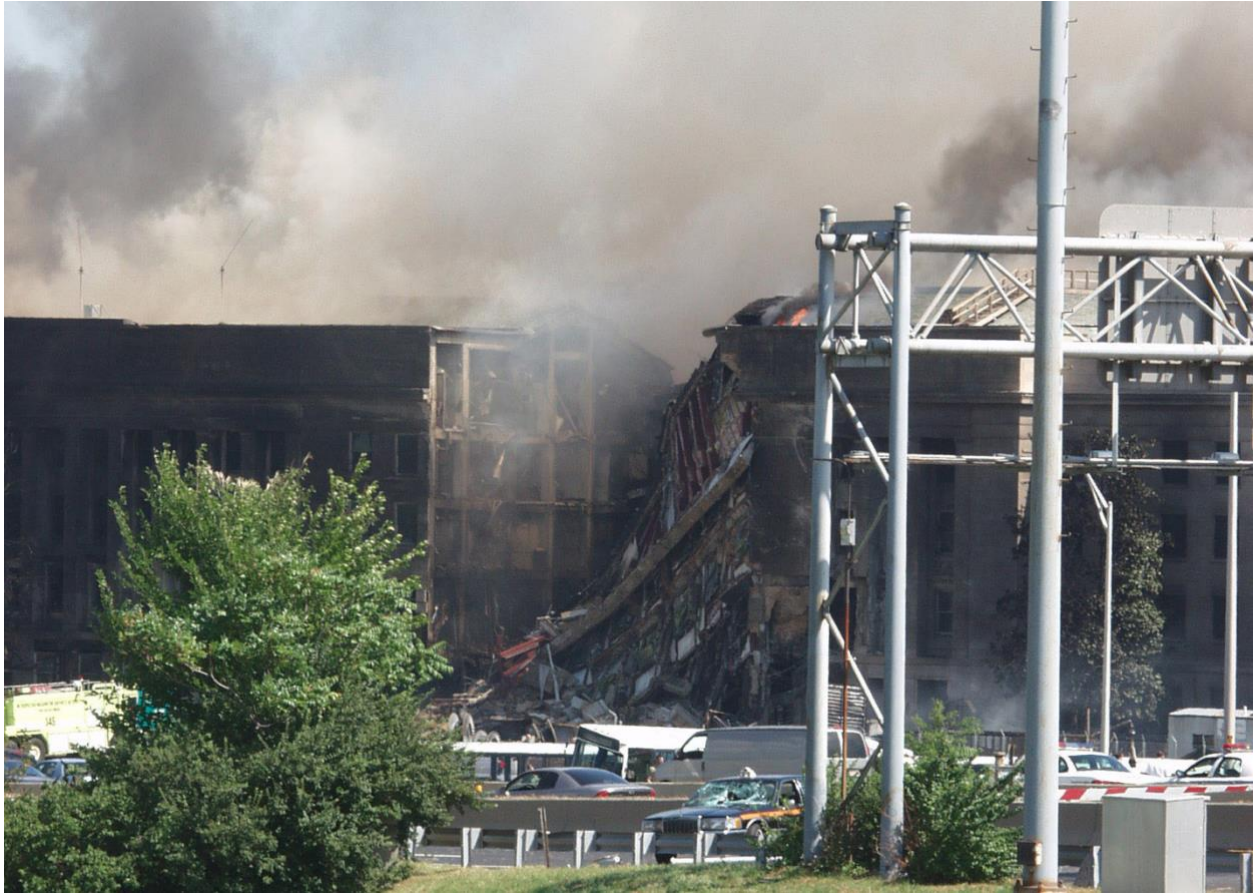
- Five light poles were knocked down (Figures 4 and 8<sup>1</sup>). Three of these poles are especially significant in our immediate inquiry.
  - The vertical shafts of the first and third poles were solidly hit by the right wing and were severed.
  - The vertical shaft of the second light pole was lightly grazed by the left wingtip. The shaft was bent about 90° and knocked over, but did not break. This contact provides a precise data point for the plane's left wingtip.
- The right engine of the incoming plane cut out a circular arc at the top of a tree on the overpass, as with a dull blade, leaving frayed ends. (Figures 1 and 2<sup>2</sup>)

*Figure 1 Circular notch in top of tree in relation to the camera pole with a scar and missing rung. This image, and the following detail views, were cropped from a photograph taken by Staff Sgt Gary Coppage on 9/11/2001. Note that this photograph was taken after the roof of the Pentagon had collapsed, approximately a half hour after impact.*

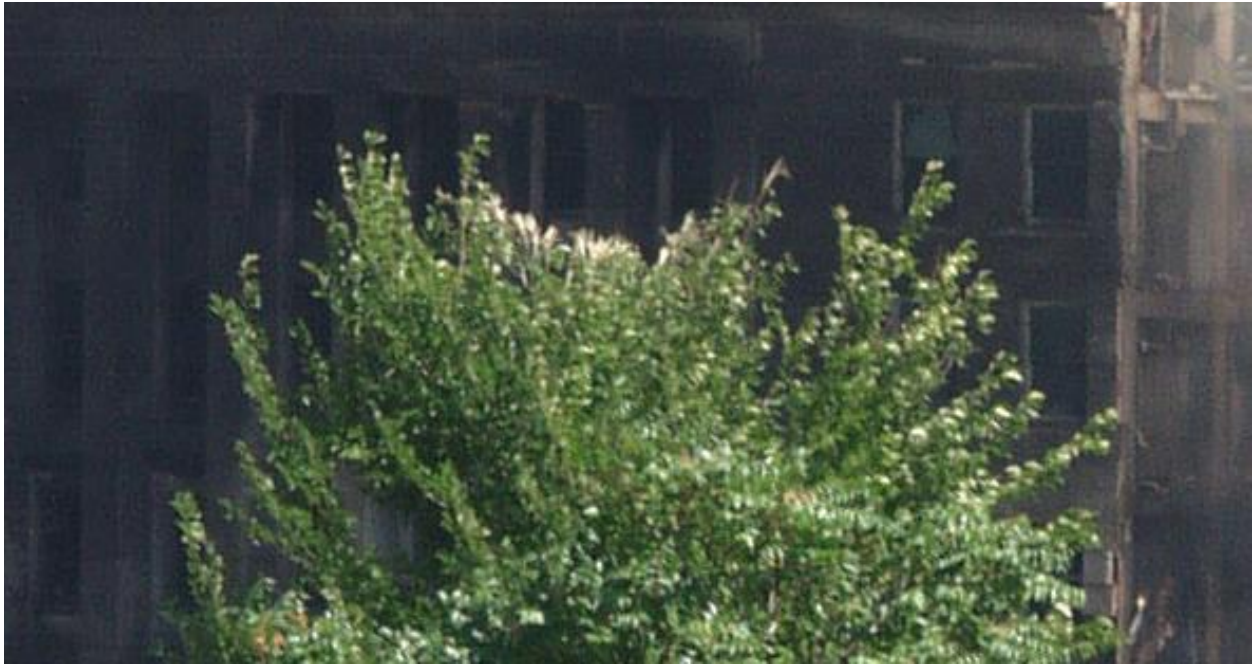
Figure 2 Detail view of tree notch, showing the frayed ends of the stems.

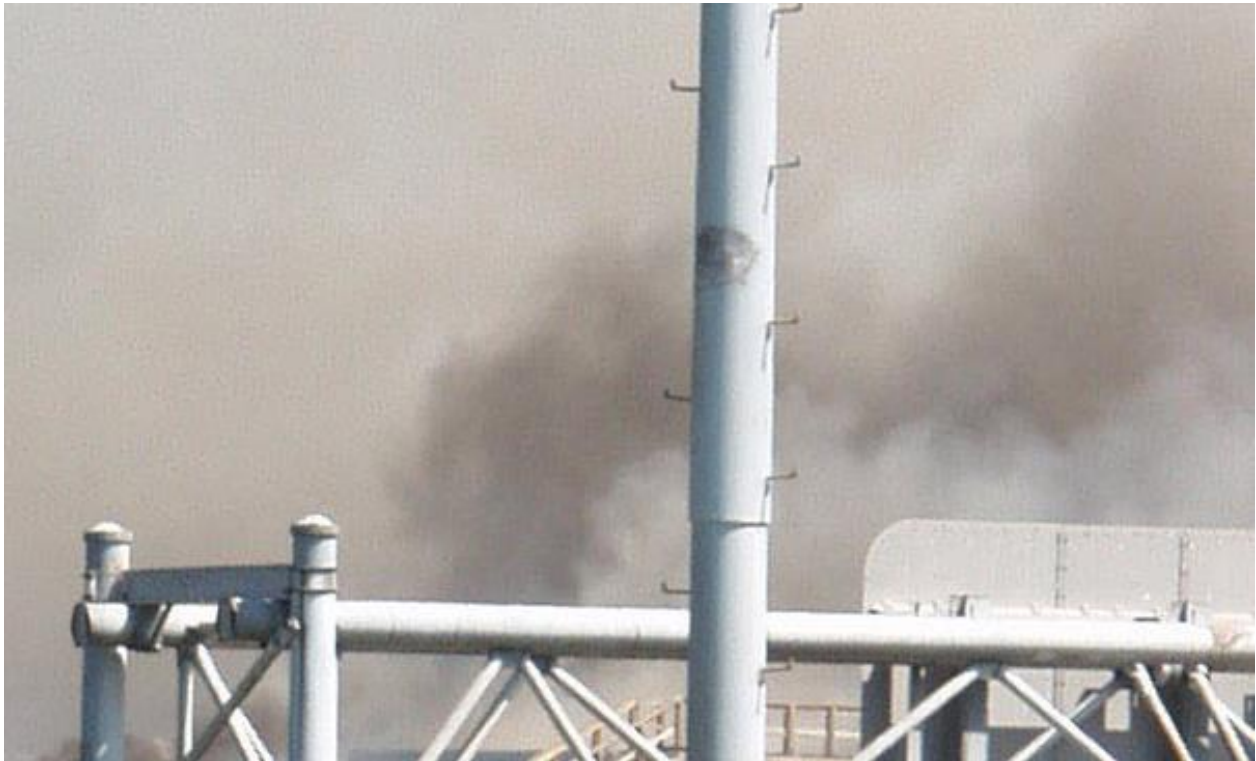
- A Virginia Department of Transportation (VDOT) highway camera pole, close to the notched tree and first light pole, has a surface scar and is missing a rung (Figures 1 and 3). There are no “before” pictures of the camera pole for comparison, but the positioning and the nature of the damage are consistent with its being grazed by the right wingtip. The lateral spacing between the camera pole and second light pole is about 125 ft.
  - As a side note, we have found an image of unknown origin that is identical with the Coppage photograph, except that it shows the rung as not missing. *This is not a different photograph.* It is an altered copy of the Coppage photograph. Besides the fact that this image conflicts with the documented original, other photographs, from earlier in the day confirm the rung is actually missing.<sup>3</sup> See Figure 4 for one notable example.

Figure 3 Detail view of scar and missing rung on the VDOT traffic camera pole cropped from the Coppage photo in Figure 1.

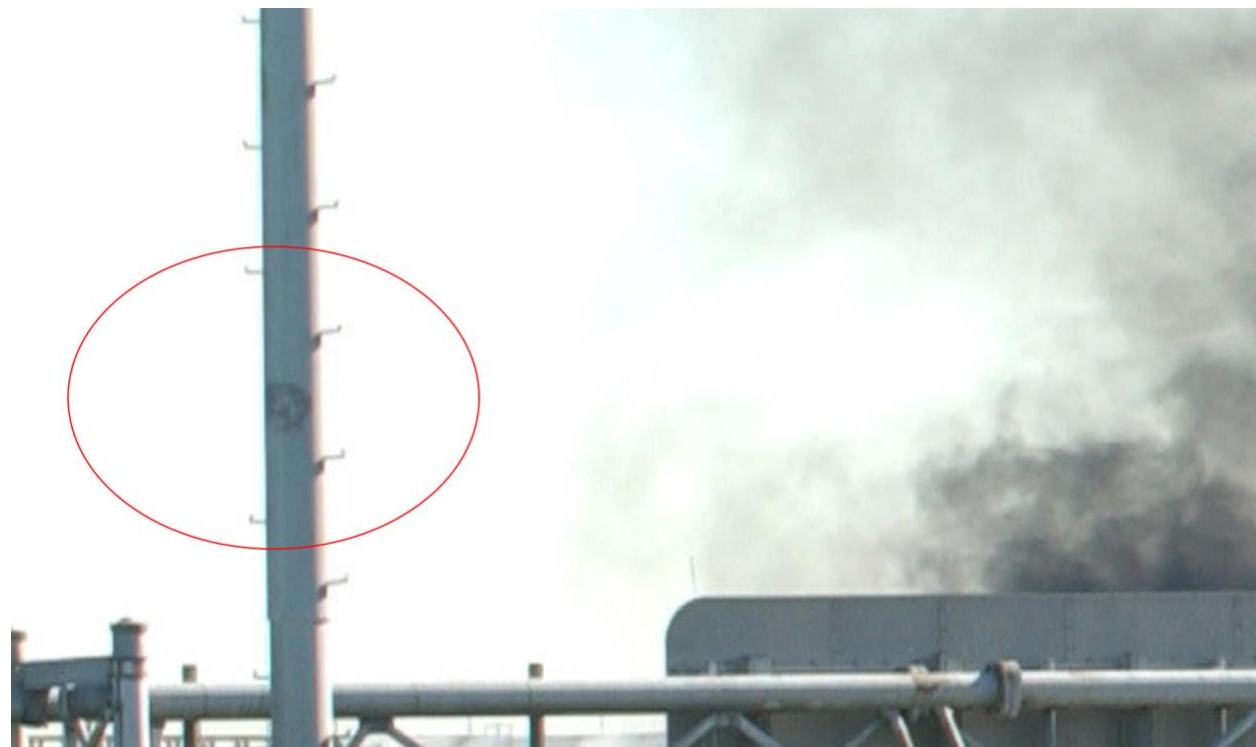
Figure 4 Confirming view from a different angle showing the rung to be missing, cropped from a Jason Ingersoll photograph taken earlier in the day before the Pentagon roof collapsed.

<sup>3</sup> The image, from an undocumented source, identical with the Coppage photo except for showing the rung intact, is archived for comparison at: <https://ic911.org/wp-content/uploads/2025/01/coppage-photo-with-rung.jpg>. The original Jason Ingersoll image, from which the detail view in Figure 4 was cropped, is available at [https://upload.wikimedia.org/wikipedia/commons/d/d2/The\\_pentagon\\_in\\_flames\\_moments\\_after\\_a\\_hijacked\\_jetliner\\_crashed\\_into\\_building\\_at\\_approximately\\_0930\\_010911-M-CI426-015.jpg](https://upload.wikimedia.org/wikipedia/commons/d/d2/The_pentagon_in_flames_moments_after_a_hijacked_jetliner_crashed_into_building_at_approximately_0930_010911-M-CI426-015.jpg). As a point of interest, note that the rung was never repaired. The eighth rung from the bottom on the north side of the pole is still missing on current Google Street View [photos](#).

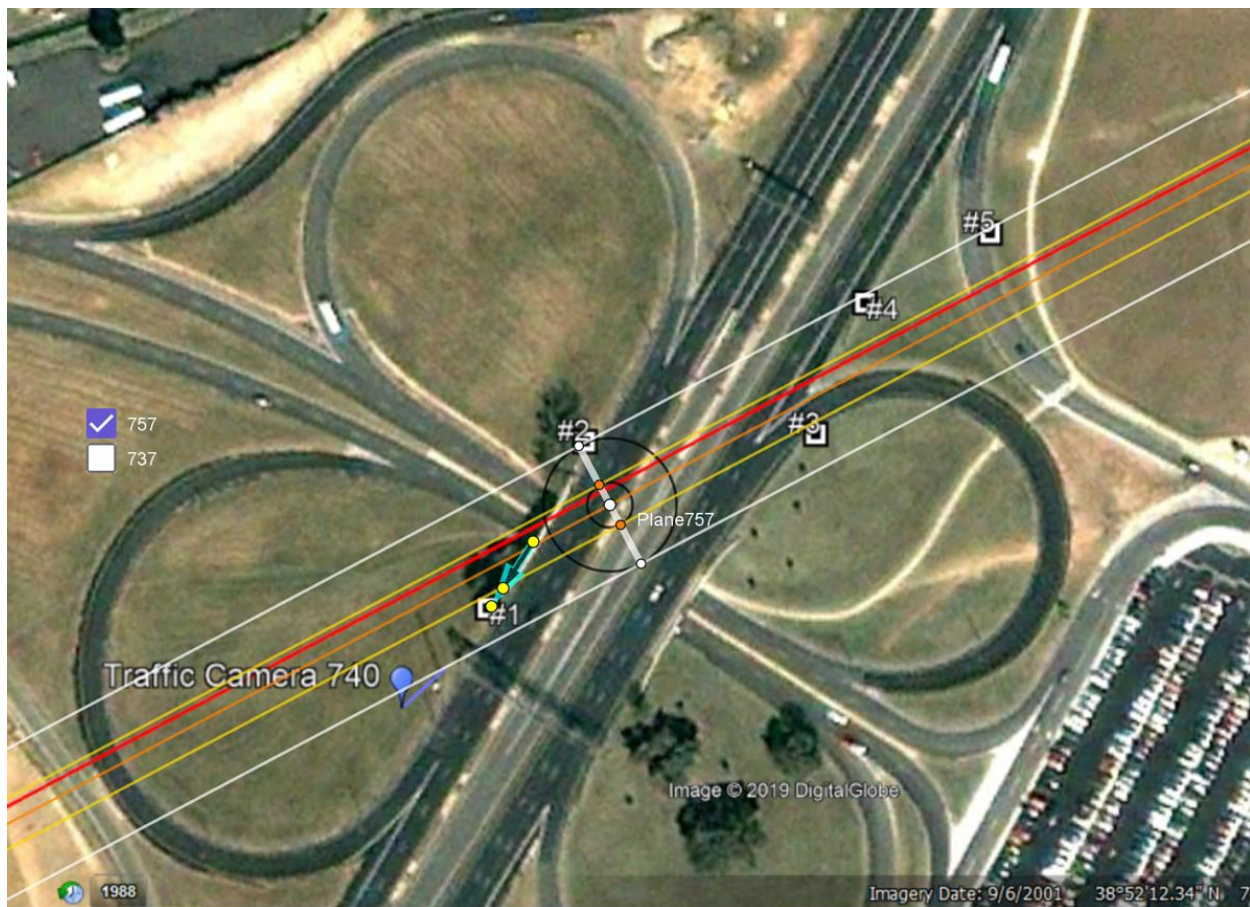
Figure 5 Tracks of the nose, the wing tips, and the engines of a 757. The near vertical linear shadow near the blue bubble near the bottom left corner of the image is the shadow of the traffic camera pole. The bottom of the shadow marks the location of the pole.

Figure 5 shows the flight path of the Pentagon plane using the wingspan and “engine span” of a 757 and the direction of motion (red line) given by the flight data recorder (FDR) whose data module was recovered in the Pentagon debris. The 757 wingspan is 124 ft 10 in, as documented in Figure 7.<sup>4</sup>

Positioning the left wingtip at light pole 2, the right engine passes directly through the notch in the tree indicated by a yellow dot at the tip of the black arrow near the first light pole in Figure 5<sup>5</sup> and the right wingtip touches the VDOT camera pole. It is hard to imagine that this spacing is coincidental, given the other corroborating evidence. Furthermore, with this wingspan and this positioning, the 1<sup>st</sup> and 3<sup>rd</sup> light poles impact the leading right wing slat just outside the right engine. Such a double impact on the wing slat can account for its damage causing it to dislodge and drop onto the lawn.

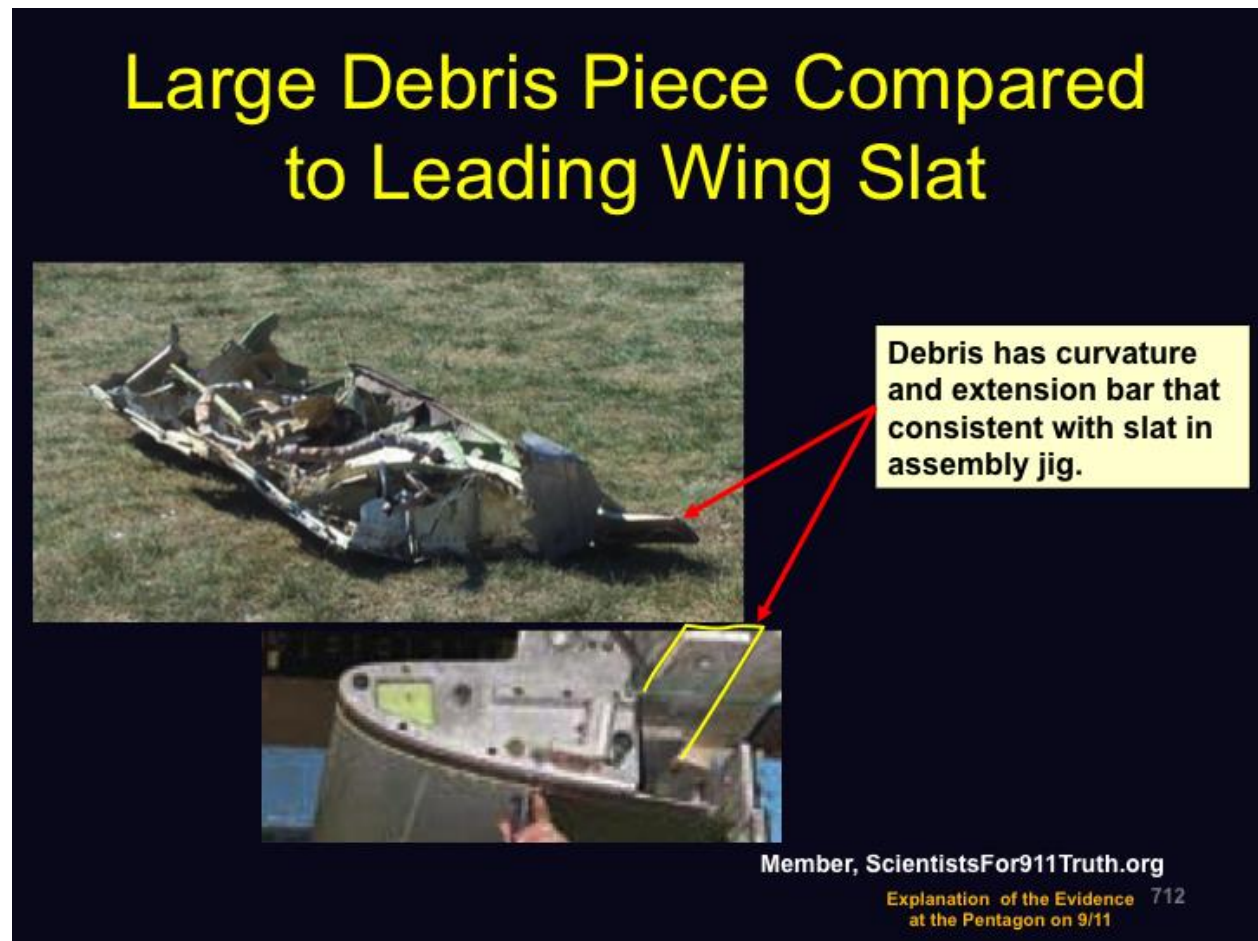
- One other piece of physical evidence of impact was the leading wing slat from the right wing of the incoming plane, Figure 6, that was dislodged and dropped onto the lawn prior to the plane hitting the Pentagon wall. For this piece to be dislodged from the wing, the impacts from light poles 1 and/or 3 would have to make solid contact with this part of the wing. This debris fragment is discussed in the video, *Chapter 12: Explanation of the Evidence at the Pentagon on 9/11* which can be found at <https://911speakout.org/wayne-coste/>.

Figure 6 Leading wing slat impacted by first and third light poles and dropped onto the lawn prior to the plane reaching the Pentagon wall.

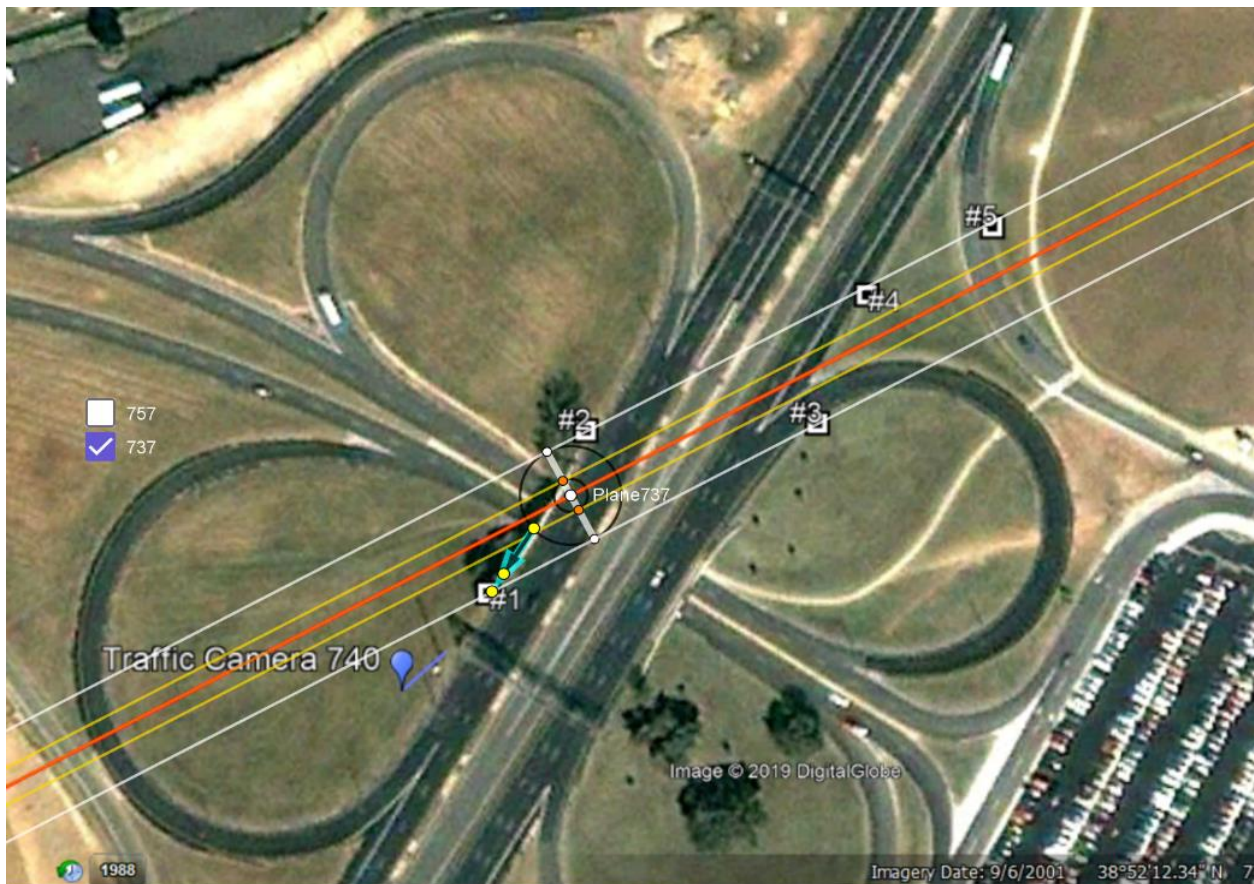
To evaluate the Boeing 737 hypothesis, I have produced a second construction (Figure 9), with the wing span and "engine span" of a 737-400 (94.75 ft and 31.6 ft respectively), as documented in Figure 8.<sup>6</sup> Note, in Figure 9, that if the left wingtip touches the 2<sup>nd</sup> light pole, the right wingtip *misses* the VDOT camera pole by a wide margin, and the right engine not only misses the notch in the tree but appears to miss the tree entirely. Furthermore, although it is possible to find a path for the wings to touch all five light poles, all of them would be grazing contacts with the wingtips. Such contacts cannot account for the fact that the vertical shafts of poles 1 and 3 were severed, and none of the impacts with the poles would have contacted or dislodged the leading wing slat of the right wing that was found on the lawn.

Figure 9 A second set of trails has been constructed to match the dimensions of a 737-400. The assembly has been positioned so the left wingtip touches the second light pole, which is an absolute requirement for any hypothetical plane flying along this path.
