Pentagon Approach Path of a Boeing 757 on 9/11/2001

By David Chandler

This paper presents evidence of a large plane, consistent with a Boeing 757, flying into the Pentagon on 9/11/2001, making contact with a number of obstacles along the approach path. This is a follow-up to the earlier paper in the IC911 Debated Topics Forum, “Large Plane Impact Damage to the Wall of the Pentagon and Adjacent Objects” by David Chandler and Wayne Coste. That paper considered evidence for impact by a large plane, consistent with a 757, based on the impact damage to the generator trailer, chain link fence, low concrete retaining wall, the large tree in front of Column 16, and the face of the Pentagon itself. As will be shown here, there is a substantial amount of corroborating physical evidence prior to the first contact of the plane with the generator trailer.

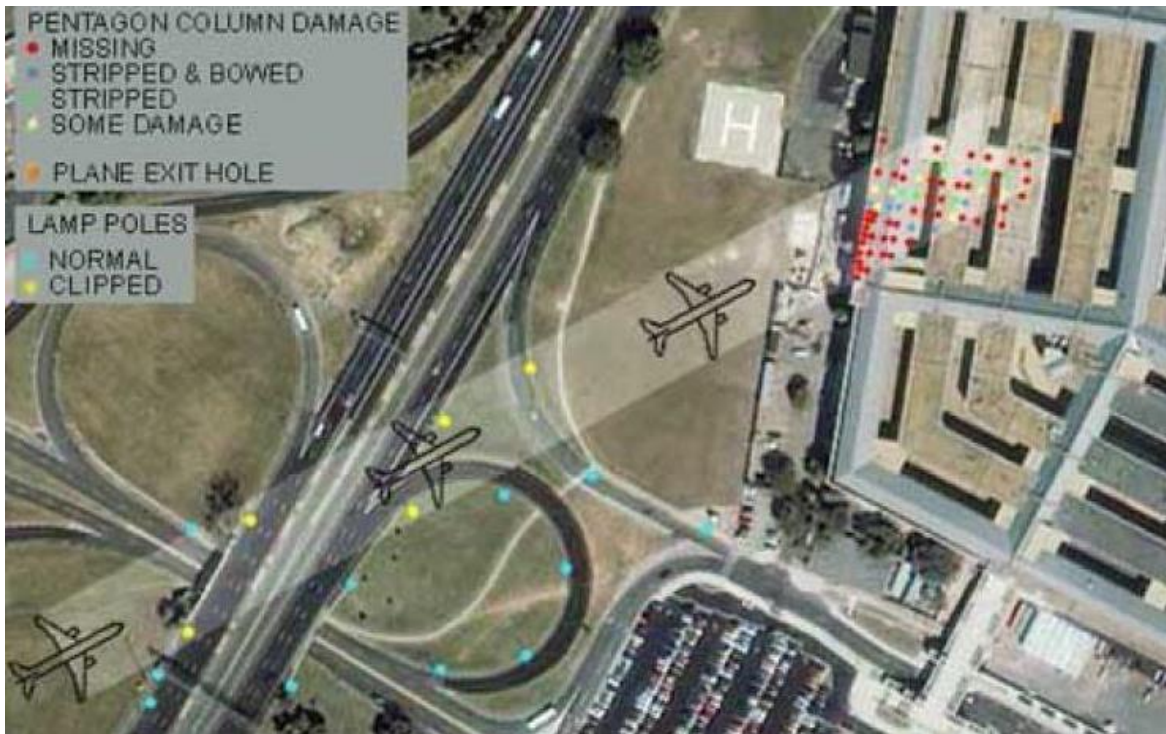
Figure 1 Alignment of light pole damage with interior damage in the Pentagon.

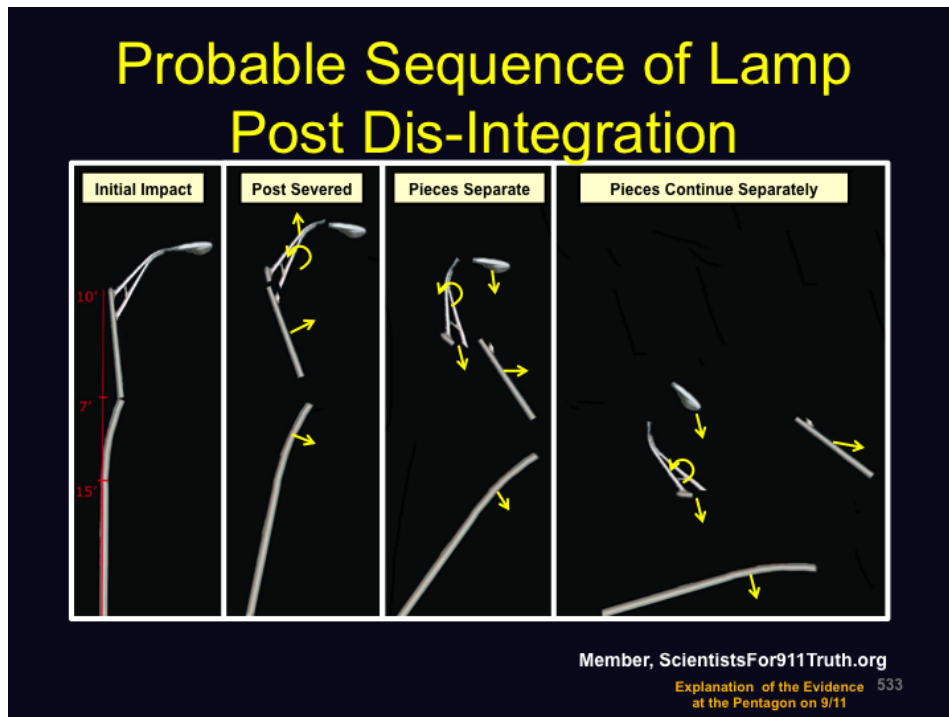
The first light pole was hit solidly by the right wing just beyond the engine. It was broken into four pieces, all of which can be identified on the highway overpass (Figure 5).³

Figure 5 Analysis of breakup of first light pole.

Some have wondered how the pieces could remain close to the original pole position given the high speed of impact. The answer is based on the physics of collisions. In order for an impact to throw an object, momentum must be transferred to it. Transfer of momentum is proportional to a quantity called “impulse”, which is the product of the force and the time of interaction. A high-speed impact (think of a bullet) may deform or destroy the impacted object at the point of contact, but has minimal time of interaction and thus reduced impulse. That is why a bullet can put a hole in someone without throwing them across the room. On the other hand, the ability of a moving object to inflict damage depends on its kinetic energy, which is proportional to the velocity squared, so increasing the speed disproportionately increases the kinetic energy. The plane had high kinetic energy because of its high speed, but could only transfer minimal momentum to the pole fragments, so the pieces were severed and broken at weak connection points but not thrown far.

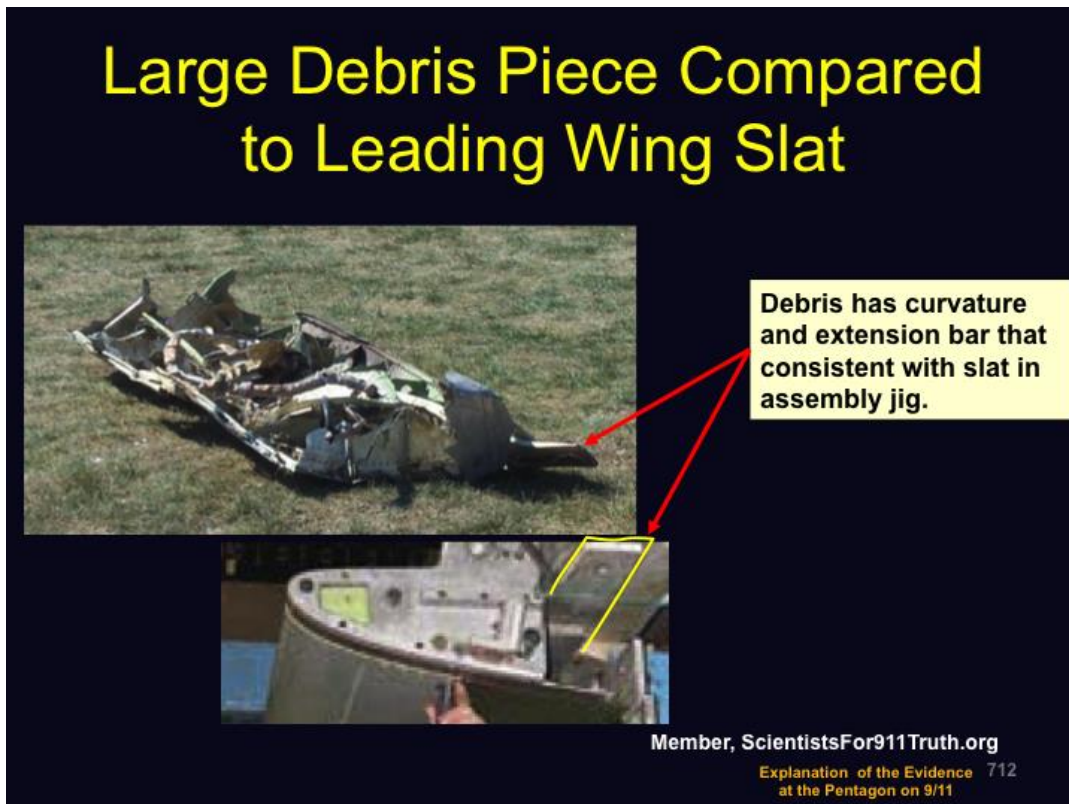
The third light pole was also severed by the right wing. One would expect the multiple impacts to damage not only the light poles but the wing. In fact, we know the wing was indeed damaged. There is a piece on the lawn which can be identified as a right wing slat, a movable section of the wing that extends to increase the wing’s surface area during normal takeoffs and landings. This piece appears to have fallen off prior to the plane’s impact with the generator tailer. (See Figures 6 and 7).

Figure 6 Leading wing slat found under path of right wing, which had hit light poles 1 and 3.

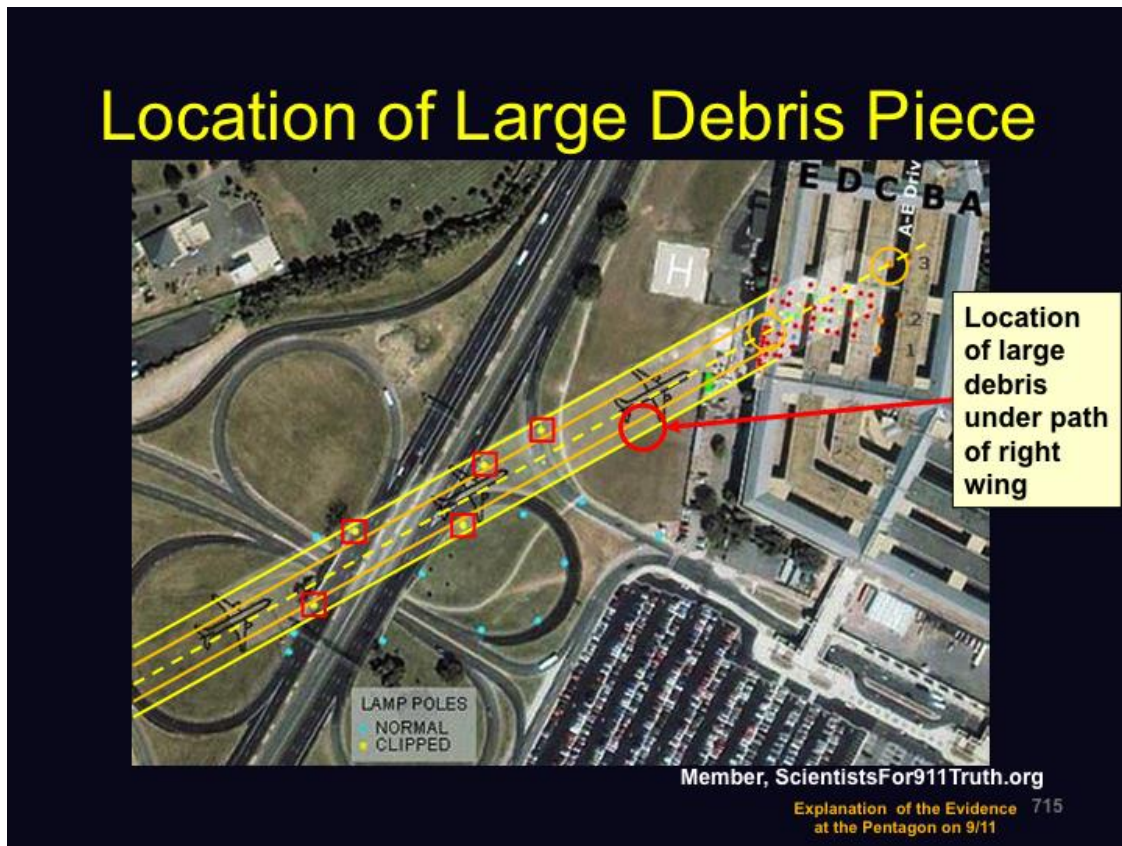
Figure 7 Location of leading wing slat on the lawn between the third light pole and the Pentagon.

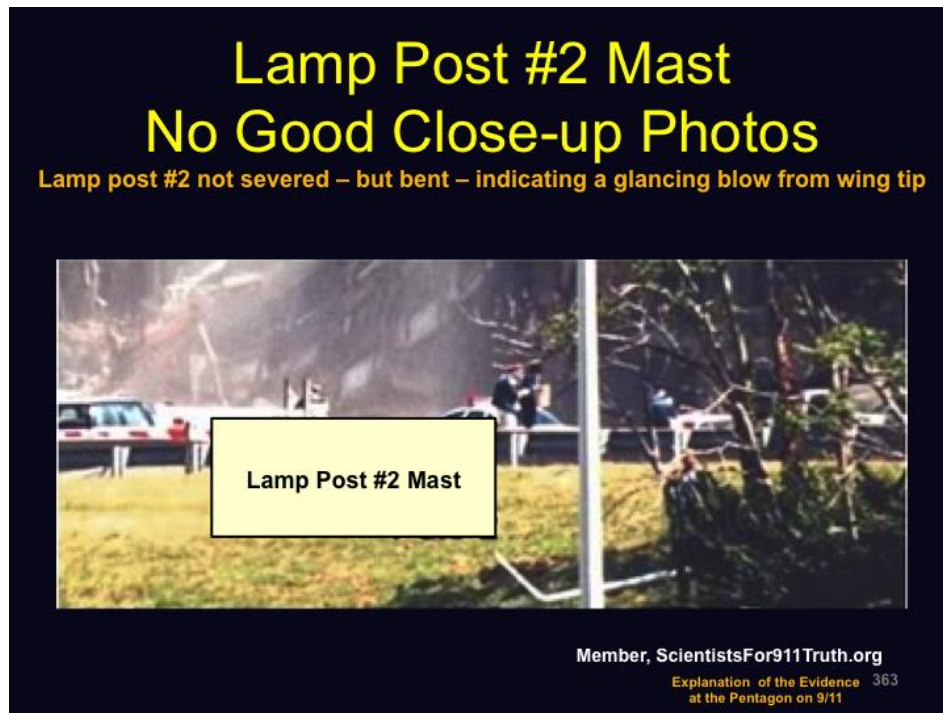
The tall, vertical section of the second light pole was bent but not severed when hit by the left wing. This means the pole was grazed by the wingtip, rather than being subjected to a direct hit. The pole can be seen after impact lying on the west side of Hwy 27 (Figure 8).

Figure 8 Mast of second light pole, bent and lying on the side of Hwy 27, but not severed.

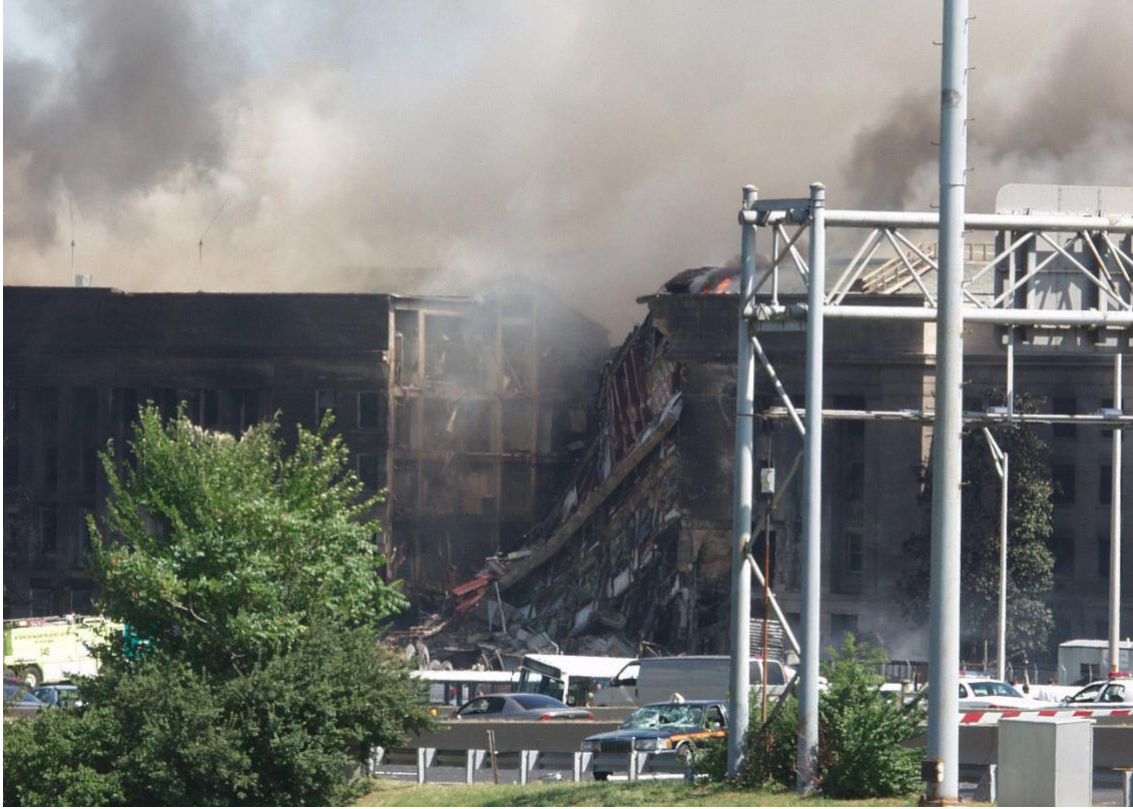
Figure 9 A photograph taken by Staff Sgt Gary Coppage shows a notch cut out of the tree on the left and a scar and missing run on the VDOT traffic camera pole at the top right. Note that this photograph was taken at least a half hour after the impact because the roof of the Pentagon can be seen to have collapsed.

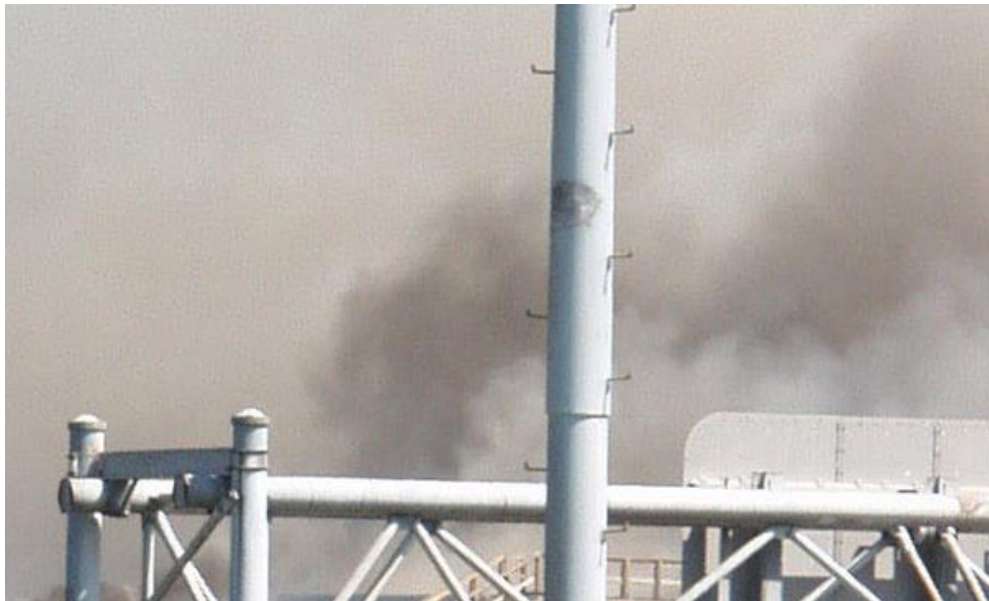
Figure 10 Detailed view of scar and missing rung on freeway traffic camera zoomed and cropped from Staff Sgt Gary Coppage Photo.

Examining that camera pole we find a scar and a missing rung. This damage was noted long ago, and the question whether it was caused by the plane was considered a matter of speculation. But with the new measurements that precisely locate the plane in relation to the light poles, the cause of the scar and missing rung can be inferred with high probability.

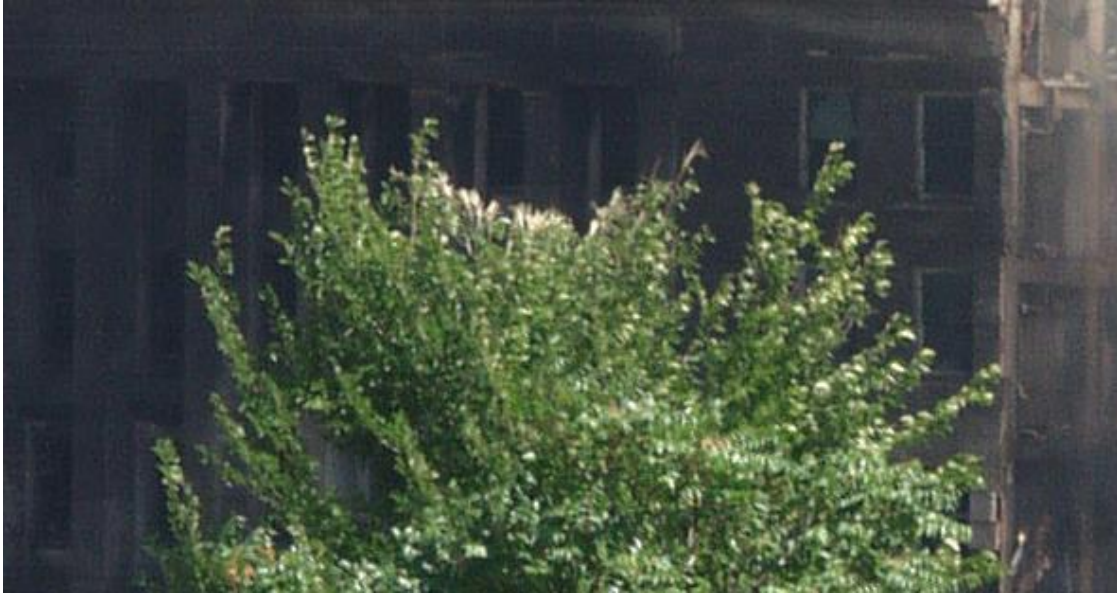
Figure 11 Detailed view showing the notch taken out of the overpass tree. Note the stripped and cut branches.

Near the camera pole and first light pole there is a tree at the top of the overpass with a circular notch with frayed ends scooped out as with a dull blade.

Based on the dimensions of a 757 and precise location of the wingtips of the plane as it grazed the freeway camera pole and the second light pole, the position of the right engine can be identified with certainty as the cause of a semicircular gouge at the top of a tree on the overpass. The roundedness of the edge of the intake to the jet engine is not an issue. The front edge of the engine, moving at over 500 mi/hr, would act like a dull mower blade cutting through brush, leaving clipped and stripped whitish tipped branch ends along the notch outline.

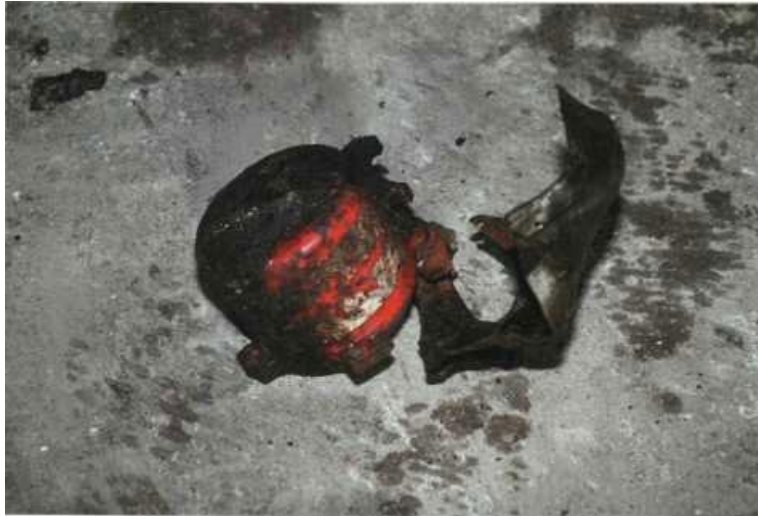
Figure 14 Memory module of Flight Data Recorder (FDR) found in the Pentagon. The data found on this memory module will be discussed in a separate paper yet to come.
