Rebuttal to 'Identification of The Plane Model That Impacted the Pentagon'

Wayne Coste, PE

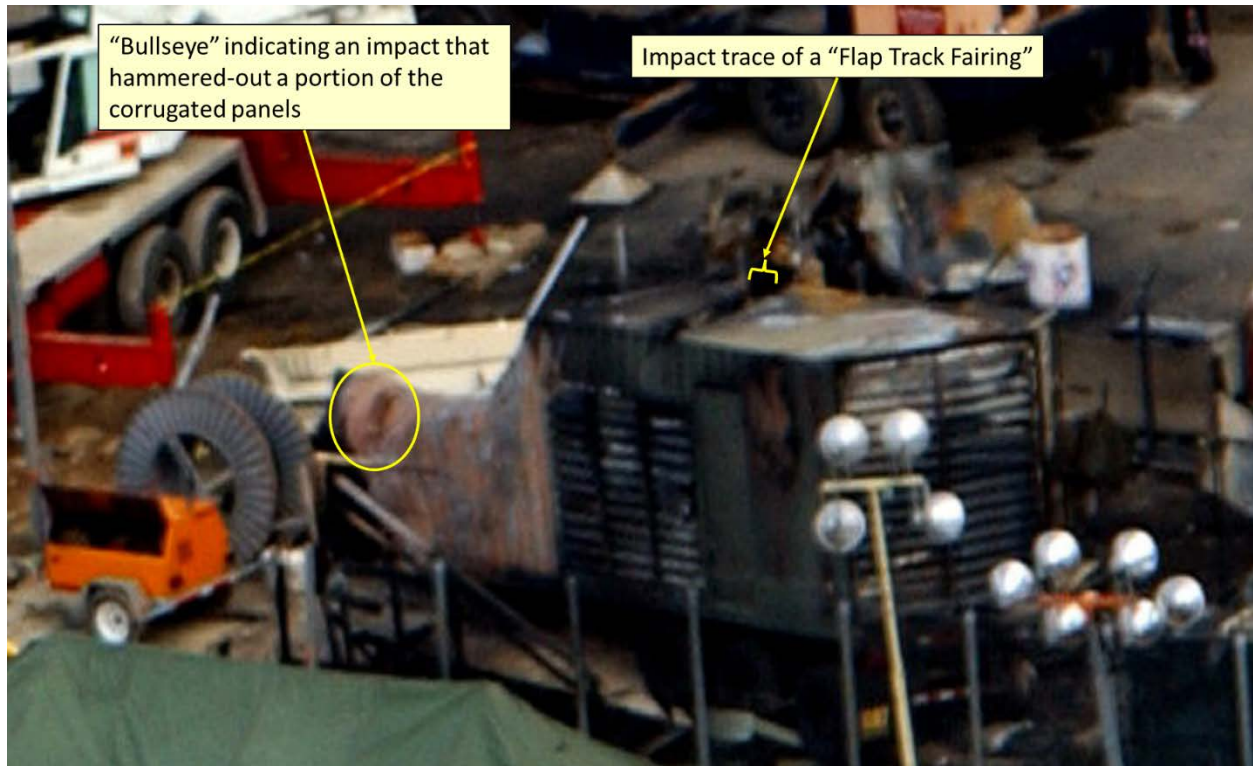
Figure 6 shows the trace of one of these fairing through the top of the generator trailer [4]. The trailer was rotated to the right as the side of the impacting right engine impacted the front-half of the left side of the generator trailer. At the appropriate height, this 52-degree impact would not only rotate the trailer out-of-the-way and toward the right, it would also collapse the front struts of the trailer allowing the trailer to be collapsed downward. This would allow sufficient rotation and descent of the trailer to allow the engine to pass alongside. This impact also created a 'bullseye' on the corrugated side of the folded-over forward portion of the trailer's steel cabin where the corrugated siding was hammered-out smooth. The 'bullseye' appears to be approximately 5 ft from the front of the trailer. This marks the exact location where the engine began impacting the trailer. The trace of the Flap Track Fairing on the top of the trailer can be used as an unambiguous data point for the height and position of a specific identifiable aircraft component. Detailed drawings are available in the appendices.

Figure 6: Impacted generator trailer showing "bullseye" and trace of a Flap Track Fairing.

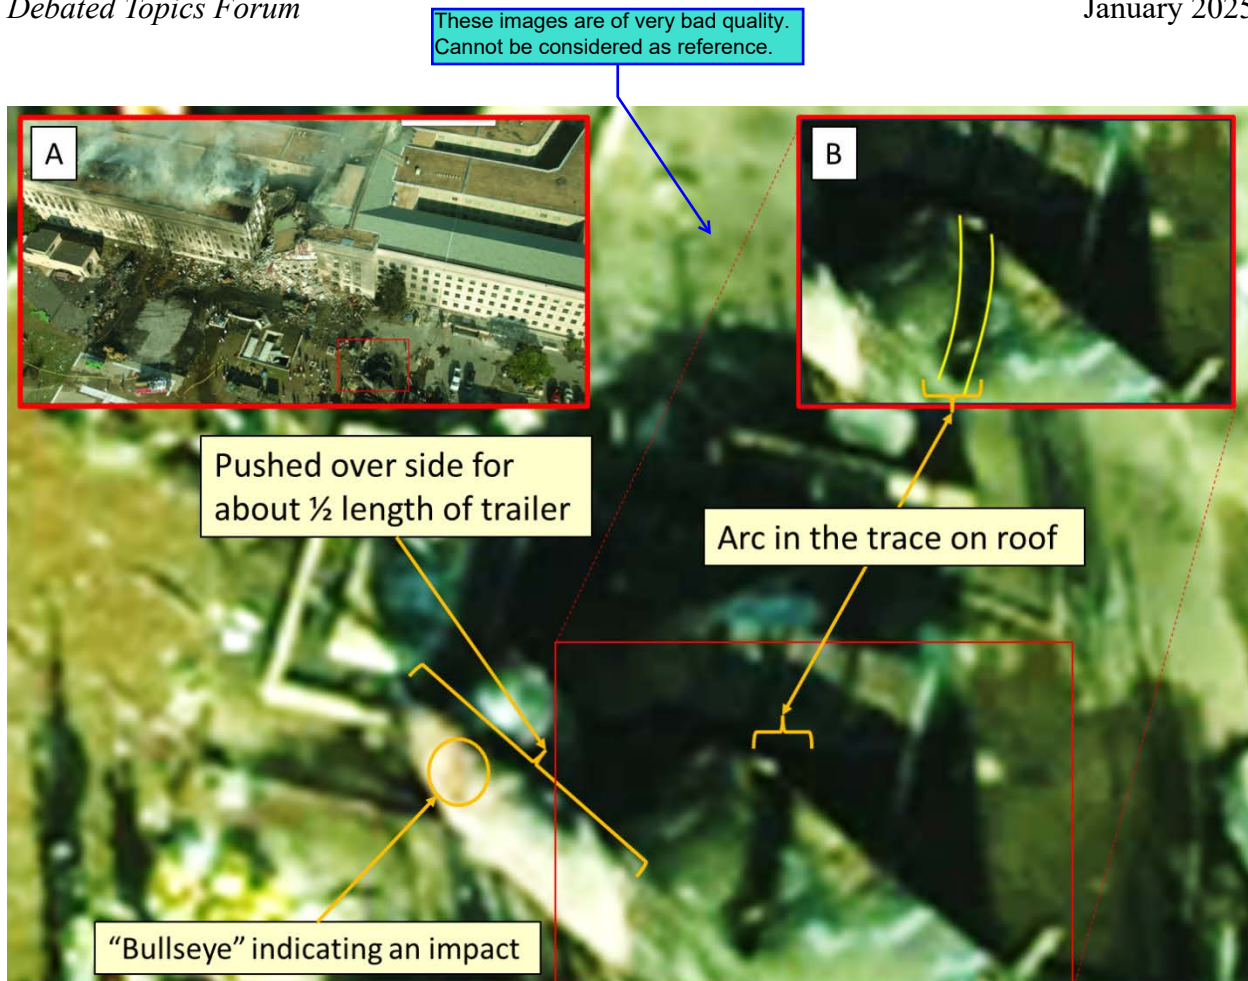
Figure 7 shows an overhead view of the trailer roof in a photo by Scott Boatwright [5]. Compared to the parallel objects on the ground, the final location of the trailer is rotated approximately 30 degrees around the rear wheels. This image shows the trace to be an arc; not a straight line. Such an arc is consistent with the generator trailer being rotated while the Flap-Track Fairing was cutting the trace. At the observed approach speed of 795 feet/sec (542 mph) [6], the contact time of the flap track fairing into the trailers roof would have been less than $2/100^{\text{th}}$ of a second. For this arc to have been captured in the roof, the trailer would have needed a significant rotational velocity. Appendix C provides a series of drawings that illustrate this process.

Figure 7: Zoomed in section of the Scott Boatwright photograph ("A") showing the arc in the trace (highlighted in "B"). (NOTE: The full Boatwright photograph can be seen at <https://sire-media-ngcdk.fichub.com/generic/photogallery-photo/16/40972.custom.jpg>)

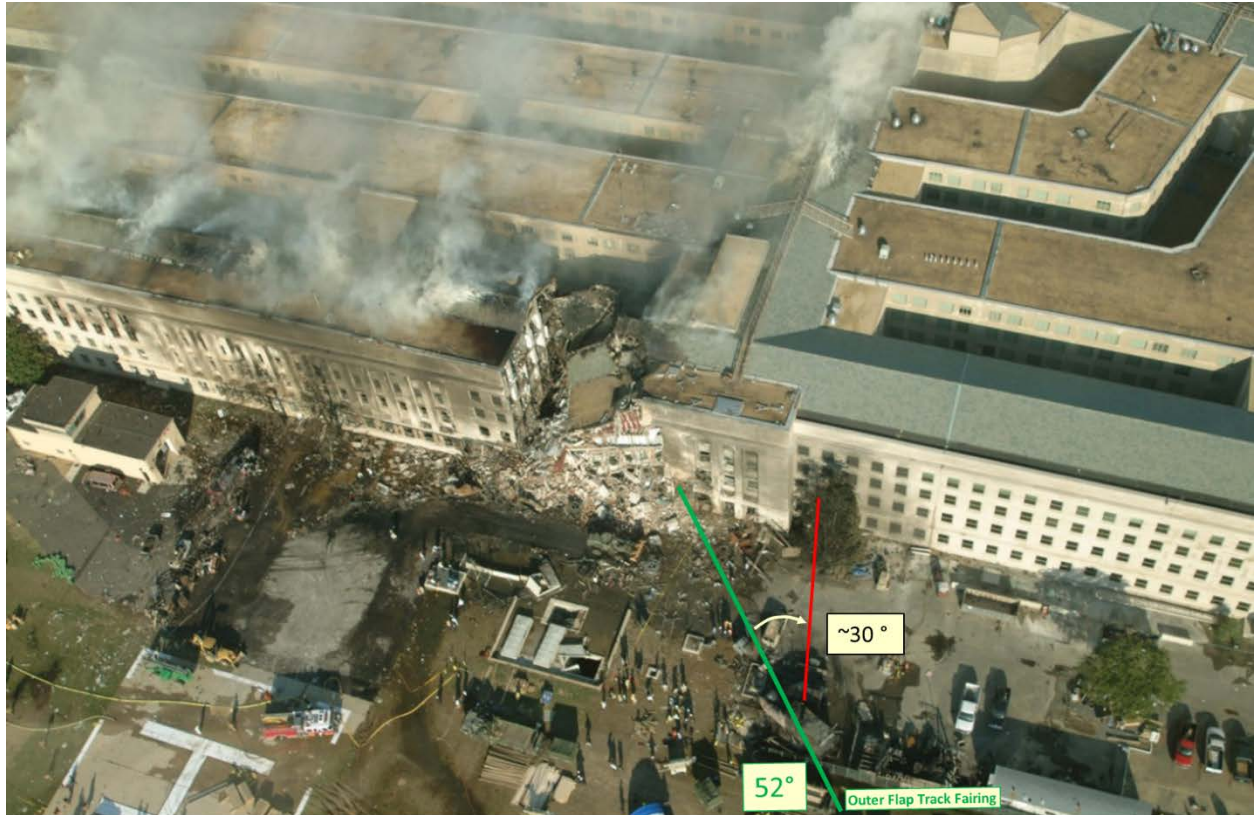
Figure 8 shows the total rotation of the trailer around its likely center of mass over the rear wheels. The total rotation is approximately 30 degrees. The imparted rotational inertia from the impact of the engine into the trailer would have caused the trailer to continue rotating after the trace was cut by the Flap Track Fairing. The axial alignment of the approaching 757 would have placed the outer right Flap Track Fairing on a path toward a point on the façade between columns 18 and 19. Once the rotation ceased, the trace is orientated in the direction of column 26 or 27. This suggests a total period of rotation of about 2 seconds before the trailer came to rest at its post impact orientation with its front support struts collapsed.

Figure 8: Due to impact and imparted energy, the trailer was rotated approximately 30 degrees around its rear wheels.

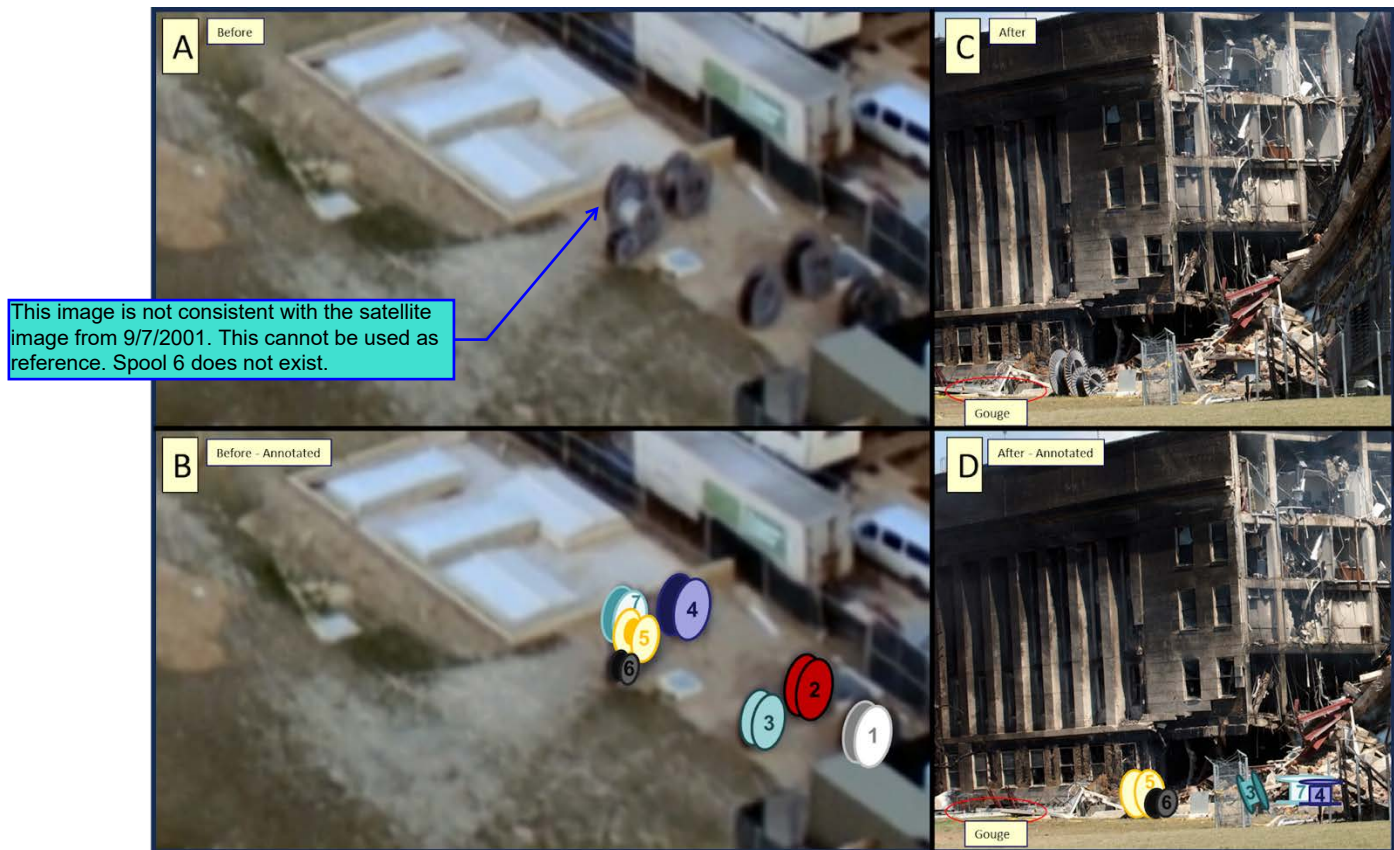
Figure 12 shows before and after images near the gouged retaining wall where the red line segment was drawn. Figure 12A shows seven wire spools from a photo taken prior to September 11. These spools are in locations consistent with the satellite images in Figures 10 and 11. The shadows do not have sufficient resolution to discern the location and size of each spool. Figure 12B provides an identification using colors and numbers. Spools 1, 2 and 3 are near the generator trailer, while spools 6, 5, 4 and 7 are seen close to the retaining wall. The spool labeled 4 is near the retaining wall and closest to the Pentagon facade.

Figures 12C and 12D show the location of the remaining spools after impact. Spools 5 and 6 are in the same location as shown in Figure 12B while spools 7 and 4 are knocked toward the facade. Figure 13 shows Scott Boatright's overhead photo, cropped to show the post impact location of the spools more clearly.

Figure 12: Location of wire spools before and after impact.

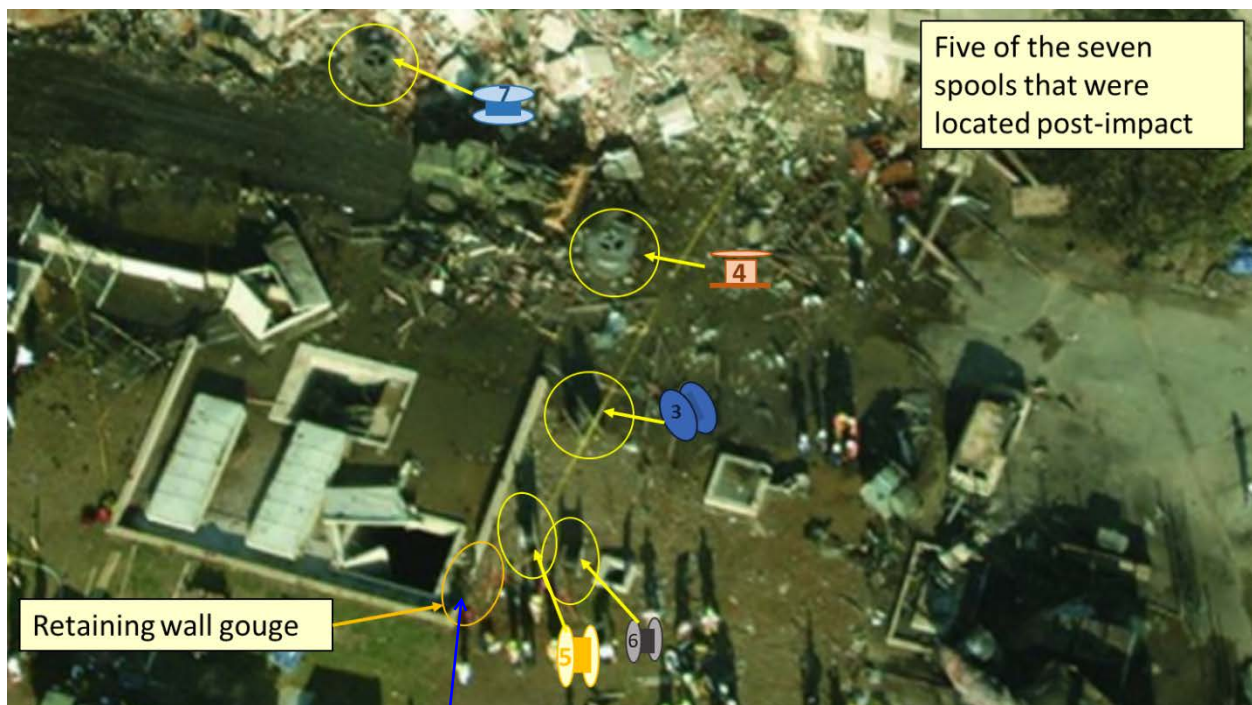
Figure 13: Overhead view of the location of the wire spools after the impact.

These resulting spool locations are consistent with the bottom of the left engine of a 757 impacting the retaining wall while the front/right side of the engine impacted spool 7 which knocked it into spool 4 sending both traveling rightward toward the facade. Meanwhile, spools 5 and 6 remained unaffected because the engine passed to their left without striking them as the wing went above them due to the clearance between the engine and fuselage shown in Figure 1.

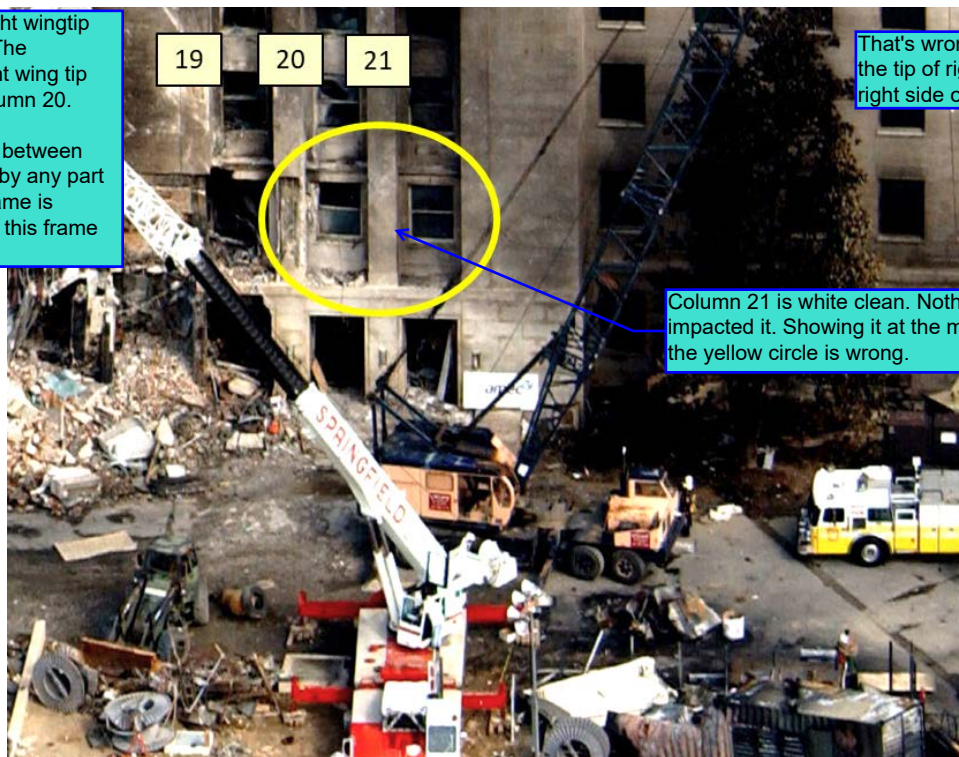
Figure 14: Debris on window sill between Columns 20 and 21.

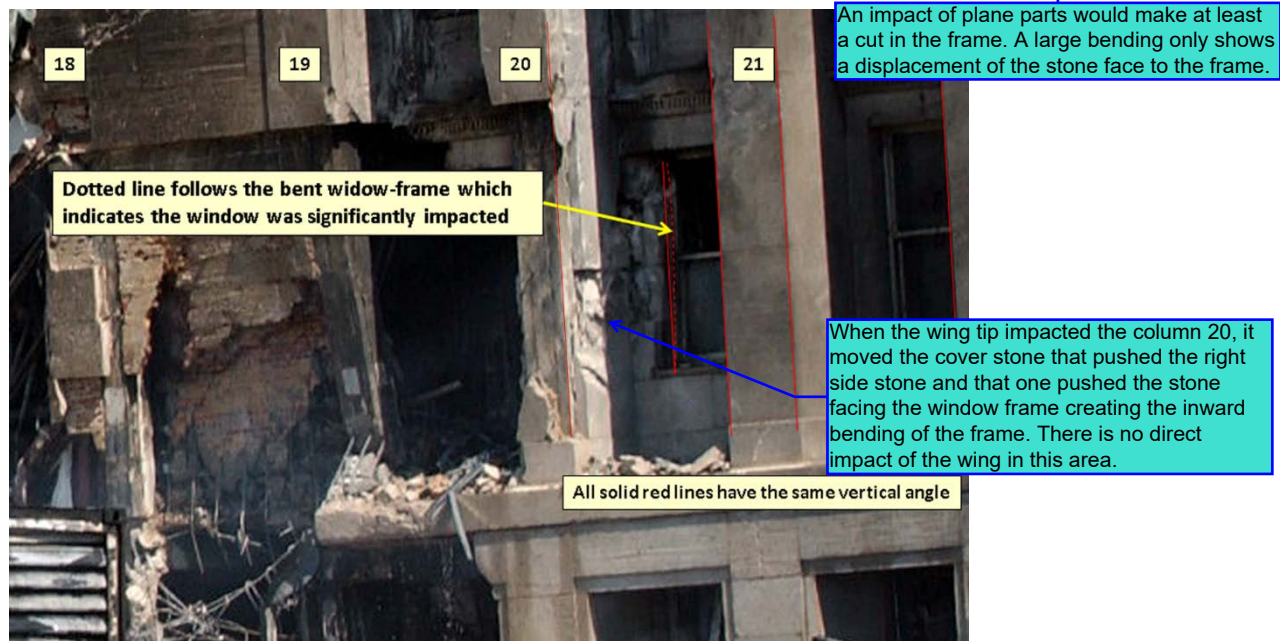
Figure 15 shows that the frame of the window between columns 20 and 21 has its left side bent. Because this window frame is constructed with 8" square steel tubing, a significant impact would have been needed to create this observed deformation. Consequently, Inan's detailed drawing (Figures MI-11 and MI-17) should have the impacting aircraft shifted at least 10 feet to the right and probably more because the right-wing tip barely touches column 20 in his analysis and cannot account for the observed damage. Detailed graphical analysis of these distances is presented in the isometric drawings in Appendix A.

Figure 15: Bent window frame between Columns 20 and 21 with significant debris on the window sill.

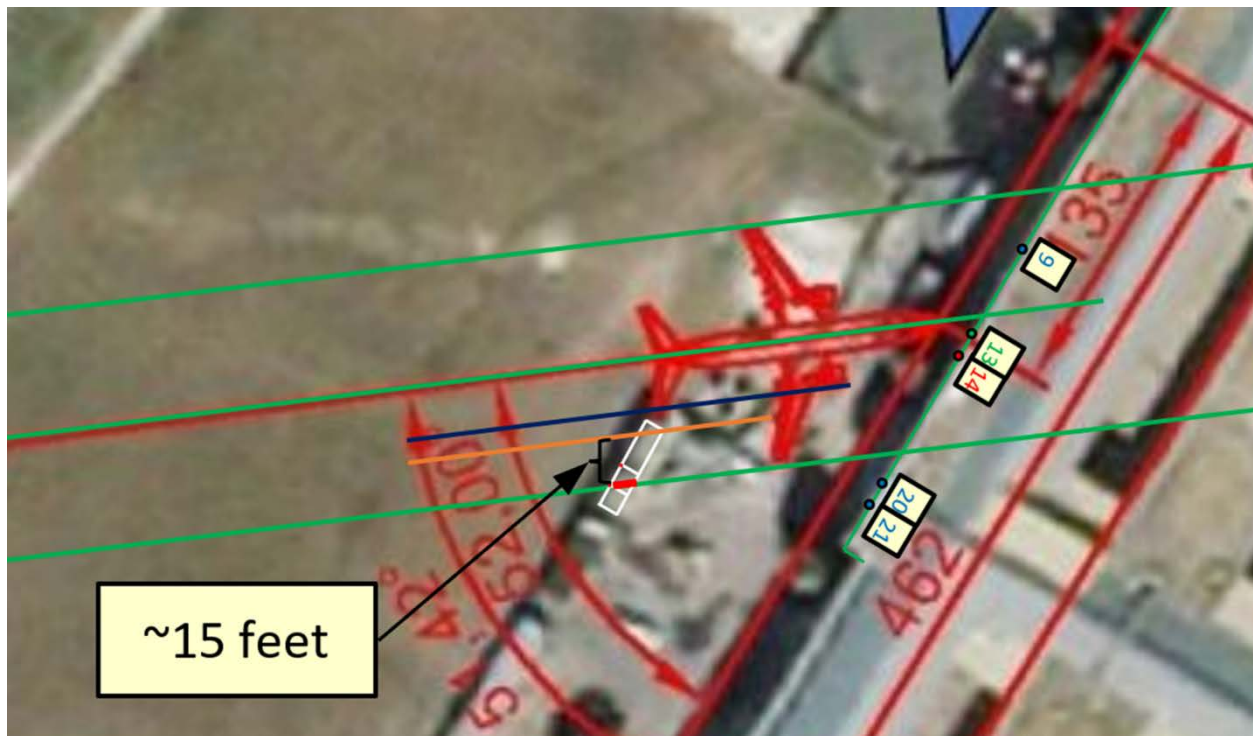
Figure 18 expands the detail of the hypothesized 737-400 approach. As shown, the nose will impact to the left of column 13. The blue line shows the position of the right engine which indicates no possibility of an impact with the generator trailer, even though this blue line is placed on the farthest outside edge of a wide, blurry red outline of the 737. The orange lines show the path of the outer Flap Track Fairing. The outer fairing is about 15 feet from the thick red line that indicates the trace on the roof of the generator trailer.

If the plane was shifted 15 feet to the south to align the Flap Track Fairing and the trace, the approach path through the light poles would likely miss both light poles #2 and #4 and the nose of the plane would impact to the right of column 14 (e.g., between columns 14 and 15).

Finally, the lower green line shows the right-wing tip does not impact column 20. The column locations along the façade are from an actual scale drawing of the wall extracted from the Arlington Fire Department's After-Action Report [7].

Figure 18: Detail of hypothesized 737-400 impact.

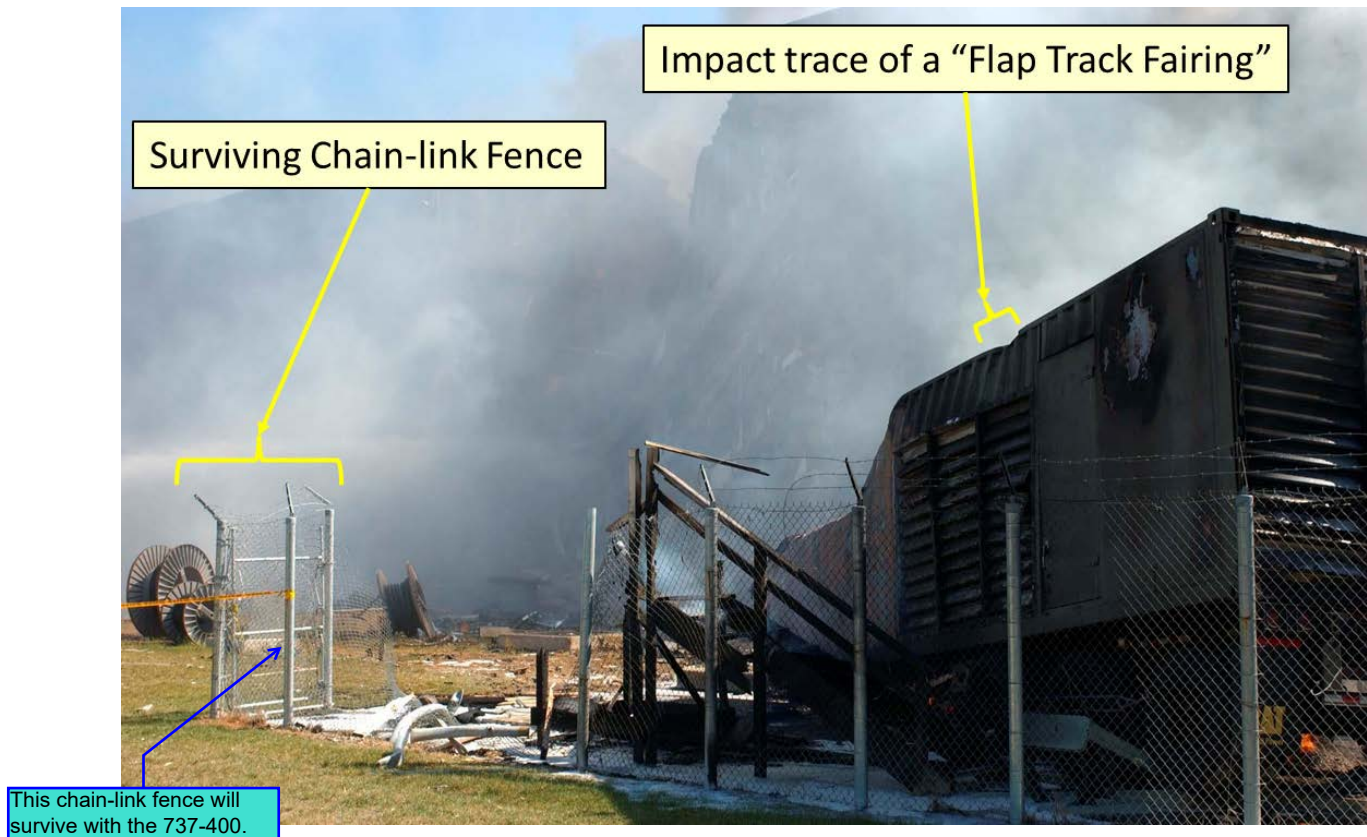
One of the minor structures that can provide insights into the dimensions of the impacting aircraft is a surviving corner segment of the chain-link fence that had surrounded the generator trailer. Figure 20 shows this surviving corner section is largely undamaged and, including the barbed-wire, it is approximately half the height of the trailer. Two sections of the fence have been knocked-down between the surviving corner segment and the continuation of the fence along the side of the trailer. As shown in Figure 18, the path of the right engine of a Boeing 737-400 would have impacted this corner fence segment. However, as shown in Figure 19, the right engine of a Boeing 757-200 would have impacted the fence at the location of the knocked-down sections while leaving the corner segment unaffected. The alignment of this fence segment can be seen in the isometric drawings in Appendix "A."

Figure 20: Generator Trailer showing surviving corner segment of the chain link fence.

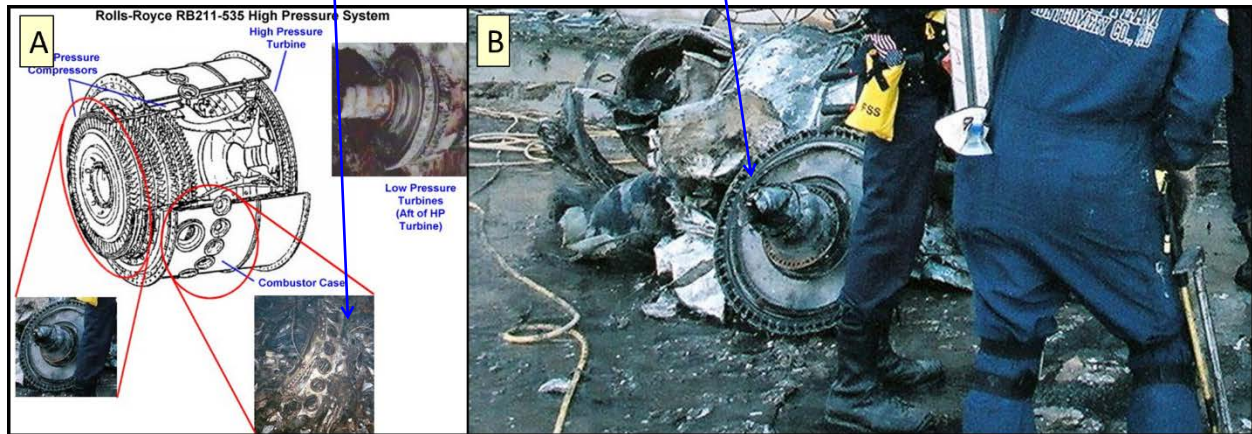
However, in his short list of explicit aircraft parts, he excludes a plethora of other parts that were photographed in and around the Pentagon. For example, many discussions about the aircraft debris show parts of a Rolls Royce RB-211-535 engine which is the type that powered American Airlines flight 77. The Boeing 737-400 uses the CFM International CFM56 engine for which no discussion of debris from this class of engine can be found in the literature about the Pentagon. Figure 21 shows some of the parts of the RB-211-535 engine.

Figure 21: Engine parts consistent with RB-211-535.

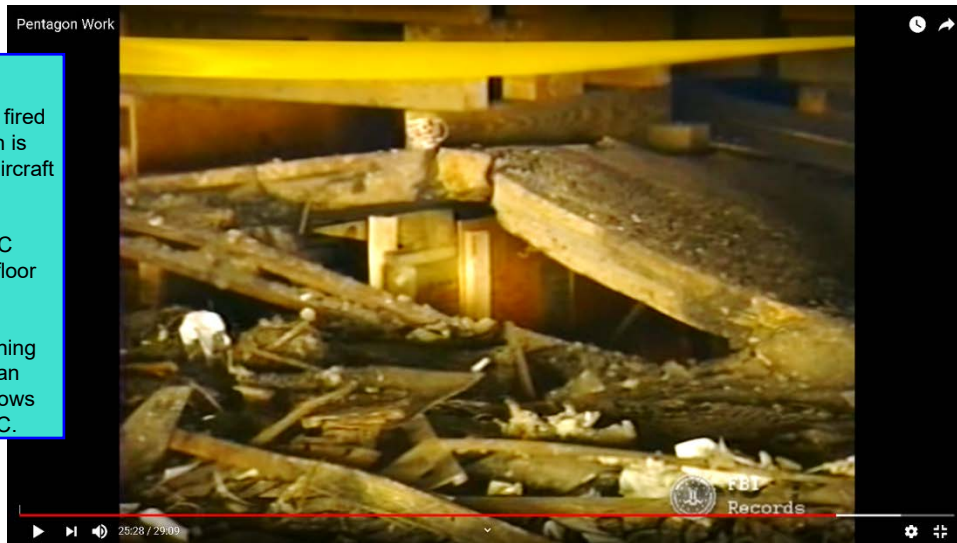
This damage to the second-floor slab was the topic of a recent Debated Topics Forum paper that identifies the source of the damage as the kinetic energy of the rapidly rotating jet engines [10] which were forced to redirect their motion chaotically due to torques from multiple impacts with columns and the dynamic effects of gyroscopic precession. Analysis of the aircraft approach and impact provides an explanation of how the left engine of the 757 entered the Pentagon, with a documented trajectory through the columns. Impacts with columns along this path would create a tumbling and bouncing 5-ton gyroscope whose trajectory would take it directly under the uplifted slab. The tenting of the slab, shown in Figure 26, reflects a mechanical snapping that would be characteristic of mechanical impact damage, not a detonation from below. Explosives of a significant scale would be very unlikely because Major David King was near the location of this alleged explosion and yet was not injured by what would have been a massive explosion.

Figure 26: Uplifted second floor slab illustrating mechanical damage, not explosive detonations.
