# The Instantaneous Free Fall of World Trade Center Building 7 and NIST's Attempt to Hide It

## Abstract

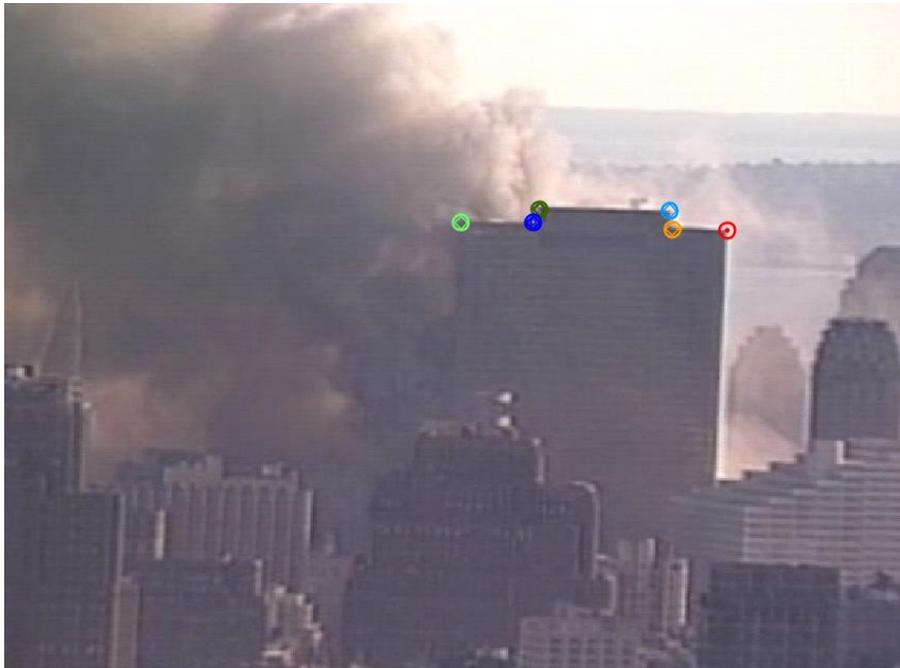
Figure 4: Neon green: Northeast corner. Blue: East center roofline (NIST's point). Orange: West center roofline (new point). Red: Northwest corner. Dark green: North screen wall. Light blue: West penthouse.

The four points we tracked across the north face roofline in the Camera 2 video as well as the point on the north screen wall and the point on the west penthouse are shown below in Figure 4. Note that the east penthouse has already collapsed into the building at this point.

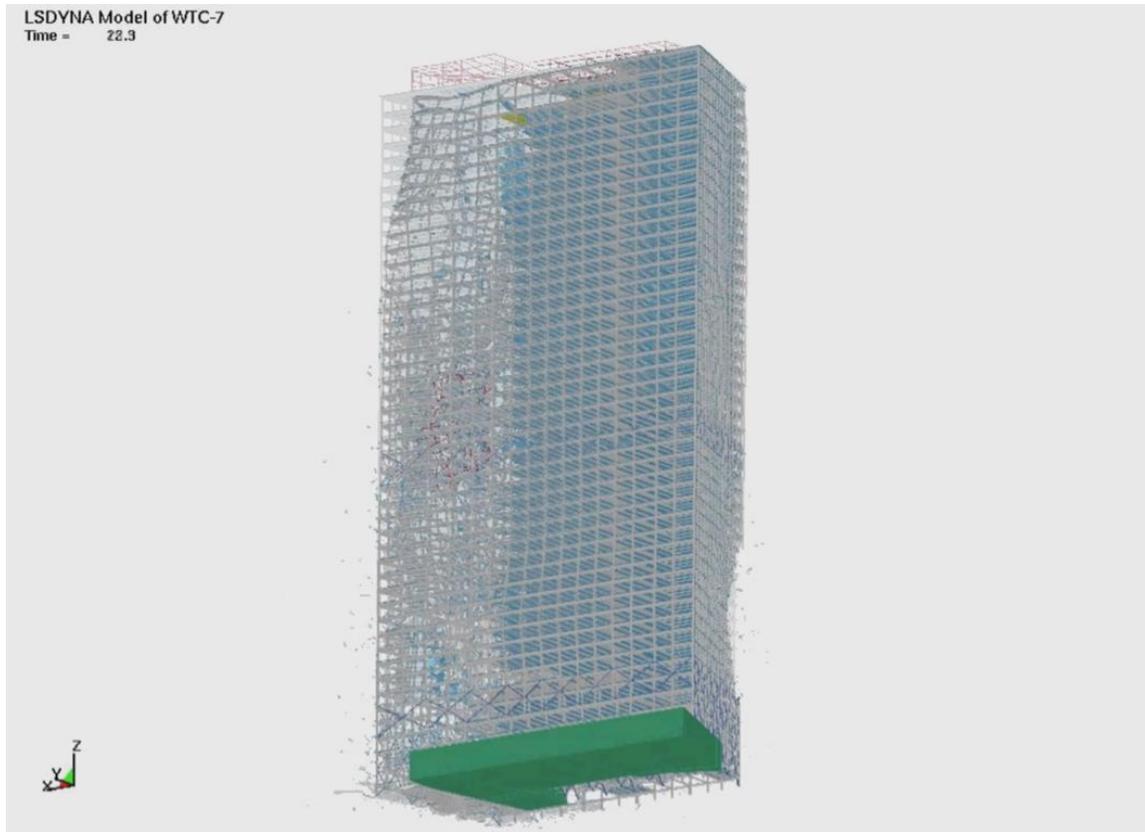
Figure 7: NIST’s global collapse animation at 6.3 seconds after the start of the east penthouse collapse laid over the animation at 0.1 seconds before the start of the east penthouse collapse.

which — consistent with NIST’s own observation in Figure 5-201 of NCSTAR 1-9 — involved *zero* deformation or displacement of the northeast corner until its instantaneous transition to free fall at 8.0 seconds.

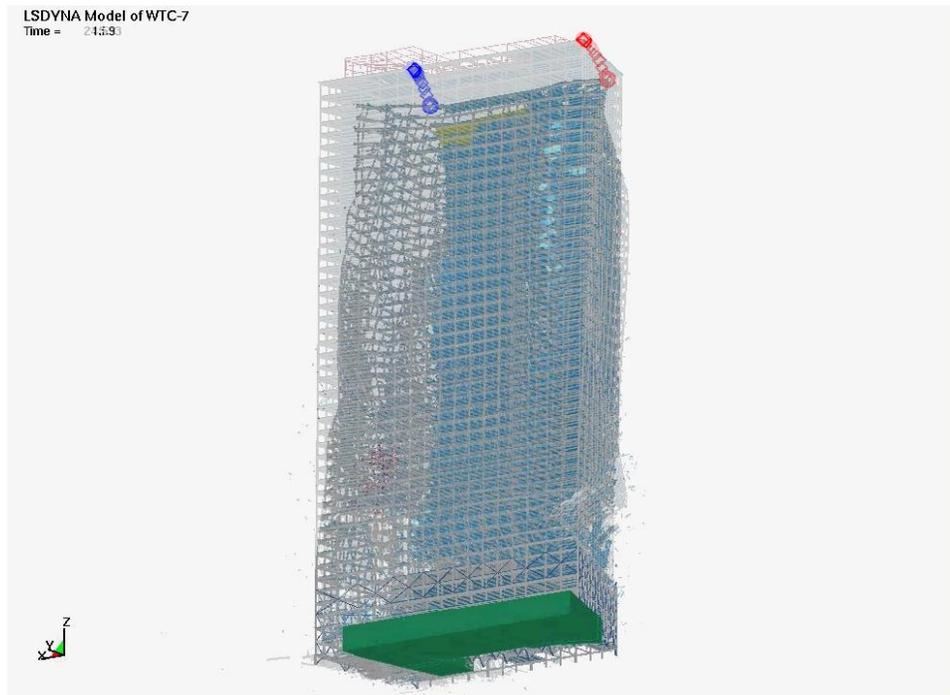
Figure 8: The final frame of NIST's global collapse animation, at 8.6 seconds after the start of the east penthouse collapse, laid over the animation at 0.1 seconds before the start of the east penthouse collapse. Blue dots track the motion at the east center roofline point. Red dots track the motion of the northwest corner.

northwest corner and one approximating NIST's east center roofline point. Below that, in Figure 9, we provide the same analysis of the Camera 3 video over the first 2.3 seconds of descent. Although it is difficult to distinguish downward motion from lateral motion in the animation, it is obvious that the building in the animation is tipping while the building in the video is descending vertically. By 2.3 seconds into the global collapse, the top of the building has tipped southward by as much as half of its north-south width.

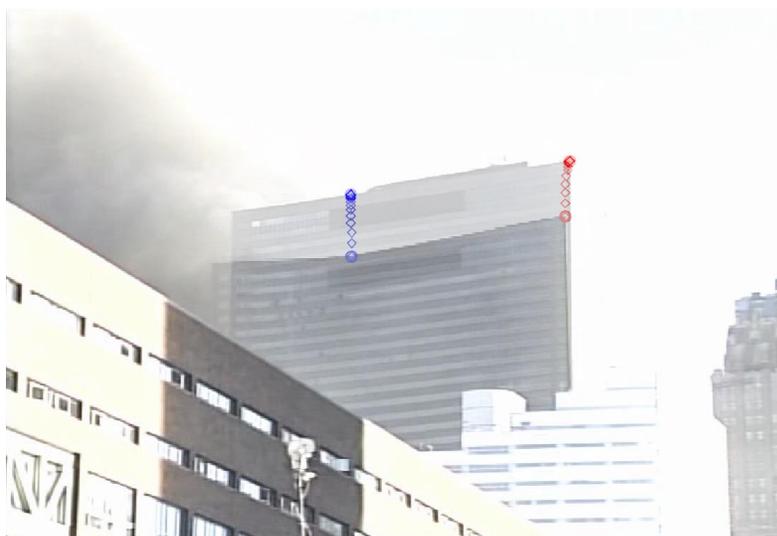
Figure 9: A frame from Camera 3 at 2.3 seconds into the downward motion laid over a frame just before the start of downward motion.
