The Descent and Tilting of the North Tower Antenna

David Chandler, Retired Physics Teacher
Coordinator, Scientists for 9/11 Truth
Board member of the International Center for 9/11 Justice

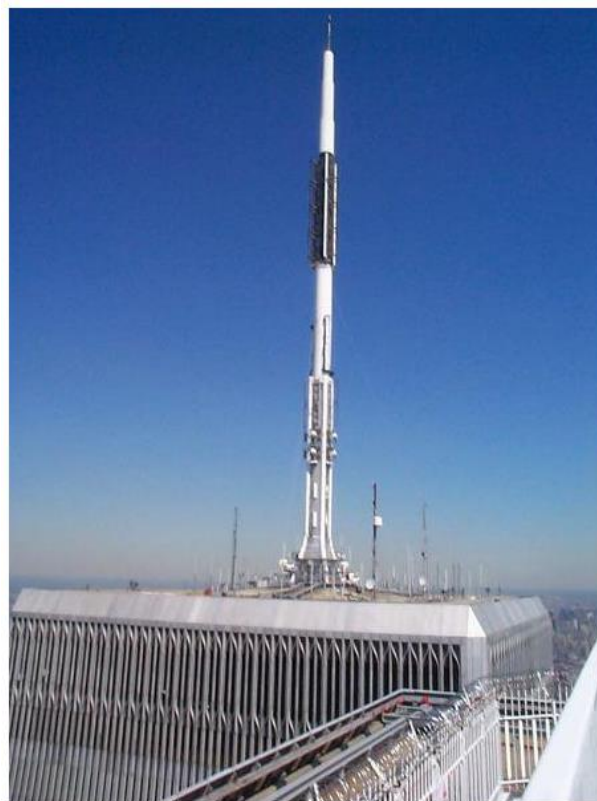
Figure 1 Transmission antenna on top of the North Tower of the World Trade Center. See Appendix A for details.

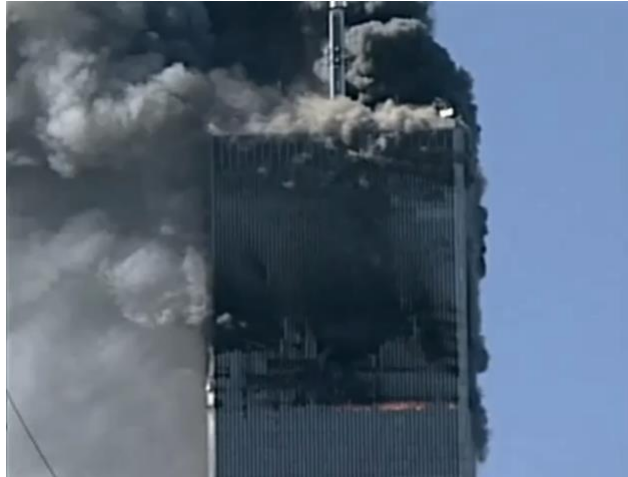
Figure 3 Image from the Sauret video of the North Tower just before it begins to descend, showing the north face of the building.

A commonly used video for studying the initial descent of the North Tower is one captured by Etienne Sauret showing the top section of the tower and the lower part of the television broadcasting antenna on its roof.⁷ The camera is almost squarely facing the nominal north side of the building. The dropping antenna and perimeter roofline (along with sections of perimeter columns in the upper block of the building) are the first signs of downward motion at the onset of the fall of the building. If the antenna and roof move vertically downward through the structure of the building from the very start of the motion, it would be evidence that all of the core columns under them were simultaneously compromised by some mechanism other than crushing, e.g., explosive charges.

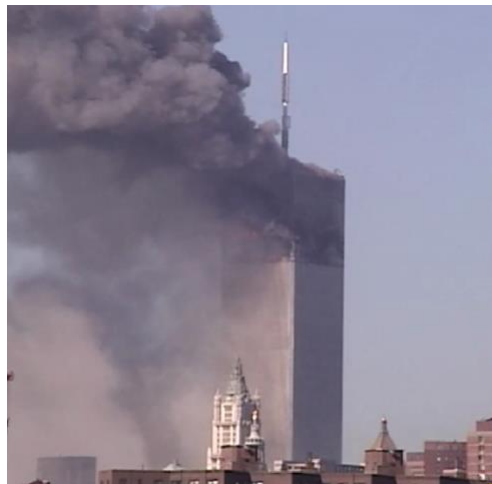
Figure 2 Image from the “Main & Ballou 17” video of the North Tower before it begins to descend, showing the North Tower from a NE perspective.

One difficulty in measuring the southward tilt of the antenna is that most video footage of the collapse of the North Tower is from cameras looking at the north face of the building. However, a few videos from other angles exist. A video labeled “Main & Ballou 17”⁸, which was released by NIST under FOIA as part of the Cumulus database, has a camera angle greater than 45° toward the east face. (This is the video from which Mackey’s single still frame was extracted.)

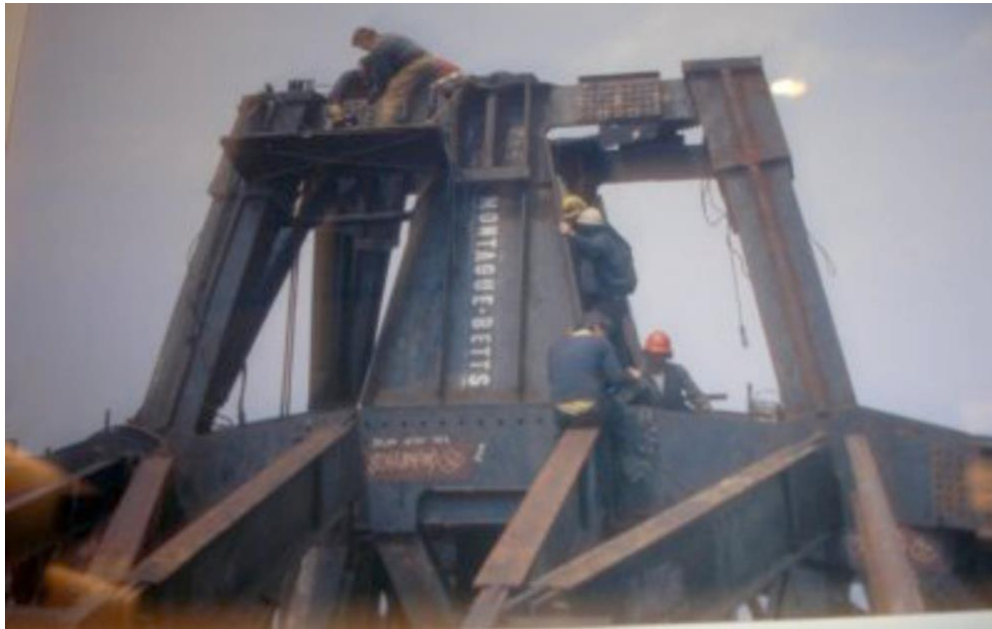
Figure 4 Base of the antenna attached to the hat truss system.

Some background on the support system for the antenna is in order. The antenna is mounted to a heavy base structure, Figure 4, which is in turn mounted to the hat truss, Figures 5 and 6,, which ties together the tops of the core columns. Several outriggers in each direction, Figure 5, form a bridge to the system of perimeter columns.

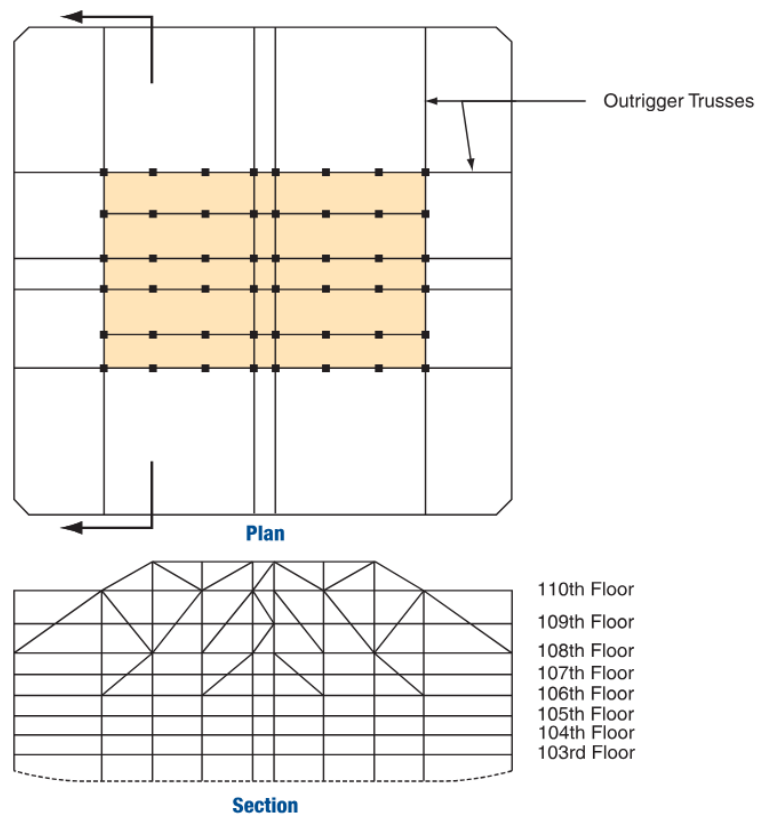
Figure 2-10 Outrigger truss system at tower roof.

Figure 6 Diagram from FEMA Building Performance Study illustrating the outrigger truss system, commonly referred to as a "hat truss."

The hat truss is described in FEMA's *World Trade Center Building Performance Study*: "Between the 106th and 110th floors, a series of diagonal braces were placed into the building frame. These diagonal braces together with the building columns and floor framing formed a deep outrigger truss system that extended between the exterior walls and across the building core framing. A total of 10 outrigger truss lines were present in each building (Figure 2-10), 6 extending across the long direction of the core and 4 extending across the short direction of the core. This outrigger truss system provided stiffening of the frame for wind resistance, mobilized some of the dead weight supported by the core to provide stability against wind-induced overturning, and also provided direct support for the transmission tower on WTC 1. Although WTC 2 did not have a transmission tower, the outrigger trusses in that building were also designed to support such a tower."¹¹

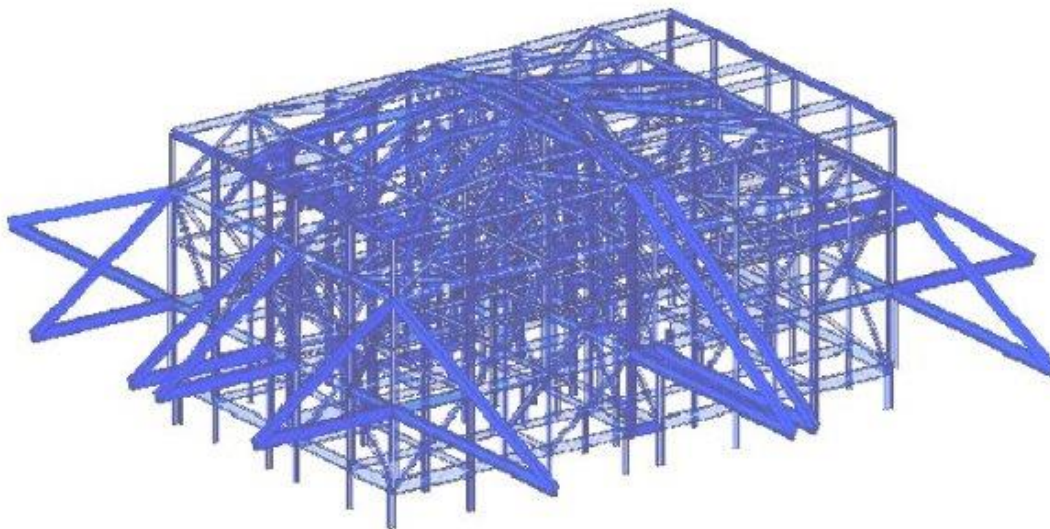
Figure 5 The hat truss shown integrated with the core columns.

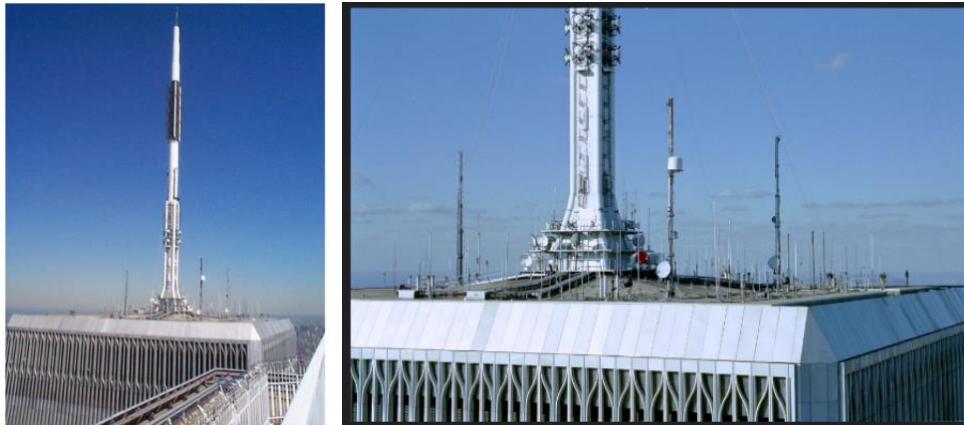
Figure 7 The antenna on the North Tower highlighting its connection to the roof structure.

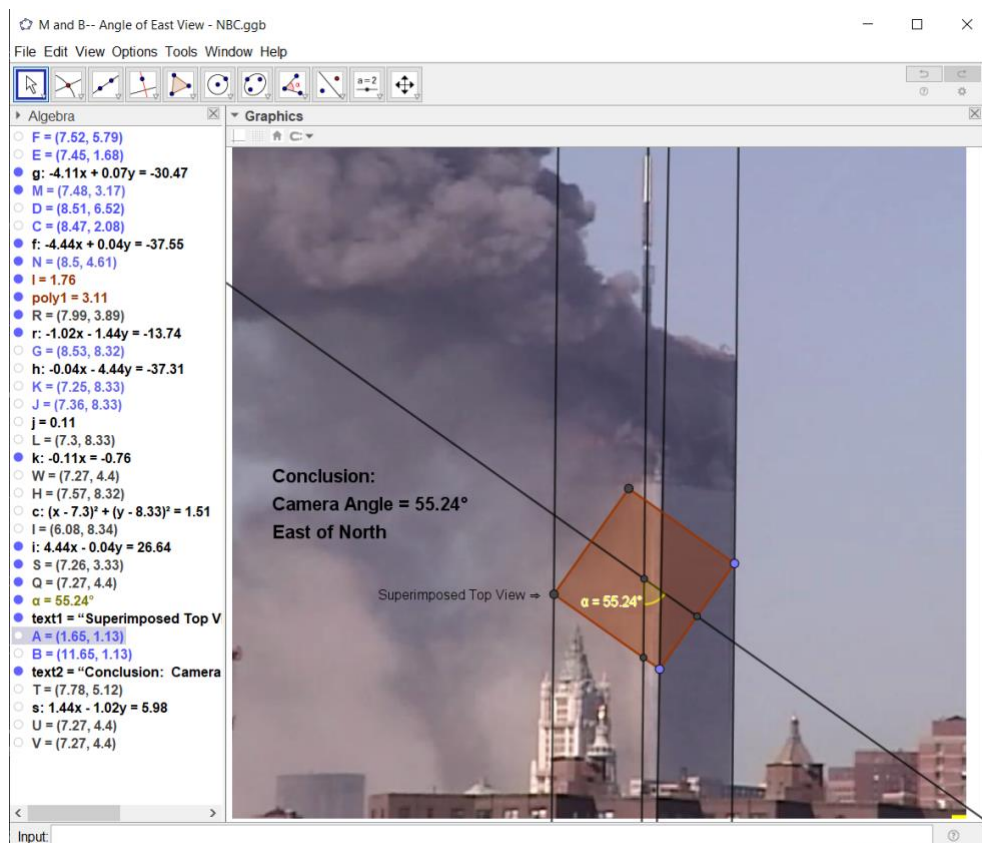
To perform the graphical calculation, a square is constructed using an automated polygon tool in GeoGebra, determined by two adjacent vertices (the blue dots on the square in Figure 1) which we place on the NE and NW edges of the building. By sliding those two defining corners along the vertical lines marking the edges of the building, the square is automatically resized and reoriented. The square is adjusted until a third corner lands precisely on the SE edge of the building. This is not a classical “compass and straightedge construction,” but high precision is obtainable with this tool when it is zoomed in. Once positioned, the square represents the top view of the building “folded” down onto the front view. The desired angle can then be directly measured. It turns out to be 55.24° .

Figure 8 Construction showing the roof of the building folded forward and superimposed on the camera view of the building.

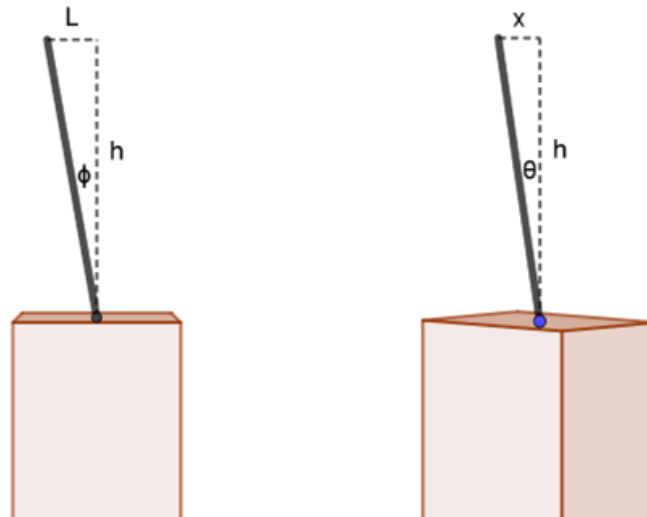
Figure 9 View from east and view from camera angle.

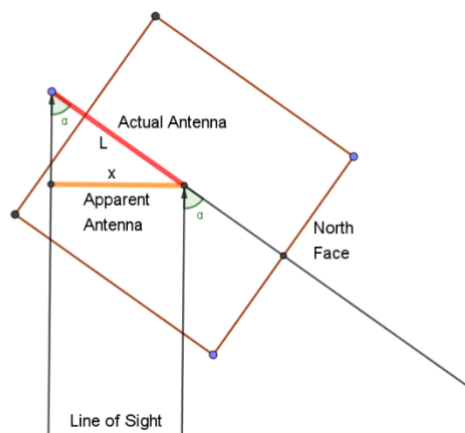
Figure 10 Derivation of transformation from apparent tilt to actual tilt of the antenna.

Figure 10 shows a bird's-eye view from above the top of the building. The diagonal line on the drawing (top left to bottom right) indicates a nominal north-south line through the centers of the north and south faces of the building. The parallel arrows pointing upward from the bottom of the drawing, indicate the line of sight from the distant camera. The southward motion of the

antenna in its plane of rotation (marked “Actual Antenna,” L) is foreshortened in its projection onto the film plane (marked “Apparent Antenna,” x). The angle α is the angle in the horizontal plane from the camera to nominal north. For the “Main & Ballou 17” video, we found this angle to be 55.24° in Appendix B.

To help with this 3-dimensional visualization, place Figure 5 horizontally on a table and place the eraser end of a vertical pencil on the center of the square in Figure 5 pointing upward. This represents the antenna. Now rotate (tilt) the pencil a little to the “south” (which would be to the upper left in the drawing) until the tip of the pencil is above the end of the red line. The red line segment on the drawing represents the horizontal component of the tilted antenna and the distance from the table up to the tip of the pencil represents the vertical component, which we call h . Note that the horizontal component L , the vertical component h , and the tilted antenna itself form a right triangle (as shown on the left in Figure 4). The small acute angle in this triangle we will call the tilt angle, ϕ .

Now picture this arrangement from the side, as indicated by the “line of sight” arrows in the diagram. This is the point of view of the distant video camera. The vertical triangle we just described is projected onto a plane perpendicular to our line of sight. The height h , remains the same. The other two sides of the triangle are foreshortened. Instead of L , the base of this triangle is the orange length labeled x . (The hypotenuse is also foreshortened, but that length doesn’t enter into the calculation, so we can ignore it.) The acute angle at the base of this right triangle we will call the apparent tilt angle, labeled θ .

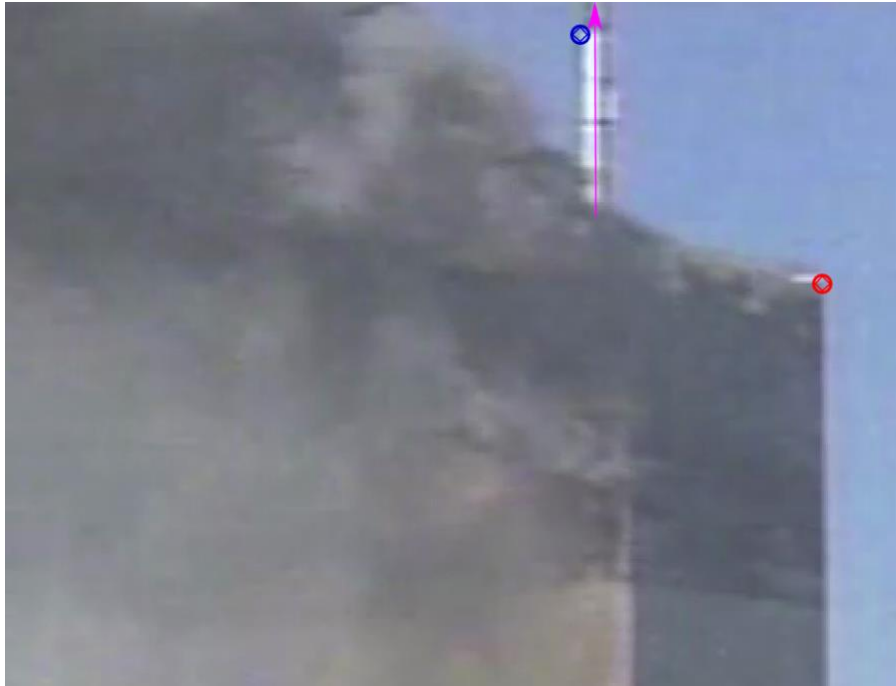
Figure 11 The blue and red markers are used for tracking the relative motion of the antenna and roofline. The magenta arrow is a vector placed along the lower section of the antenna to measure the apparent tilt angle of the antenna.

Using the Tracker program, we measure the height of the north face perimeter wall (measured at the NW corner), the height of the antenna, the apparent tilt of the antenna as a function of time.

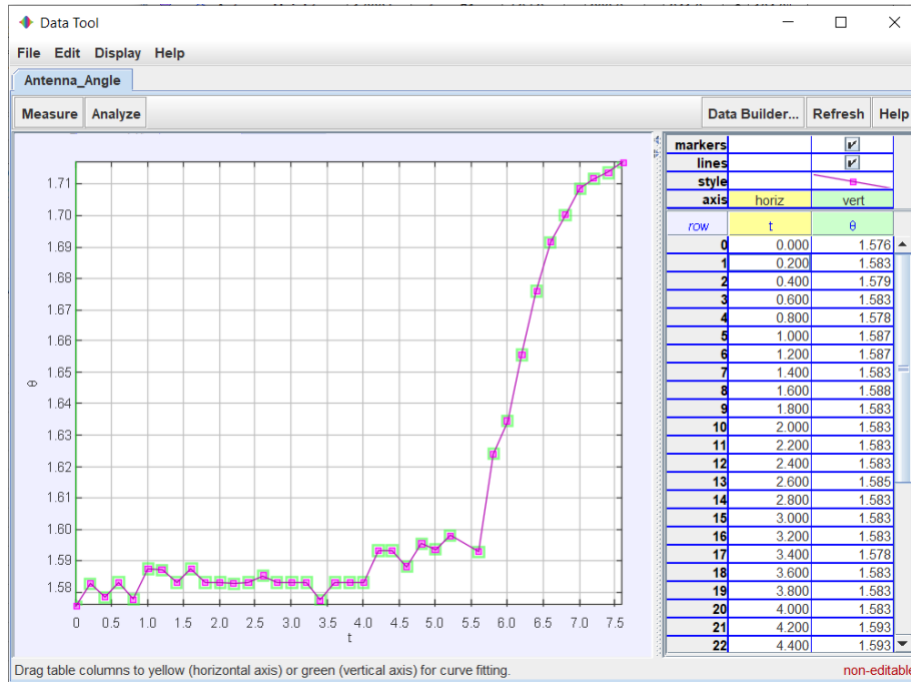
Figure 12 Apparent antenna tilt vs time

3. From Appendix D we can see that the tilt of the antenna remains less than 1° until after the initiation of downward motion of the antenna. Since the building is stationary at this time, we can assume that the small variations we are seeing are due to measurement uncertainties.

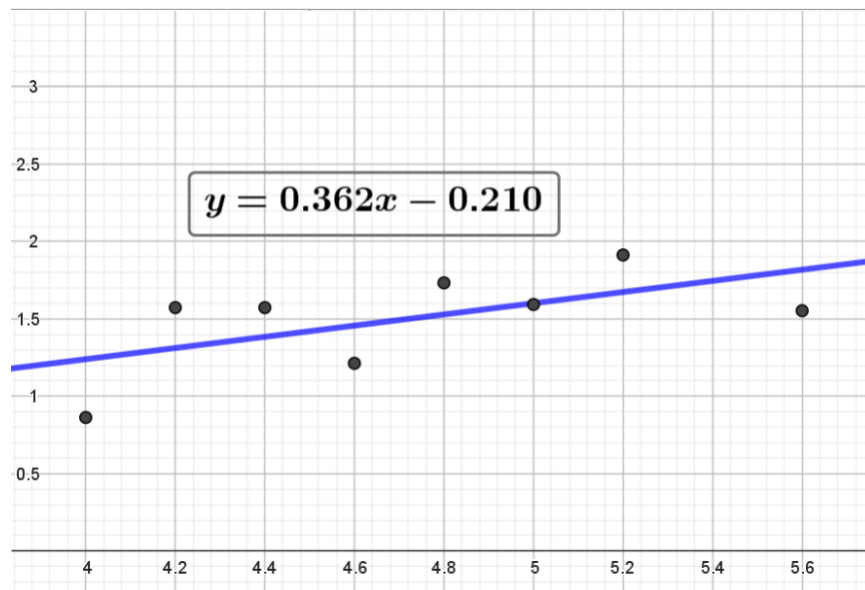
Figure 13 From $t = 4.0$ to $t = 5.6$ the antenna rotated 0.58 degrees.

4. From Appendix E we see that the antenna rotated only about 0.58° during the first 1.6 sec of its fall. This corresponds to a drop of no more than 32 cm. However, the measured drop during this interval was 5.71 m. Therefore, the vertical motion of the antenna cannot be accounted for by the rotation of the roof-antenna complex.

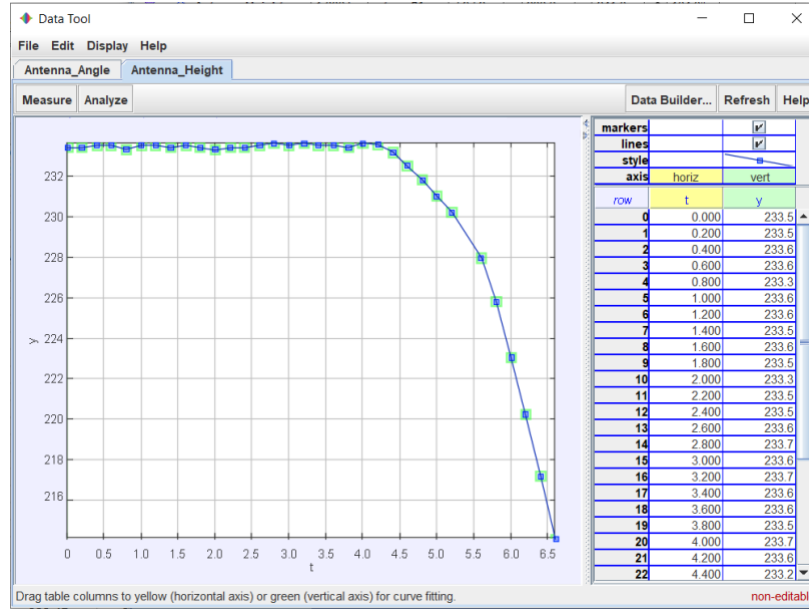
Figure 14 Antenna height vs time

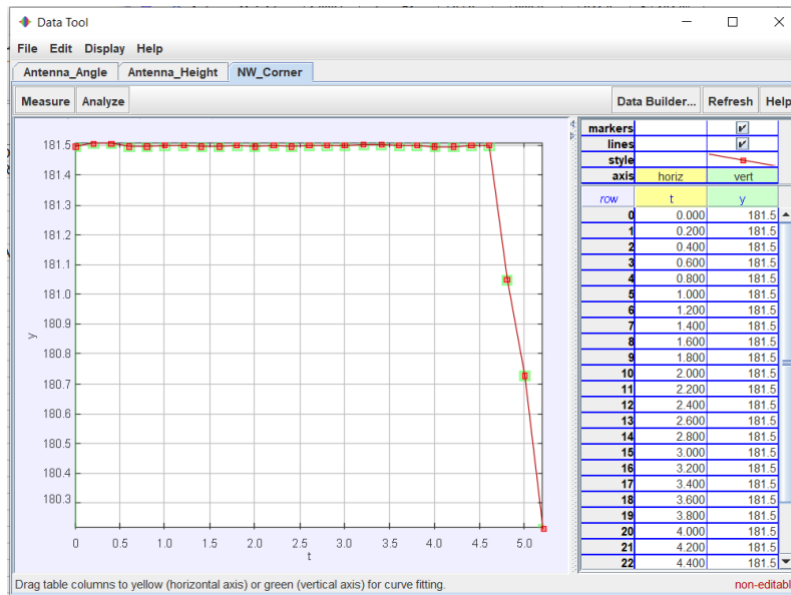
Roof height vs time, measured at the NW corner of the building.

Figure 15 Roof height vs. time

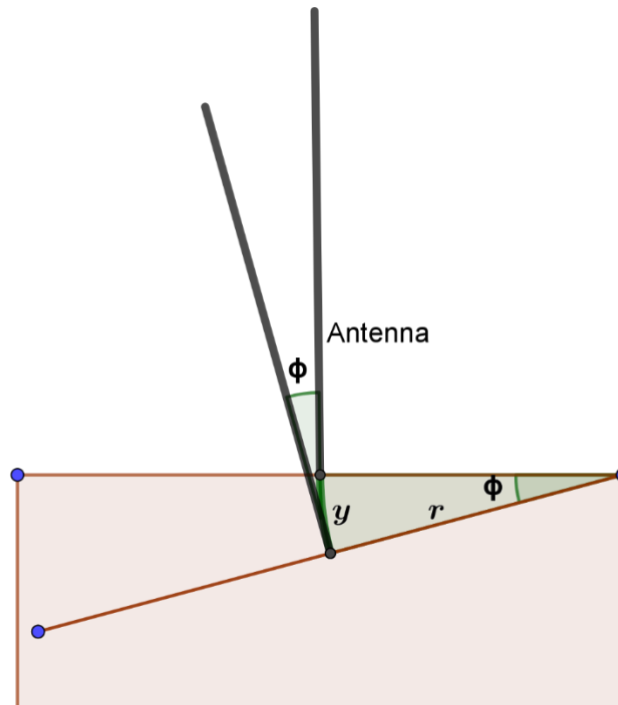
Figure 16 The ratio of the arc length of the motion (y) to the radius of the rotation (r) is the radian measure of the angle of rotation. On the hypothesis that the tilting of the antenna is part of a coherent rotation of the roof, the center of rotation would have to be a supported pivot point, so r could be a maximum of 32 m.

The antenna displays a combination of rotation and downward translation, as shown in Table 1 and Figures 6-9. In the first 1.6 sec of descent, from 4.0 to 5.6 sec, the antenna descends 5.71 m but rotates only 0.58° , or 0.01 radians. (If the roof had descended 5.71 m due to pure rotation of the roof pivoting at the edge of the roofline, the rotation of the antenna would have been 10.28° .) Let us hypothesize that the observed downward translation of the antenna is actually the vertical component of the rotation of the roof-antenna complex. To a very close approximation that would be the arc length of the rotation of the roof.

We have found that for the initial 1.6 sec of motion, the radian measure of the rotation angle would be 0.01. Multiplying this by the maximum possible radius (32 m) gives an arc length of 32 cm. However, the measured vertical motion of the antenna over this same interval is 5.71 m. Therefore, we can conclude that a rotation of the roof-antenna complex cannot account for the drop of the antenna. The vertical drop of the antenna is therefore real, not an illusion.
