The Descent and Tilting of the North Tower Antenna

David Chandler, Retired Physics Teacher
Coordinator, Scientists for 9/11 Truth
Board member of the International Center for 9/11 Justice

Abstract

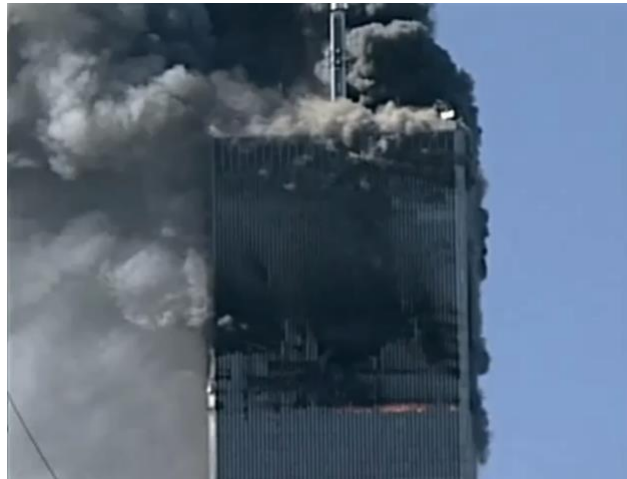
Figure 2 Image from the Sauret video of the North Tower just before it begins to descend, showing the north face of the building.

A commonly used video for studying the initial descent of the North Tower is one captured by Etienne Sauret showing the top section of the tower and the lower part of the television broadcasting antenna on its roof.⁷ The camera is almost squarely facing the nominal north side of the building. The dropping antenna and perimeter roofline (along with sections of perimeter columns in the upper block of the building) are the first signs of downward motion at the onset of the fall of the building. If the antenna and roof move vertically downward through the structure of the building from the very start of the motion, it would be evidence that all of the core columns under them were simultaneously compromised by some mechanism other than crushing, e.g., explosive charges.

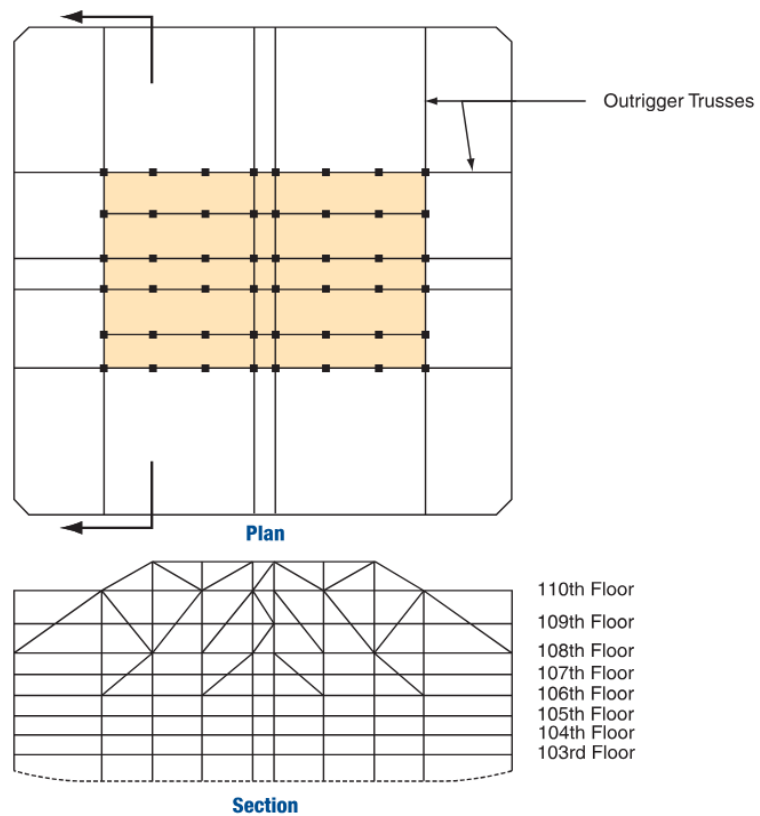
Figure 2-10 Outrigger truss system at tower roof.

Figure 5 Diagram from FEMA Building Performance Study illustrating the outrigger truss system, commonly referred to as a "hat truss."

Some background on the support system for the antenna is in order. The antenna is mounted to a heavy base structure, Figure 4, which is in turn mounted to the hat truss, Figures 5 and 6,, which ties together the tops of the core columns. Several outriggers in each direction, Figure 5, form a bridge to the system of perimeter columns.

The hat truss is described in FEMA's *World Trade Center Building Performance Study*: "Between the 106th and 110th floors, a series of diagonal braces were placed into the building frame. These diagonal braces together with the building columns and floor framing formed a deep outrigger truss system that extended between the exterior walls and across the building core framing. A total of 10 outrigger truss lines were present in each building (Figure 2-10), 6 extending across the long direction of the core and 4 extending across the short direction of the core. This outrigger truss system provided stiffening of the frame for wind resistance, mobilized some of the dead weight supported by the core to provide stability against wind-induced overturning, and also provided direct support for the transmission tower on WTC 1. Although WTC 2 did not have a transmission tower, the outrigger trusses in that building were also designed to support such a tower."¹¹

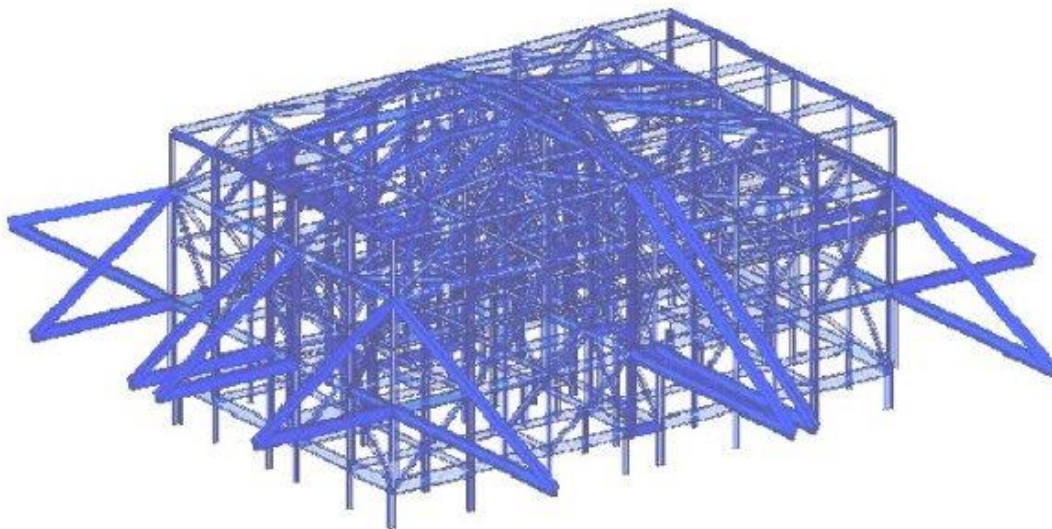
Figure 6 The hat truss shown integrated with the core columns.

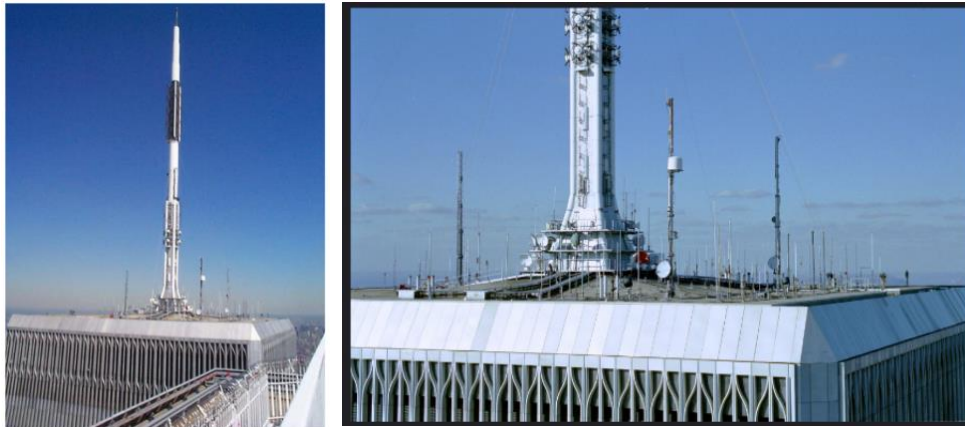
Figure 7 The antenna on the North Tower highlighting its connection to the roof structure.

Note that if the columns were to fail as described by NIST, starting with the south wall perimeter columns and propagating through the core columns, one would expect the antenna and hat truss to tip as a unit. If, on the other hand, the antenna dropped into the building as the initial motion, either the hat truss or the columns supporting it would have to fail. No mechanism for such a failure, other than explosive charges, has been proposed.

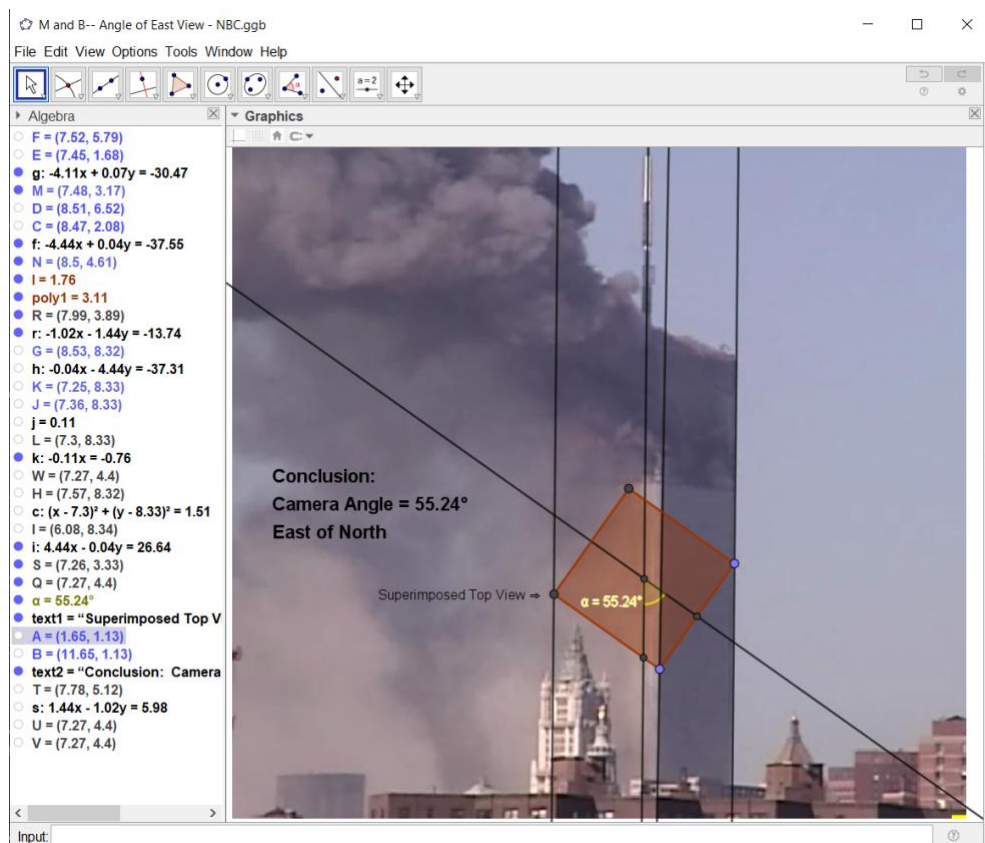
Figure 8 Construction showing the roof of the building folded forward and superimposed on the camera view of the building.

To perform the graphical calculation, a square is constructed using an automated polygon tool in GeoGebra, determined by two adjacent vertices (the blue dots on the square in Figure 8) which we place on the NE and NW edges of the building. By sliding those two defining corners along the vertical lines marking the edges of the building, the square is automatically resized and reoriented. The square is adjusted until a third corner lands precisely on the SE edge of the building. This is not a classical “compass and straightedge construction,” but high precision is obtainable with this tool when it is zoomed in. Once positioned, the square represents the top view of the building “folded” down onto the front view. The desired angle can then be directly measured. It turns out to be 55.24° .

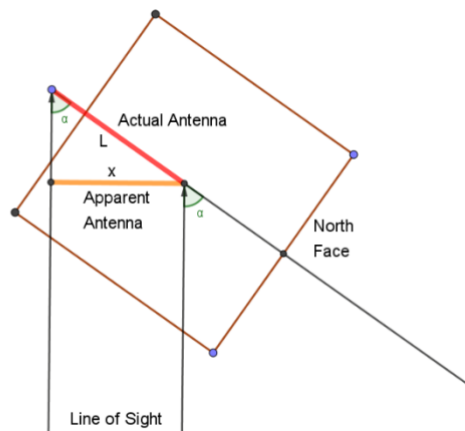
Figure 10 Derivation of transformation from apparent tilt to actual tilt of the antenna.

Figure 10 shows a bird's-eye view from above the top of the building. The diagonal line on the drawing (top left to bottom right) indicates a nominal north-south line through the centers of the north and south faces of the building. The parallel arrows pointing upward from the bottom of the drawing, indicate the line of sight from the distant camera. The southward motion of the

antenna in its plane of rotation (marked “Actual Antenna,” L) is foreshortened in its projection onto the film plane (marked “Apparent Antenna,” x). The angle α is the angle in the horizontal plane from the camera to nominal north. For the “Main & Ballou 17” video, we found this angle to be 55.24° in Appendix B.

To help with this 3-dimensional visualization, place Figure 5 horizontally on a table and place the eraser end of a vertical pencil on the center of the square in Figure 5 pointing upward. This represents the antenna. Now rotate (tilt) the pencil a little to the “south” (which would be to the upper left in the drawing) until the tip of the pencil is above the end of the red line. The red line segment on the drawing represents the horizontal component of the tilted antenna and the distance from the table up to the tip of the pencil represents the vertical component, which we call h . Note that the horizontal component L , the vertical component h , and the tilted antenna itself form a right triangle (as shown on the left in Figure 4). The small acute angle in this triangle we will call the tilt angle, ϕ .

Now picture this arrangement from the side, as indicated by the “line of sight” arrows in the diagram. This is the point of view of the distant video camera. The vertical triangle we just described is projected onto a plane perpendicular to our line of sight. The height h , remains the same. The other two sides of the triangle are foreshortened. Instead of L , the base of this triangle is the orange length labeled x . (The hypotenuse is also foreshortened, but that length doesn’t enter into the calculation, so we can ignore it.) The acute angle at the base of this right triangle we will call the apparent tilt angle, labeled θ .

$$\tan \phi = \tan \theta / \sin \alpha$$

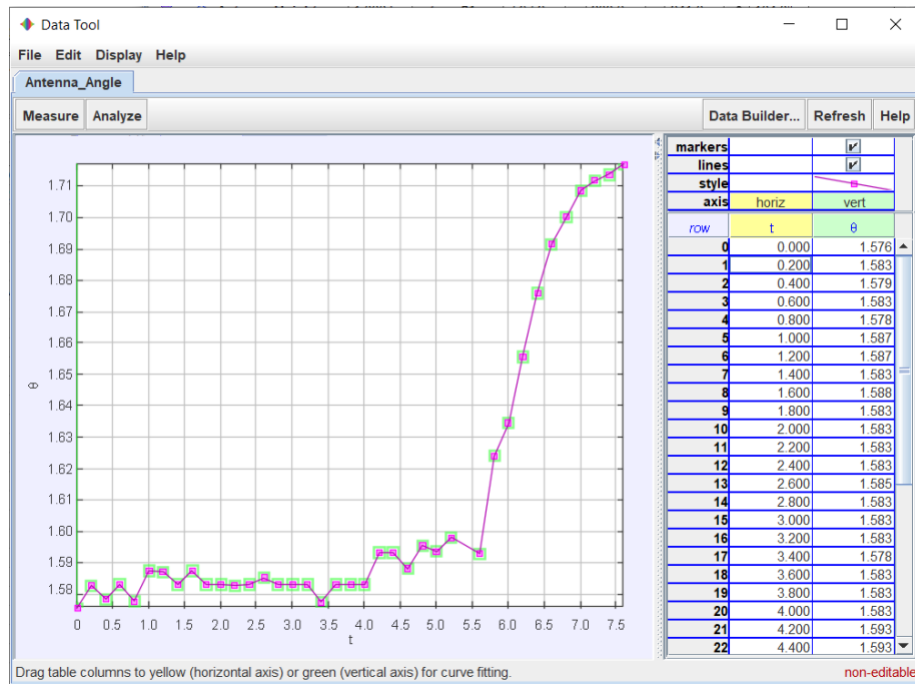
Figure 12 Apparent antenna tilt vs time

The antenna displays a combination of rotation and downward translation, as shown in Table 1 and Figures 12-15. In the first 1.6 sec of descent, from 4.0 to 5.6 sec, the antenna descends 5.71 m but rotates only 0.58° , or 0.01 radians. (If the roof had descended 5.71 m due to pure rotation of the roof pivoting at the edge of the roofline, the rotation of the antenna would have been 10.28° .) Let us hypothesize that the observed downward translation of the antenna is actually the vertical component of the rotation of the roof-antenna complex. To a very close approximation that would be the arc length of the rotation of the roof.

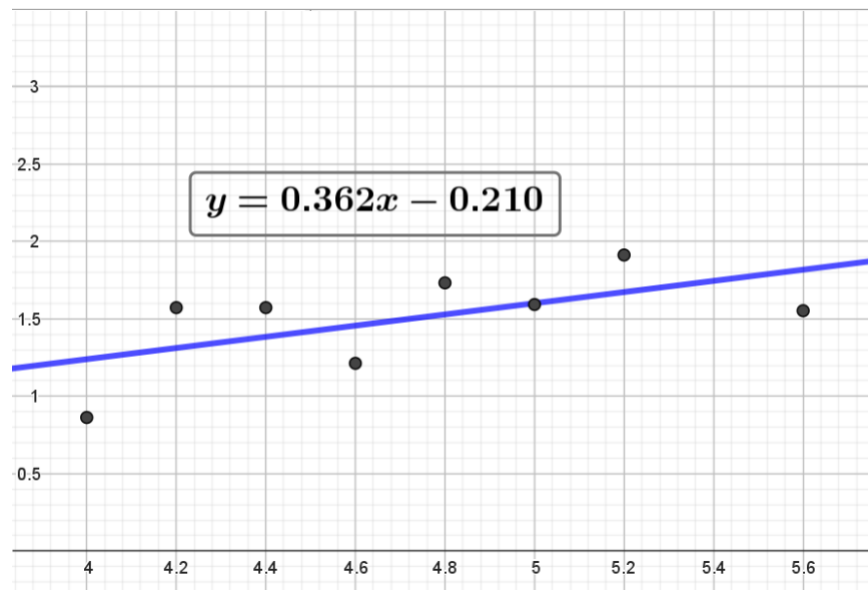
Figure 13 From $t = 4.0$ to $t = 5.6$ the antenna rotated 0.58 degrees.

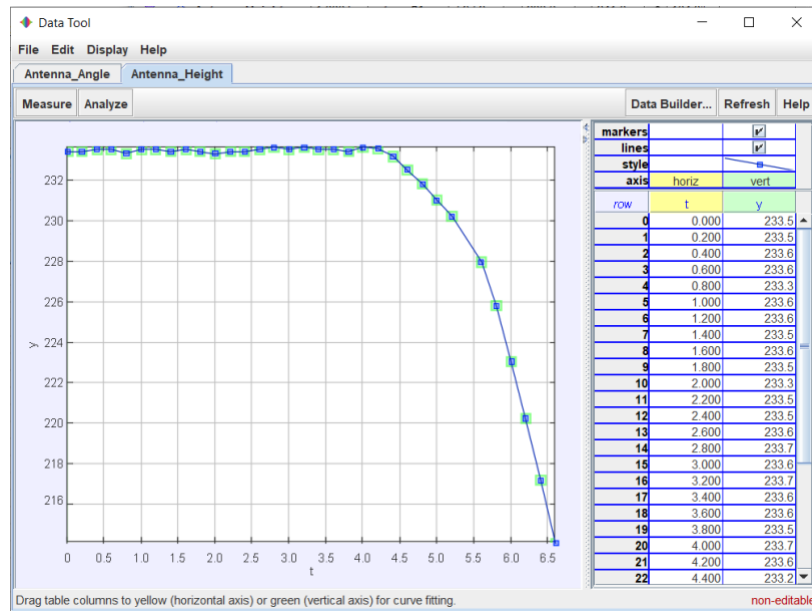
Figure 14 Antenna height vs time

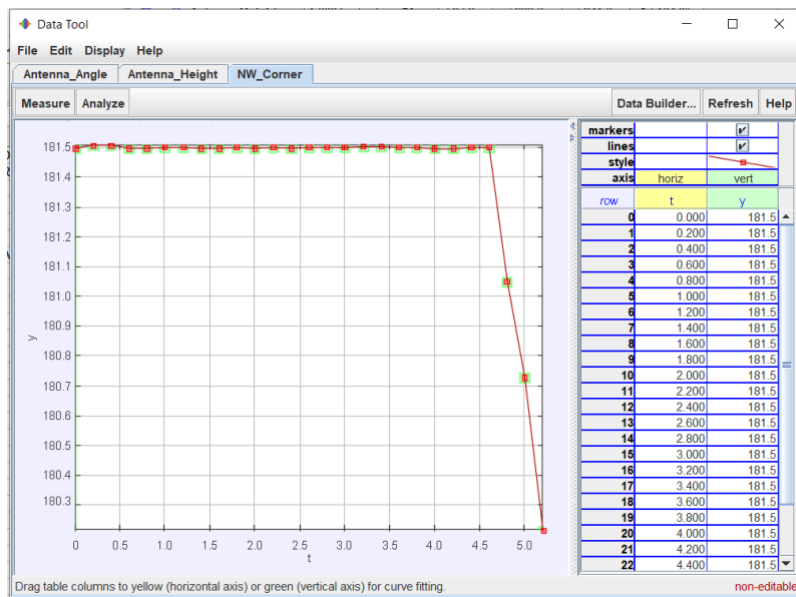
Figure 15 Roof height vs. time

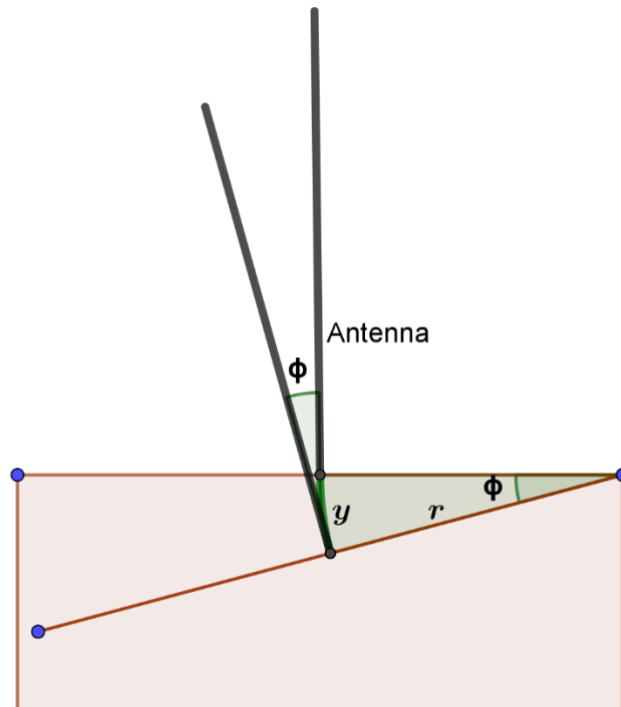
Figure 16 The ratio of the arc length of the motion (y) to the radius of the rotation (r) is the radian measure of the angle of rotation. On the hypothesis that the tilting of the antenna is part of a coherent rotation of the roof, the center of rotation would have to be a supported pivot point, so r could be a maximum of 32 m.

We have found that for the initial 1.6 sec of motion, the radian measure of the rotation angle would be 0.01. Multiplying this by the maximum possible radius (32 m) gives an arc length of 32 cm. However, the measured vertical motion of the antenna over this same interval is 5.71 m. Therefore, we can conclude that a rotation of the roof-antenna complex cannot account for the drop of the antenna. The vertical drop of the antenna is therefore real, not an illusion.
