April 15, 2020

**Re: Request for Correction Under the Data Quality Act to NIST's Final Report on the Collapse of World Trade Center Building 7**

Part 1: NIST’s Computer Simulations

Part 2: NIST’s Omission and Distortion of Evidence of Explosions and Incendiaries

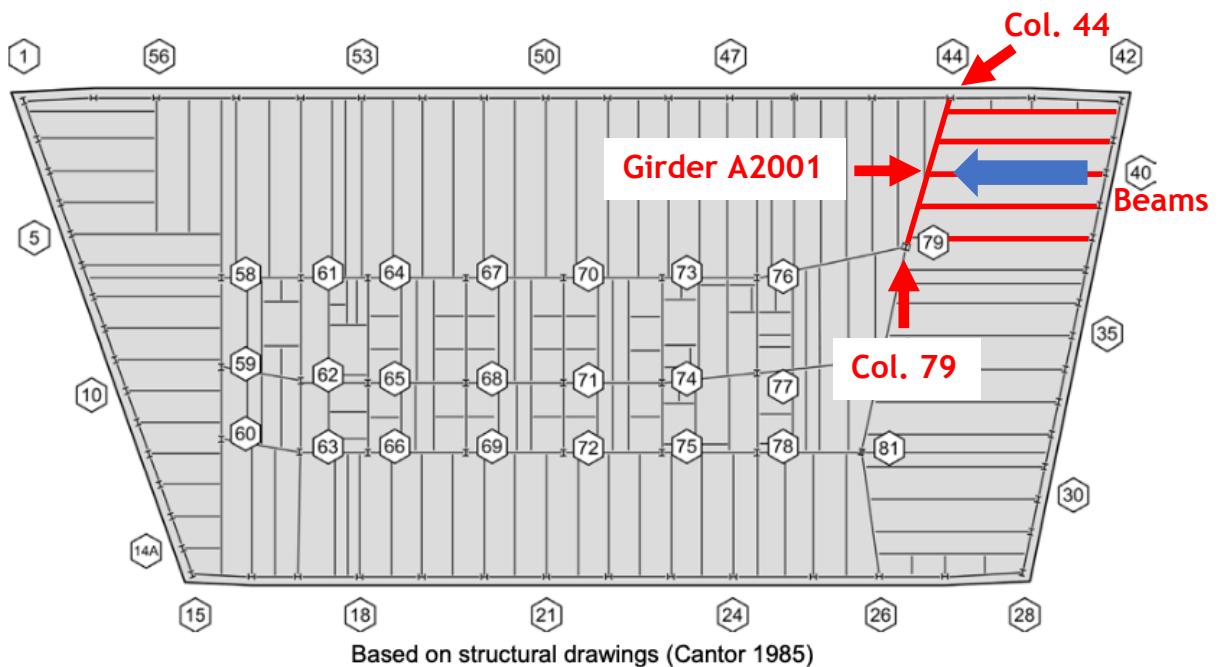
**Figure 1–5. Typical WTC 7 floor showing locations of the columns, girders, and beams.**

case, the floor beams on the east side of the building expanded enough that they pushed the girder spanning between Columns 79 and 44 to the west on the 13th floor. (See Figure 1–5 for column numbering and the locations of girders and beams.) This movement was enough for the girder to walk off of its support at Column 79.

The structural elements mentioned above are shown below in Figure 1.5 of NCSTAR 1A. The blue arrow indicates the westward direction in which, according to NIST, the floor beams thermally expanded and caused the girder (Girder A2001) to walk off its support at Column 79.

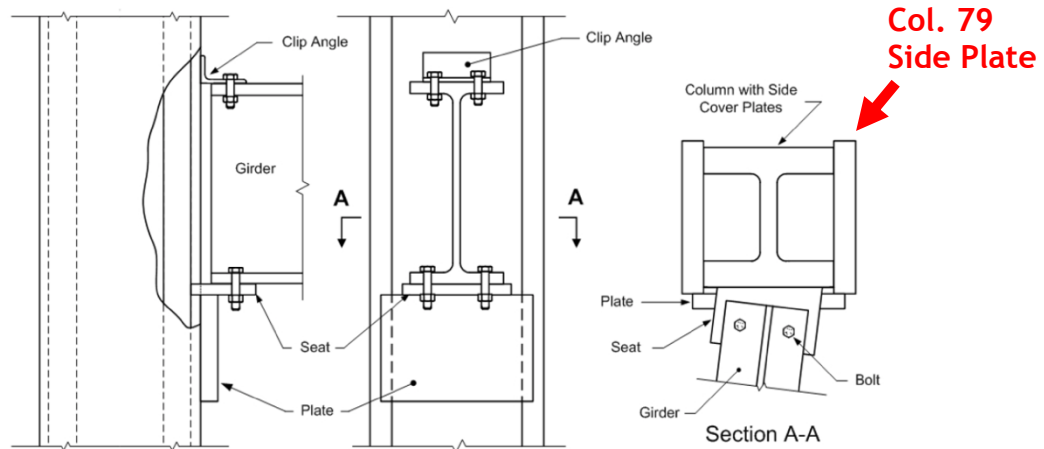
**Figure 8–21. Seat connection at Column 79.**

Column 79 was a W14 x 730 standard structural shape column with 2” x 26” built-up side plates welded to its flanges at Floor 13. Column 79 and its side plates are pictured in Figures 8-21 and 8-23 of NCSTAR 1-9, shown below, with the western side plate pointed out. The dimensions of the side plates are given in the fabrication shop drawings. (See Frankel Steel Limited, Drawing 1091.)

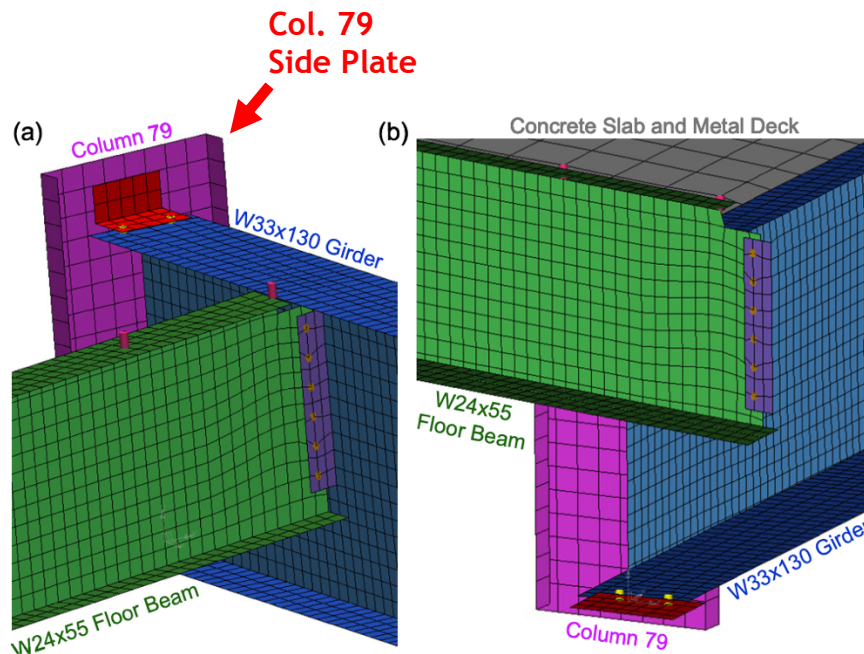
**Figure 8–23. Views from northeast showing seat connection at Column 79 and bolted shear plate connection of floor beam to girder.**

NIST, however, omitted these web stiffeners from its analyses. The omission of these web stiffeners is evident in Figure 8-21 of NCSTAR 1-9 (shown in the previous section) and was also confirmed via email on October 25, 2013, by NIST public affairs officer Michael Newman, who wrote (*see Exhibit C*):

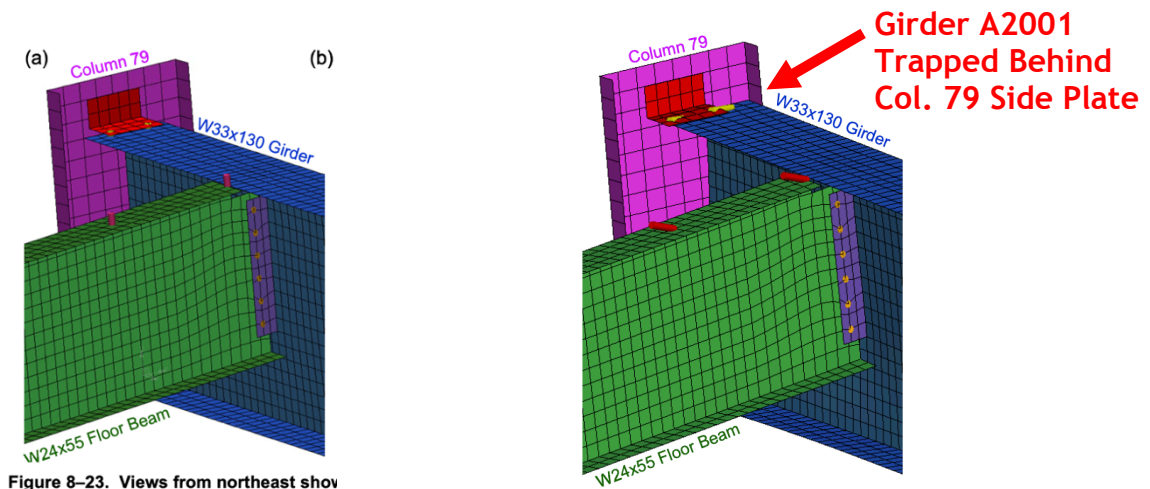
The trapping of Girder A2001 behind the Column 79 side plate in NIST’s preliminary LS-DYNA analysis is illustrated graphically in Figure 8-26 of Section 8.8 shown below. Juxtaposing Figure 8.23 (left) with Figure 8.26 (right) illustrates the westward travel of Girder A2001.

Figure 8–23. Views from northeast show shear plate connecti

Figure 8–26. Lateral displacement of girder due to thermal expansion of floor beam. Note: failed bolts and shear studs

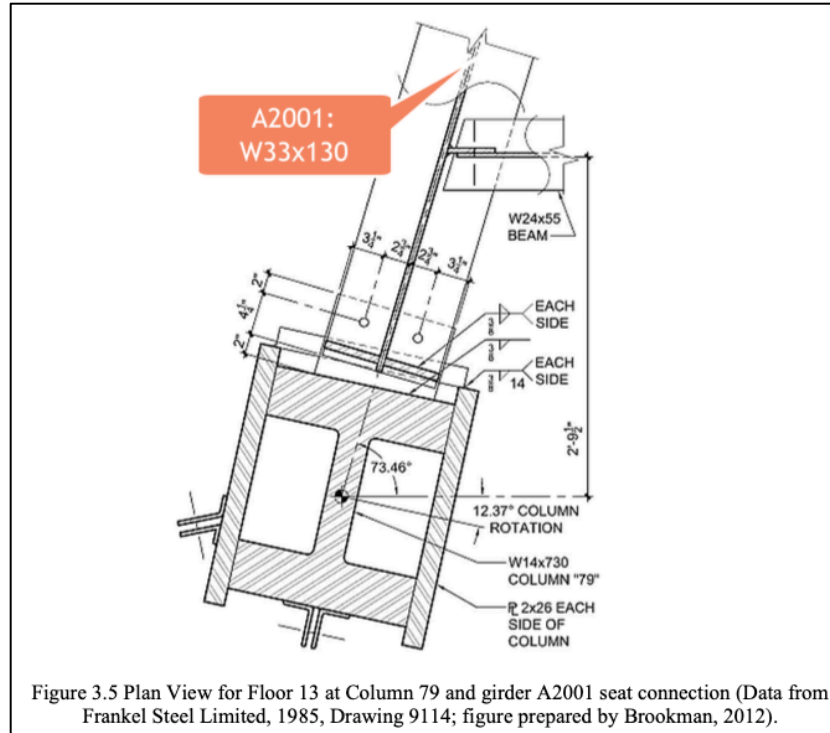
. . . Figure 3.5 [shown below] shows the girder bearing seat at Column 79 is 12 inches wide. The flange width for W33 x 130 girder A2001 is 11.510 inches wide and centered on the seat; its web is 0.580 inches thick. **This would require a lateral travel distance of 6.290 inches for the web to be beyond the seat.** However, the distance between the column side plates is 17.89 inches. **The girder and bearing seat are slightly off center to the east, with just 3.678 inches between the girder's western edge and Column 79's western side plate. Thus, the side plate prevents the girder's web from traveling beyond the bearing seat.** (Emphasis added.)

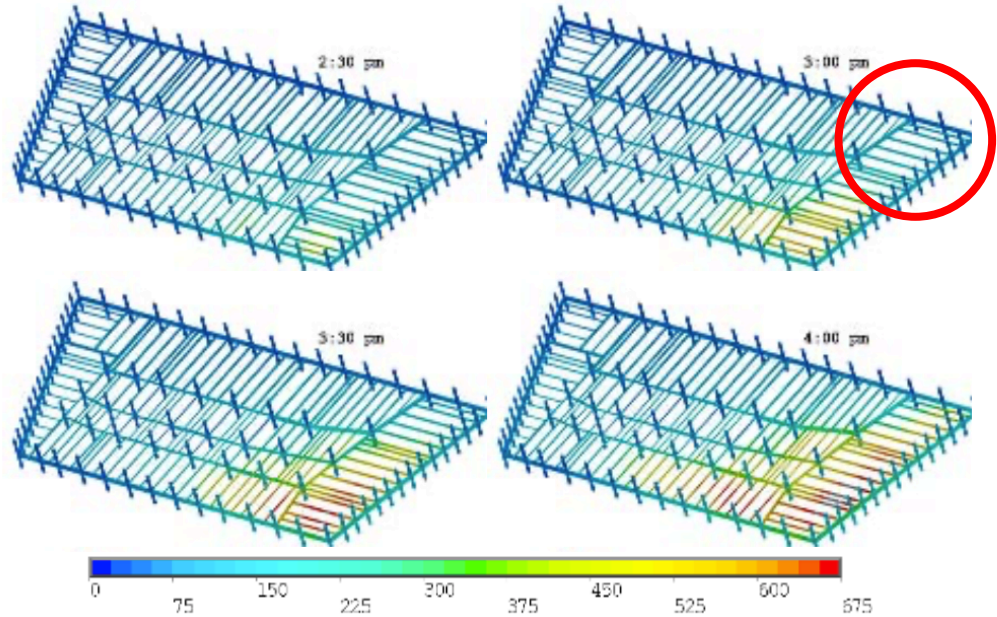
**Figure 10–39. Computed temperature distribution (°C) on the floor beams of Floor 13 at 12 different instants in time (Case B, floor slabs removed).**

The Case B floor temperatures used in NIST’s 16-story ANSYS model are somewhat difficult to decipher in Figure 10-39 below. (The Case B floor temperatures are the computed worst-case scenario temperatures, which NIST then used in its global collapse analyses.) Nevertheless, careful review indicates that the temperatures of Girder A2001 and the floor beams to its east were approximately the same until at least 3:30 PM, and that Girder A2001 reached temperatures 164 °C (enough for it to move within the envelope of the Column 79 side plate) long before the floor beams to its east were heated sufficiently to push Girder A2001 to the west at least 3.678 inches. Focusing on beam K3004, which was the closest beam to Column 79 framing into Girder A2001, and thus dictated the extent of westward displacement of Girder A2001 at Column 79, the thermal expansion from room temperature length would be only 2.527 inches at 300 °C and would not reach 3.700 inches until 430 °C (based on NIST’s Coefficient of Thermal Expansion (CTE) value for steel of  $1.4 \times 10^{-5}$  in/in-°C, and the room temperature (20 °C) length of beam K3004 of 644-11/16 inches).

**Girder A2001 Is Heated to at Least 164°C Long Before Floor Beams Are Sufficiently Heated to Push It 3.678 Inches to the West**

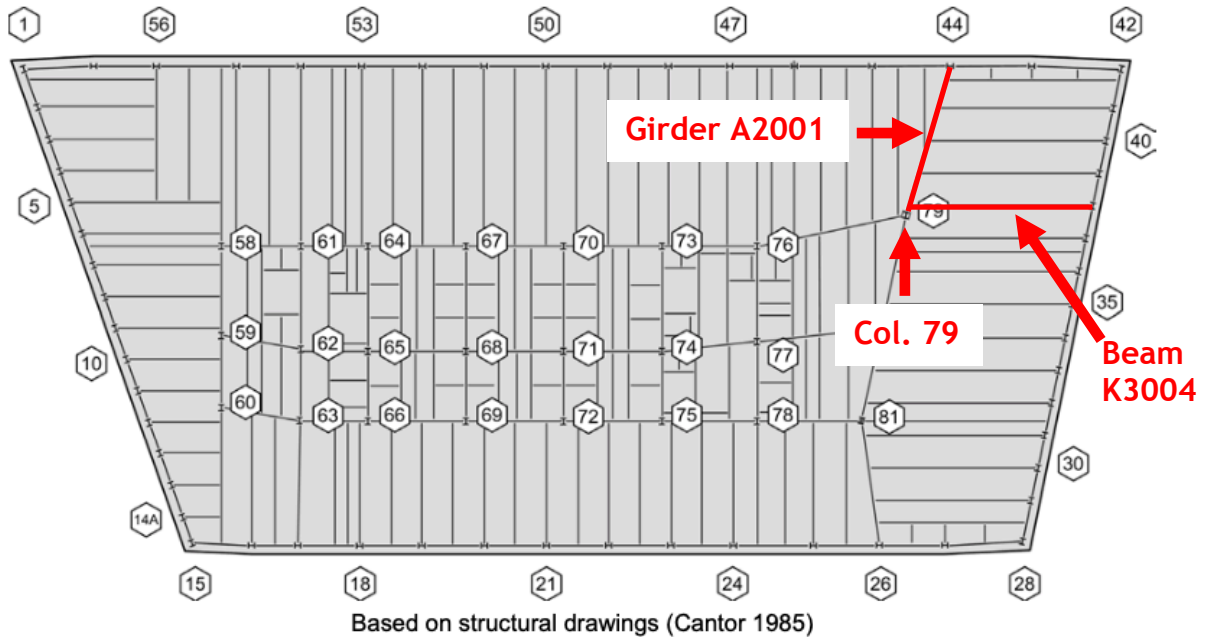
**Figure 1-5. Typical WTC 7 floor showing locations of the columns, girders, and beams.**

As noted above, beam K3004 was the closest beam to Column 79 framing into Girder A2001 from the east. Therefore, the thermal expansion of beam K3004 dictated the extent of westward displacement of Girder A2001 at Column 79. Beam K3004 is indicated in Figures 1-5 and 8-21 of NCSTAR 1-9 below.

### a) Revise the NIST WTC 7 Report to Reflect that Beam K3004 Could Not Thermally Expand Enough to Cause the Walk-Off of Girder A2001

First, NIST must revise the NIST WTC 7 Report to reflect that beam K3004 could not thermally expand enough to cause the walk-off of Girder A2001. Alternatively, if NIST maintains that beam K3004 was able to thermally expand enough to cause the walk-off of Girder A2001, it must amend the NIST WTC 7 Report to include analysis that satisfies the objectivity, utility, transparency, and reproducibility standards of information quality.

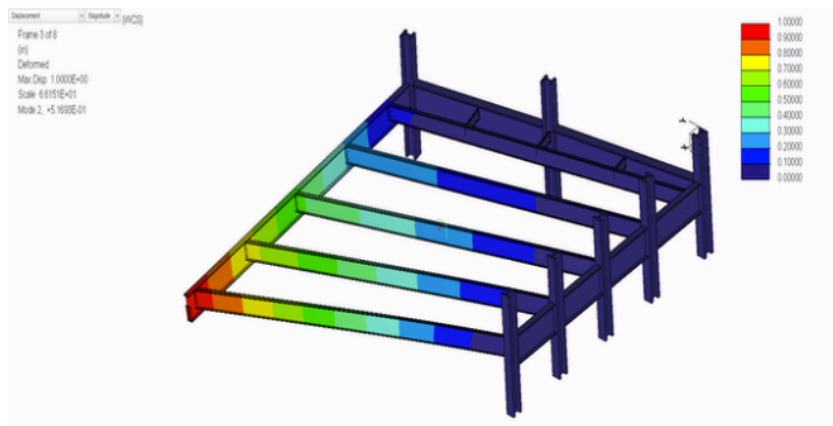
To determine the stiffness of the falling Floor 13 beam and girder assembly, a finite element modal analysis was performed with the assembly constrained at the north and east exterior walls and the girder sitting on its bearing seat at Column 44 with the bolts at the girder seat broken there. The results are shown in Figure 3.15. The first mode of 22 Hz involved only the beams moving in a transverse direction and was not relevant. The second mode of 0.52 Hz involved the participation of the entire beam and girder assembly in the vertical direction and was relevant.

Figure 3.15 The relevant 0.52 Hz mode of the falling beam and girder assembly.

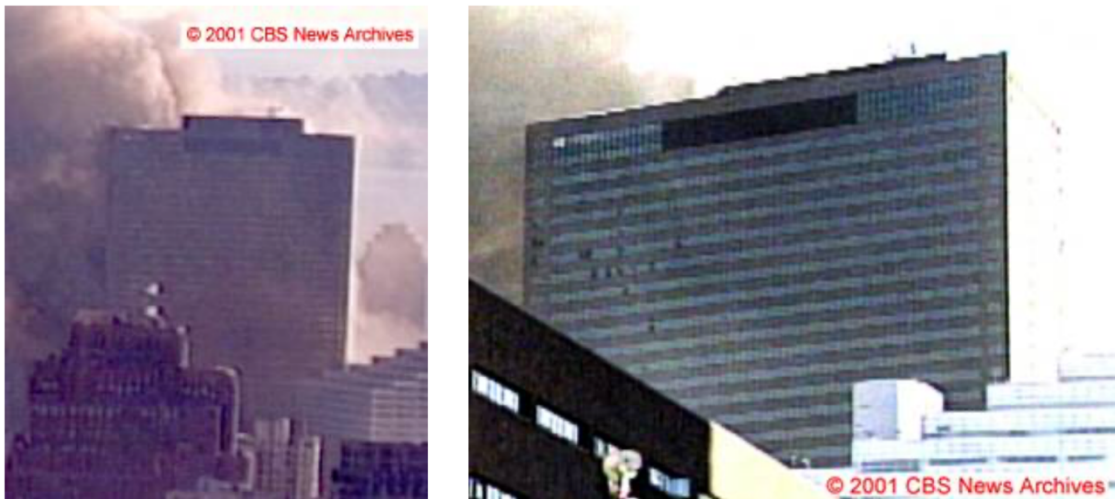
First and most apparent, NIST's global collapse analysis predicts significant deformation of the upper exterior walls both before and after the initiation of global collapse. **Yet, per NIST's own observations, there is no observed deformation or displacement of the upper exterior corners as late as 7.5 seconds after the initiation of the east penthouse collapse (which is .6 seconds after NIST claims that global collapse initiated).** Figures 5-199, 5-200, and 5-201 from NCSTAR 1-9, which compare the position of WTC 7's exterior at 5.0 seconds and 7.5 seconds after the initiation of the east penthouse collapse, demonstrate the **total absence** of deformation or displacement in the upper exterior corners, with NIST actually commenting: "Interestingly, little movement of the northeast and northwest corners of the building is indicated." (See NCSTAR 1-9, p. 274.)

**Figure 5–199. Cropped frames from the Camera 2 video clip in Figure 5–185 and the Camera 3 video clip in Figure 5–186, showing the north face of WTC 7 5.0 s ± 0.1 s after the east penthouse began to move downward.**

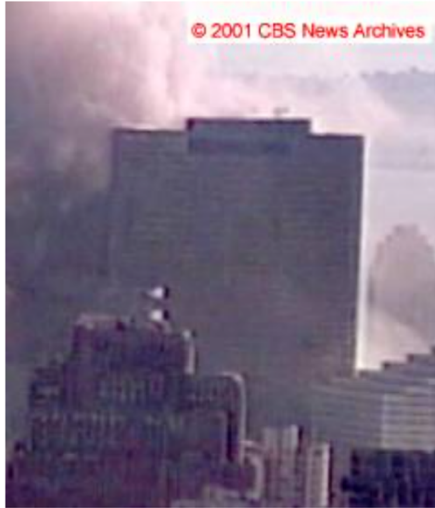
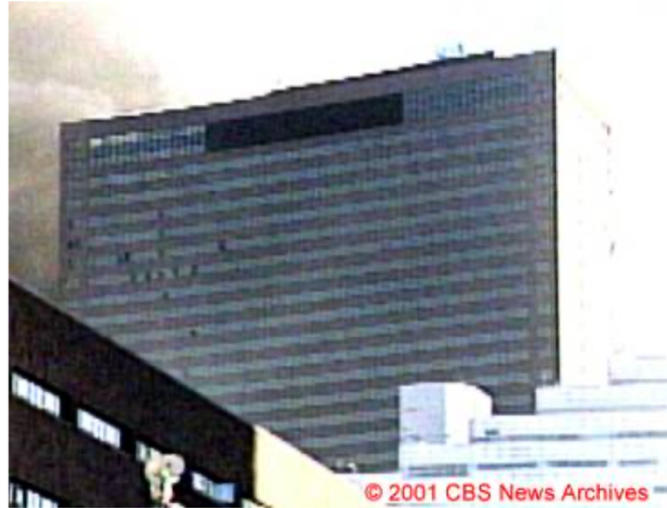
**Figure 5–200. Cropped frames from the Camera 2 video clip in Figure 5–185 and the Camera 3 video clip in Figure 5–186, showing the north face of WTC 7 7.5 s ± 0.1 s after the east penthouse began to move downward.**  
The intensities have been adjusted.

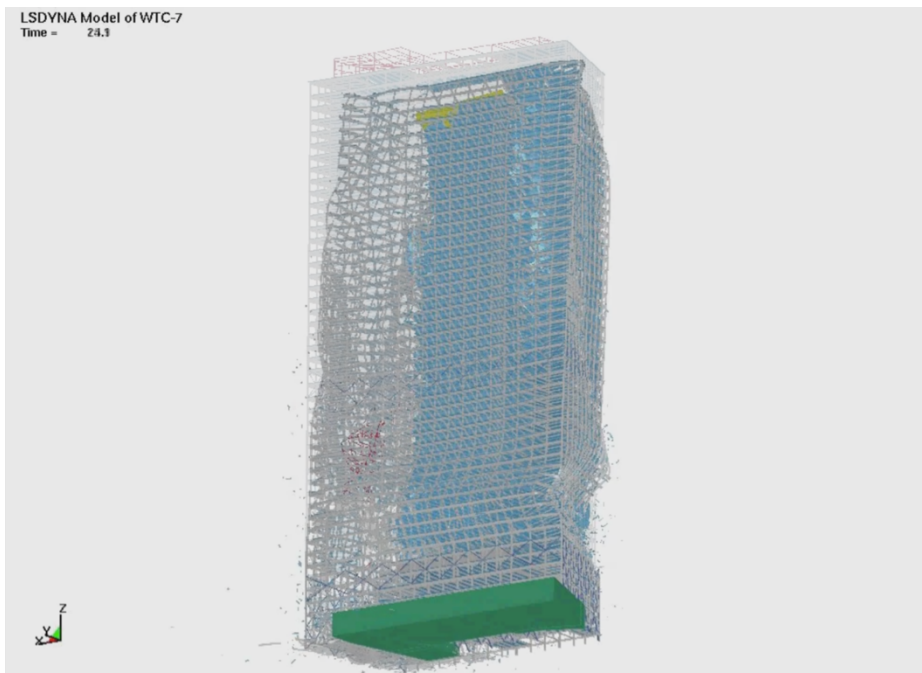
Figure 4: NIST's global collapse analysis at 8.1 seconds after the initiation of the east penthouse collapse laid over .1 seconds before the east penthouse collapse initiation.

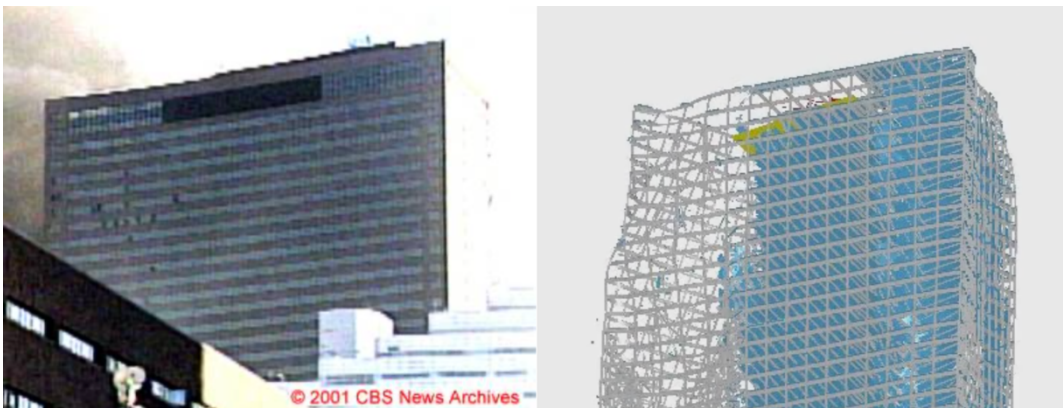
Figure 6: Video and analysis animation at 7.5 seconds after initiation of east penthouse collapse.

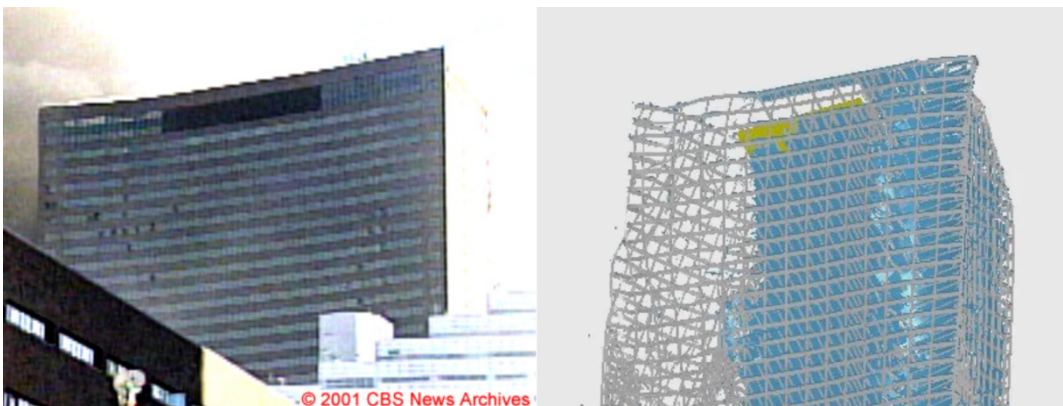
Figure 7: Video and analysis animation at 8.1 seconds after initiation of east penthouse collapse.

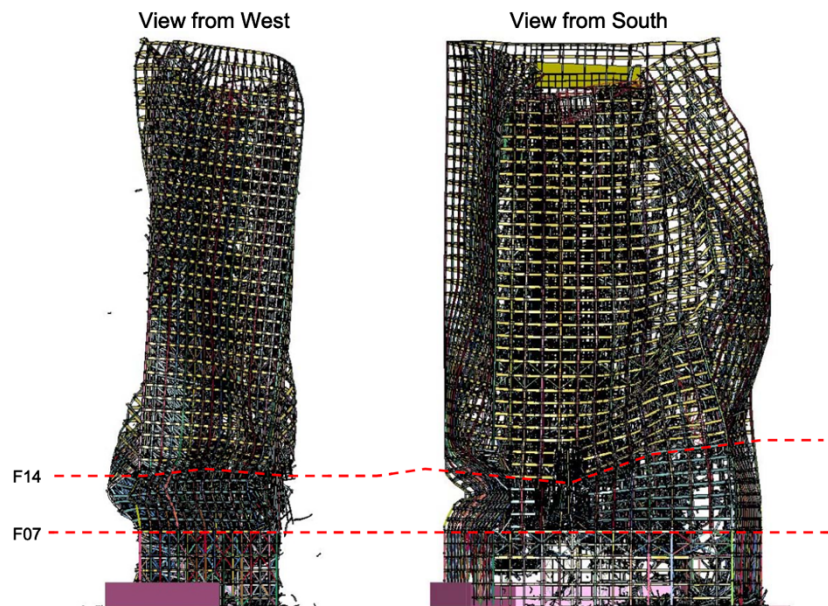
In addition to the global collapse analysis animation shown above, Figure 12-62 from NCSTAR 1-9, shown below, illustrates the significant deformation of the exterior predicted in NIST’s global collapse analysis, with the upper eastern exterior folding inward to the south dramatically, as acknowledged by NIST: “In both analyses, the eastern exterior wall deflected inward at the roof level as the structure became unsupported after the vertical collapse event.” (See NCSTAR 1A, p. 44.) However, this behavior was not observed in any videos of the collapse.

**Figure 12–62. Exterior column buckling after initiation of global collapse with debris impact and fire-induced damage (slabs removed from view).**

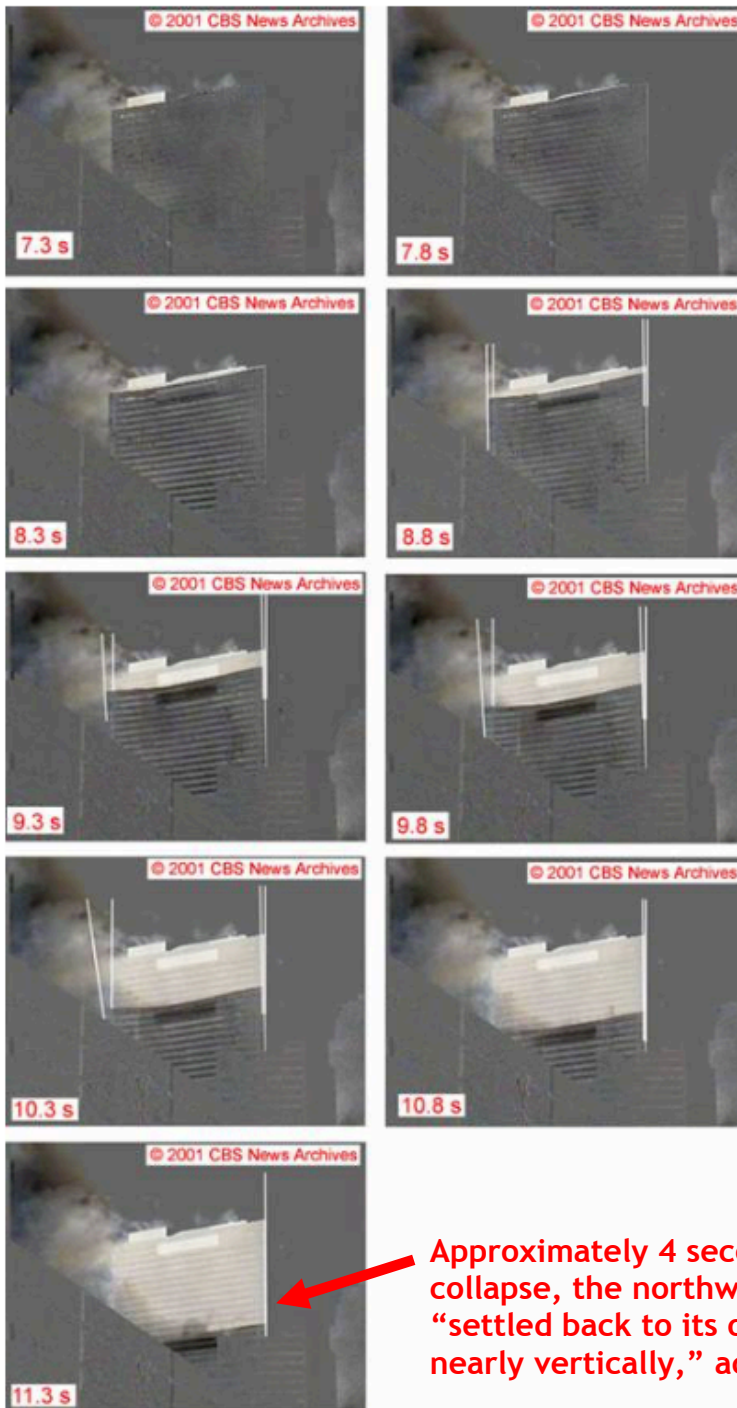
The second way that NIST’s global collapse analysis fails to match most of the observed behavior is in the direction of the collapse. As illustrated in Figure 5-205 of NCSTAR 1-9 shown below, the northwest edge of WTC 7 descended nearly symmetrically during the first 4 seconds of the global collapse. Analyzing Figure 5-205, NIST states (*see* NCSTAR 1-9, p. 277):

**Figure 5–205.**  
**Difference images**  
**from the Camera 3**  
**video clip showing**  
**the rotation of the**  
**northeast edge of**  
**WTC 7 during the**  
**global collapse.**  
 Times are referenced  
 to the time the east  
 penthouse began to  
 descend into the  
 building.

Approximately 4 seconds into the global collapse, the northwest edge had “settled back to its original line and fell nearly vertically,” according to NIST.

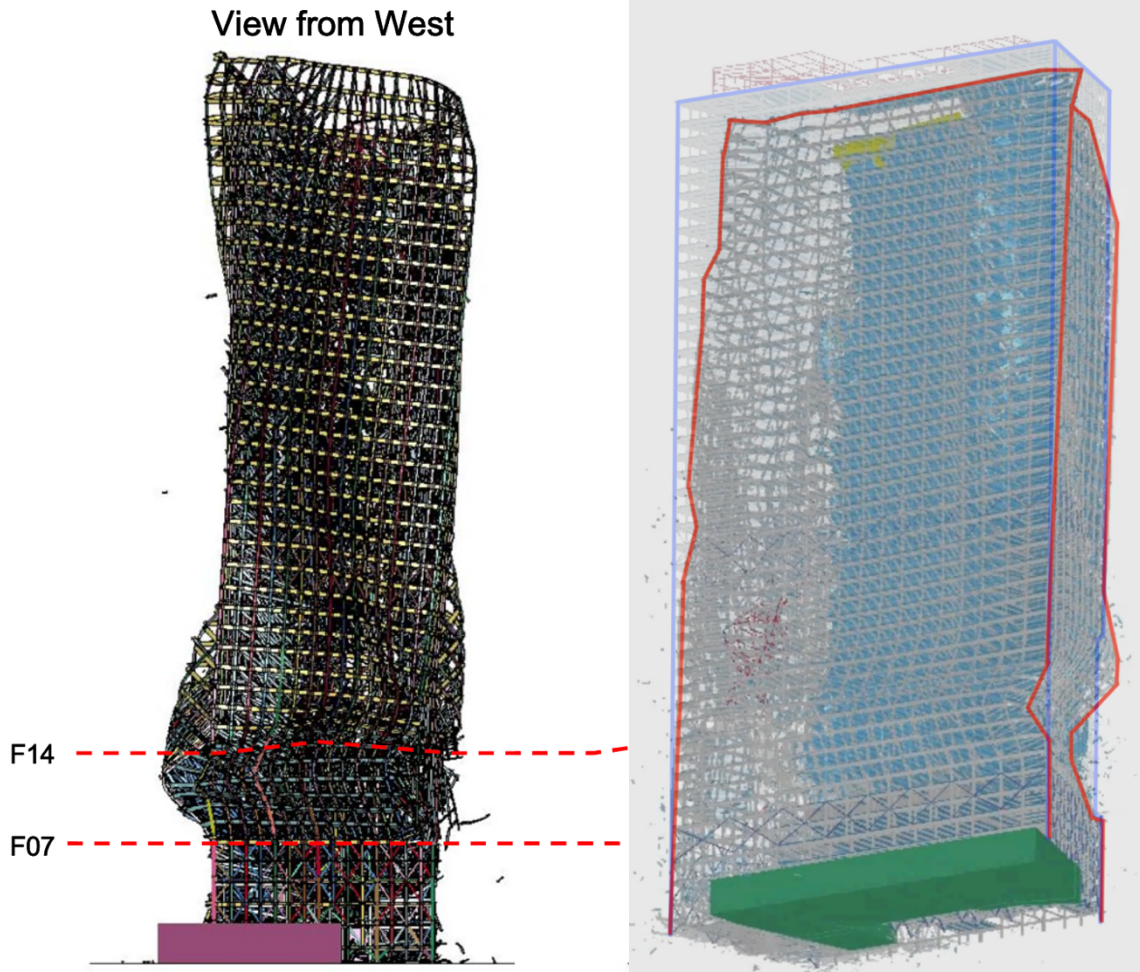
In contrast, NIST’s global collapse analysis predicts both the northeast and northwest edges of WTC 7 tipping to the south — not to the north — in a manner that appears they would not have tilted back to the north and, in the case of the northwest edge, that it would not have settled back to its original line. The southward tipping predicted in NIST’s global collapse analysis is shown below in the western view from Figure 12-62 of NCSTAR 1-9 (left) and in the overlay of the final frame from NIST’s global collapse analysis animation on top of the frame just before the initiation of the east penthouse collapse (right).

It should be noted that the illustration and animation of NIST’s global collapse analysis shown in Figure 8 below correspond approximately to the position of WTC 7 at 8.3 seconds in the video, at which point there is no tipping or tilting of the building (see “8.3 s”). It is apparent that at the rate of tipping shown in the global collapse analysis, approximately 3 seconds later the model would have shown the building tipping southward dramatically far from its original position.

Figure 8: NCSTAR 1-9 Figure 12-62 View from West (left); NIST's global collapse analysis at 8.1 seconds after east penthouse collapse initiation laid over .1 seconds before the east penthouse collapse initiation (right).

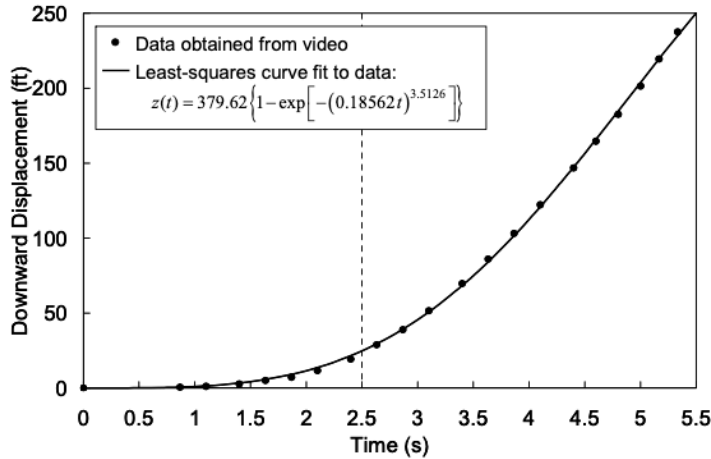
Figure 12-76  
Downward  
displacement of  
north face roofline  
as WTC 7 began to  
collapse.

Figure 12–76 presents a plot of the downward displacement data shown as solid circles. . . . The fitted displacement function was differentiated to estimate the downward velocity as a function of time, shown as a solid curve in Figure 12–77. . . . The slope of the straight line, which represents a constant acceleration, was found to be  $32.2 \text{ ft/s}^2$  (with a coefficient of regression  $R^2 = 0.991$ ), equivalent to the acceleration of gravity  $g$ . (Emphasis added.)

Upon closer examination, we find that NIST’s method of measuring the building’s downward motion by tracking the vertical position of a single point “near the center of the roofline” oversimplifies and misrepresents the actual downward motion of the entire roofline.

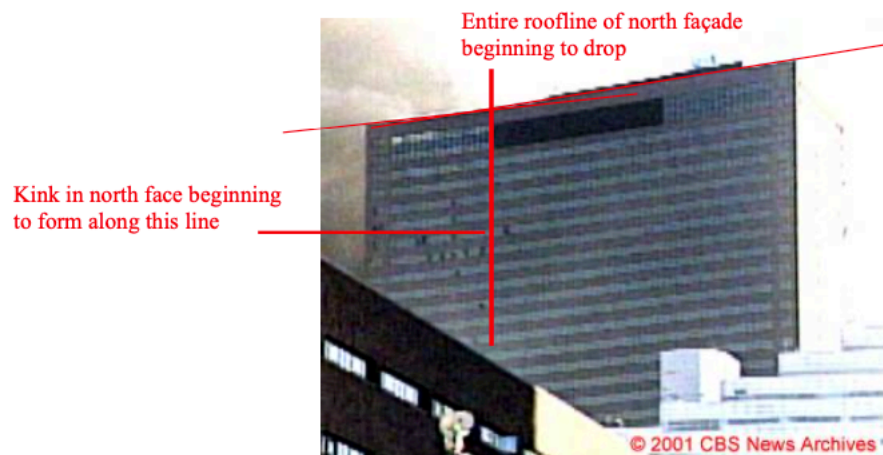
**Figure 8–5. Global collapse of WTC 7 begins about seven seconds after the onset of collapse of the east penthouse.**

**Thus, the downward motion of WTC 7’s north face roofline at the onset of global collapse is more accurately characterized as a sudden transition to free fall.** Prior to the initiation of the entire roofline’s free fall, the middle of the roofline dropped approximately half a meter, then stopped, and then dropped approximately 1 meter further, before entering into free fall along with the entire roofline.

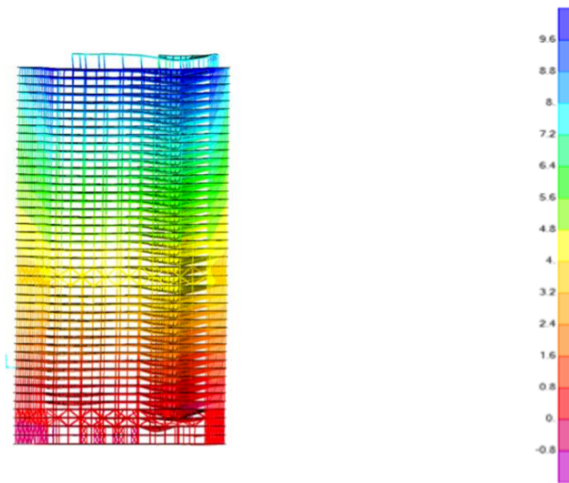
Figure 4.2 Columns 79, 80, and 81 are removed from Floor 6 to Floor 13. The key to the right is expressed in inches of movement. The building tilts to the east almost 10 inches. The penthouse does not collapse.

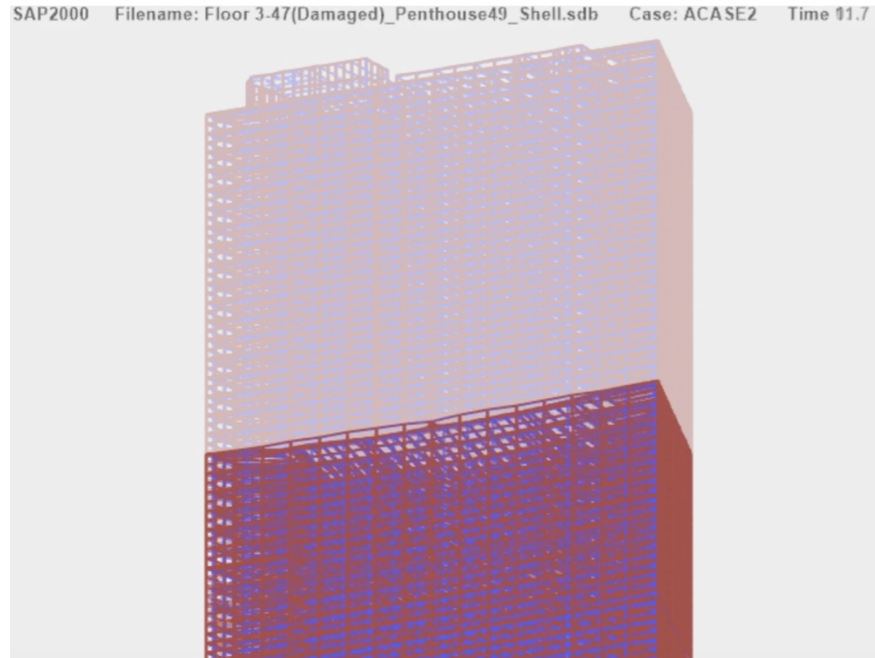
Figure 11 below illustrates how the collapse progressed in the UAF global collapse analysis by overlaying the last frame of the animation on the first frame the animation. As is apparent, the UAF global collapse analysis predicts minimal deformation of the exterior and a clean vertical descent, as observed in videos of the collapse.

Figure 11: The last frame of the UAF global collapse analysis overlaid on the first frame.

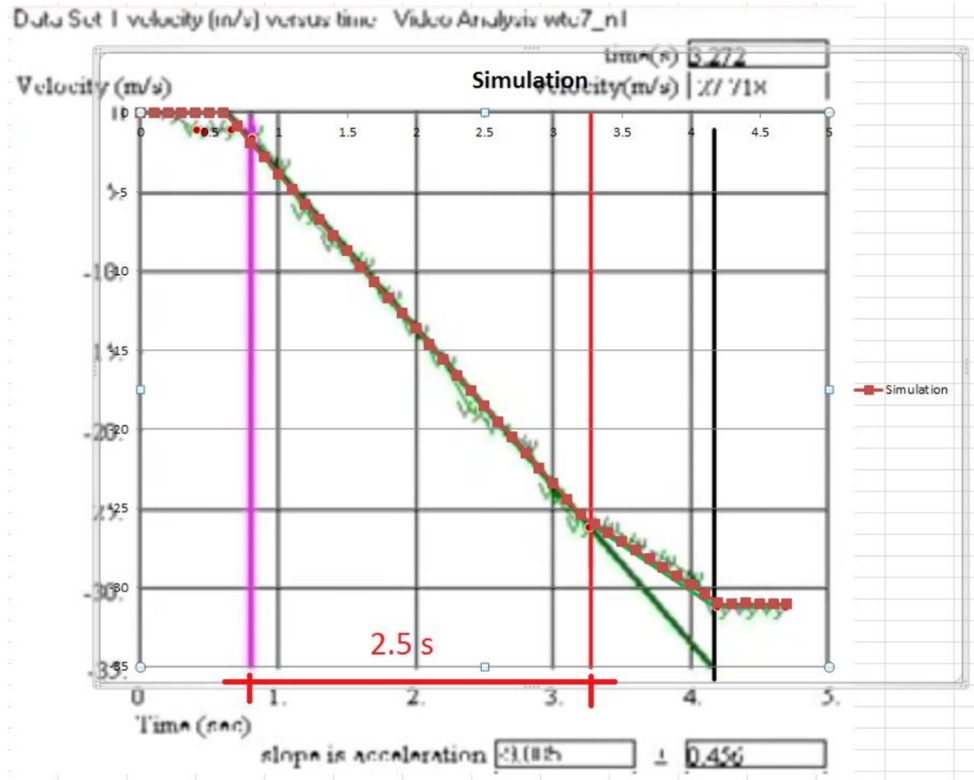
The UAF team also found that the simultaneous failure of all core columns over 8 stories followed 1.3 seconds later by the simultaneous failure of all exterior columns over 8 stories resulted in a downward velocity and acceleration that matched almost exactly with the observed 2.5 seconds of free fall, as illustrated below in Figure 4.20 from the UAF Report.

Figure 4.20 Velocity comparison between Chandler measurement (green plotted line) and UAF simulation (red plotted line). Bold green trend line illustrates free fall.

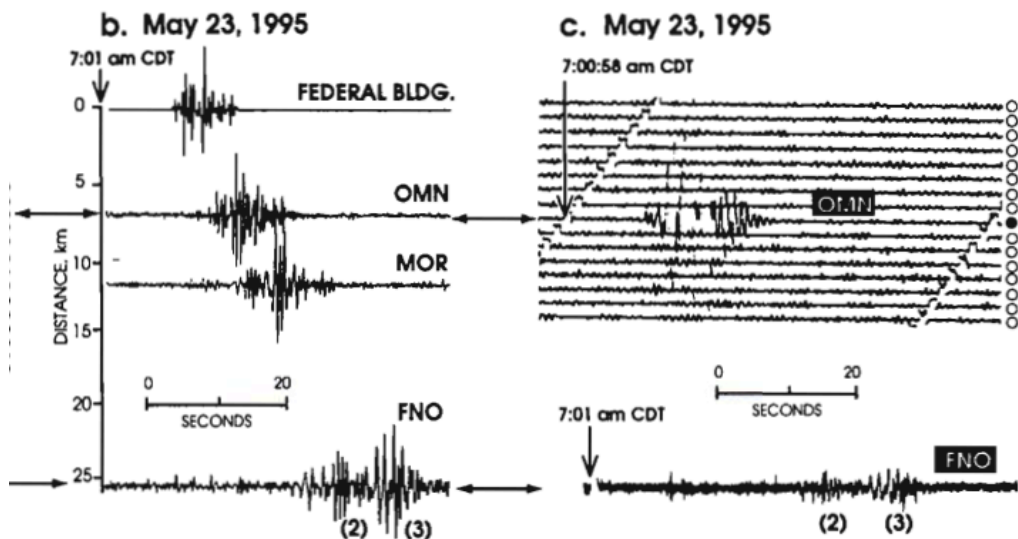
The seismogram data generated during the demolition of the Alfred P. Murrah Federal Building is shown below. (See Holzer et al.) The data represented under “b” are seismograms of vertical velocity recorded by portable digital seismographs at the Federal Building and at three other locations 7 km, 12 km, and 26 km, respectively, from the Federal Building. The data represented under “c” are seismograms recorded at the two permanent seismometers (OMN and FNO) 7 km and 26 km away from the Federal Building, respectively.

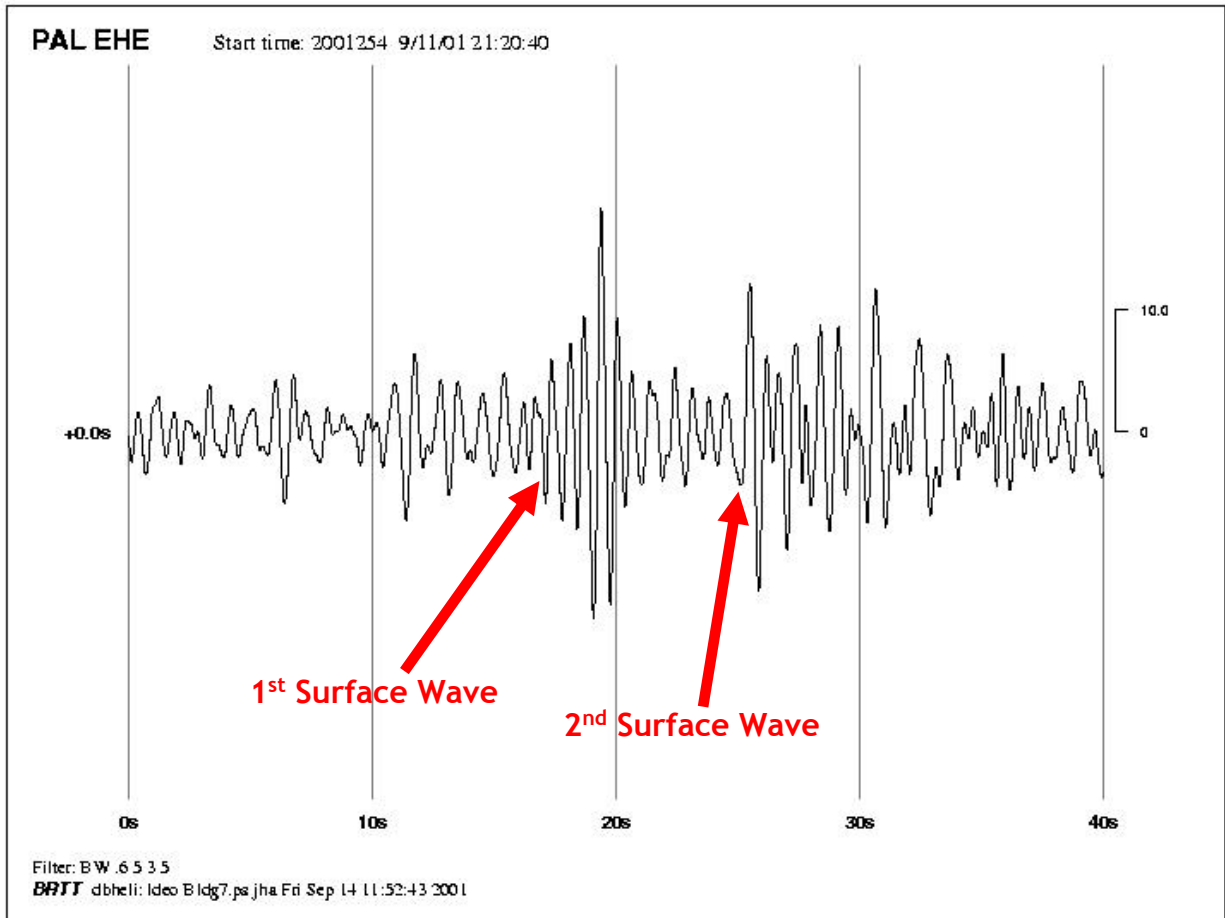
Furthermore, as Rousseau states in his declaration, “the recorded frequency of about 1 Hertz (1 Hz, or one cycle per second) is consistent with the frequency of waves generated by explosions, whereas the frequencies of waves generated by percussion are above 10 Hz and often

around 100 Hz.” Furthermore, Rousseau attests, “the bell-like form in the LDEO seismogram points to an impulsive source of energy, not percussion on the ground due to the fall of debris.”

Figure 12: LDEO seismogram shows .6 Hz to 5 Hz waves. “PAL” refers to Palisades. In “EHE,” E: short periods, H: high gain, and E: east-west component. Rousseau cites this seismogram in his analysis. The NIST WTC 7 Report includes a different set of broadband seismograms.

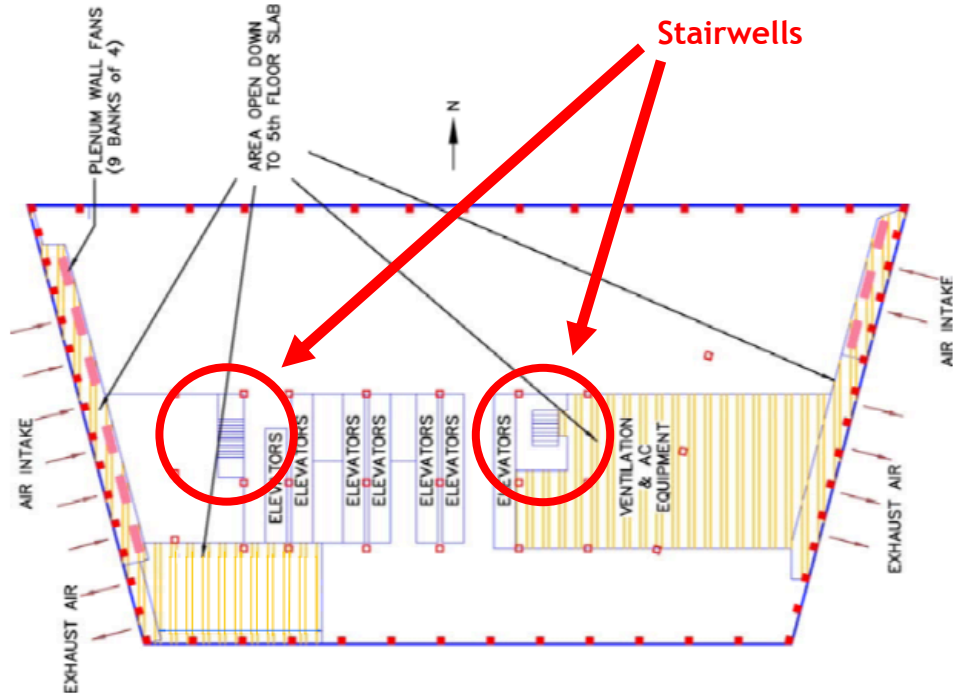
Figure 3–2. Schematic of Floor 6.<sup>1</sup>

It is also inconceivable that debris impacting the south face of WTC 7 could cause a landing in a stairwell on the northern side of the building's core to give way or at least make the stairwell impassable. (*See* Figure 3-2 of NCSTAR 1-9 below, which shows the stairwell on the northern side of the building's core.) Apparently recognizing this issue, the NIST WTC 7 Report makes no mention of the landing giving way or any other structural damage to the stairwell. Instead, the NIST WTC 7 Report implies that Hess and Jennings retreated to the 8<sup>th</sup> floor because the staircase "filled with smoke and debris." The NIST WTC 7 Report does not explain how debris impacting the south face of WTC 7 could cause a stairwell on the northern side of the building's core to fill with debris. Nor does it attempt to account for the damage described by Jennings.

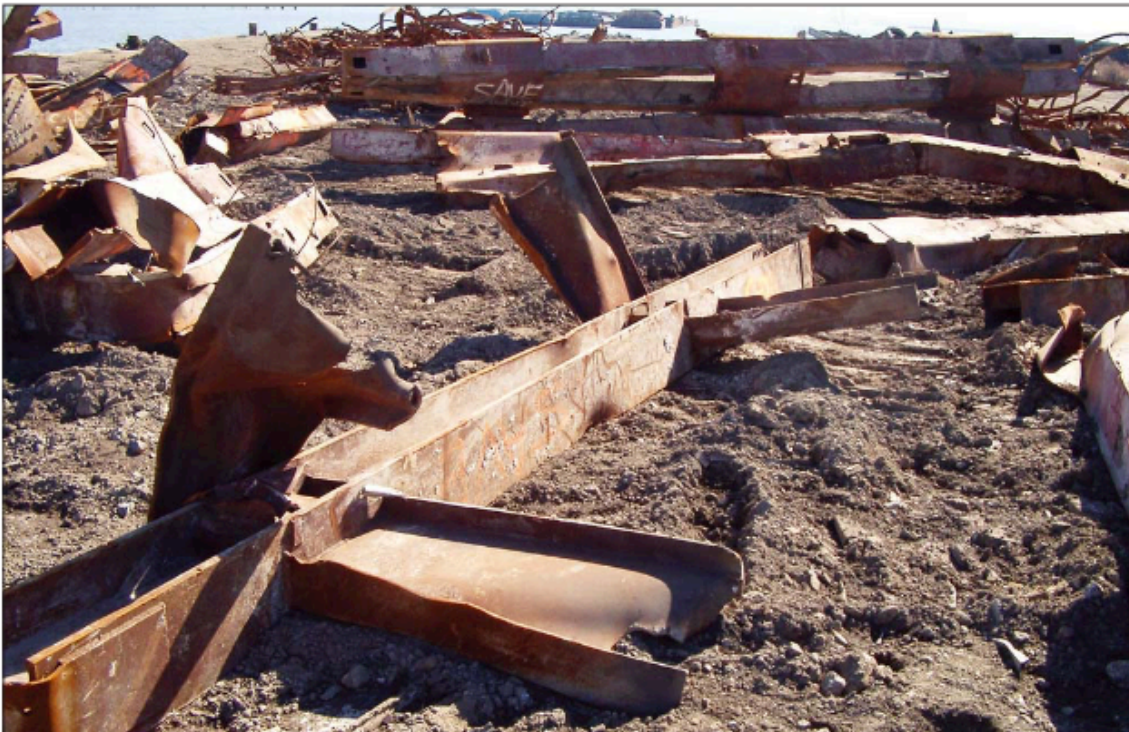
*Figure D-14 WTC 7 W14 column tree with beams attached to two floors.*

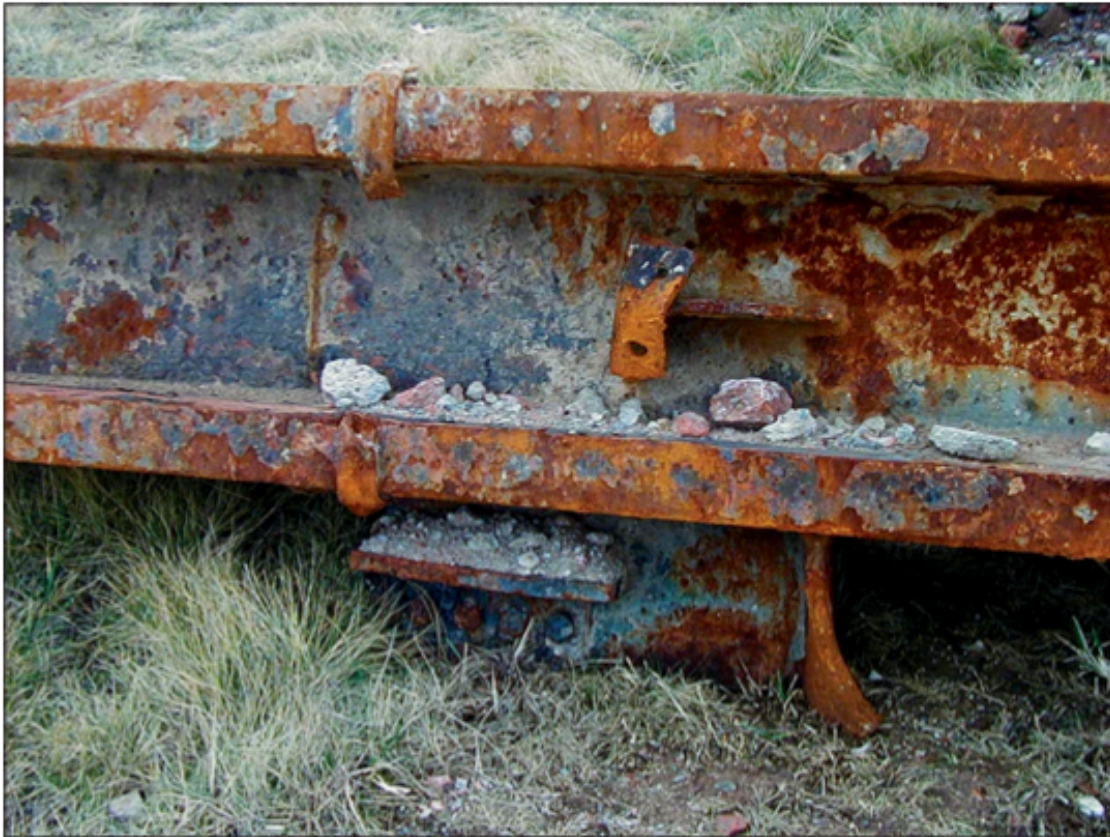
Figure D-17 Seat connection in fire-damaged W14 column from WTC 7.
