Large Plane Impact Damage to the Wall of the Pentagon and Adjacent Objects

By David Chandler and Wayne Coste¹

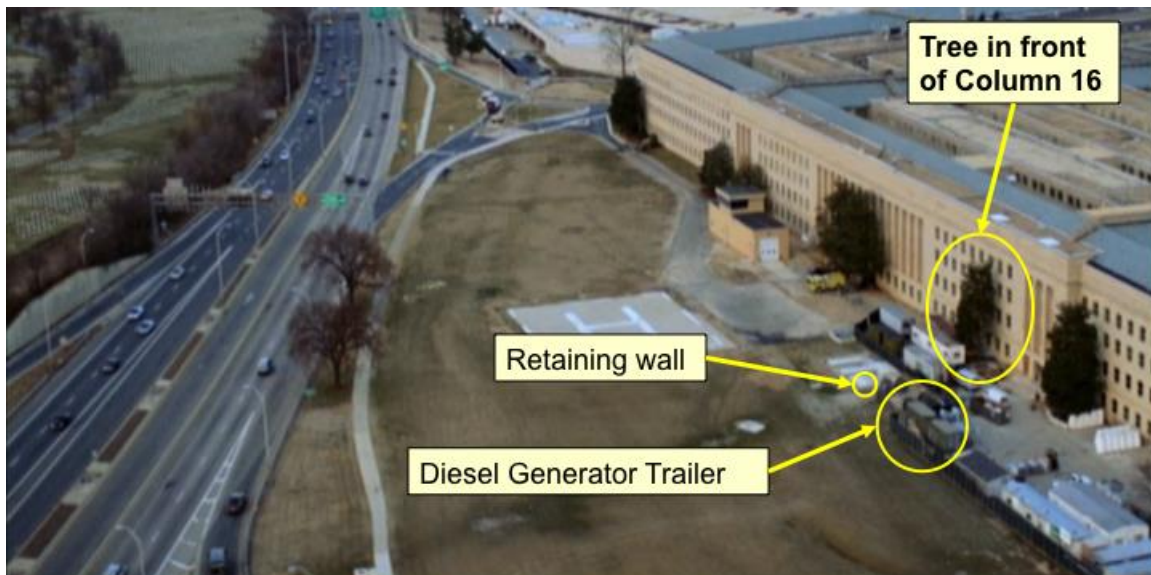
Figure 1: Pre 9/11 aerial photograph of the impact zone, highlighting: tree at Column 16, low concrete retaining wall, and generator trailer surrounded by chain link fencing. Some of the other equipment shown here was removed prior to 9/11.
