Controversy About the Uplifted Second-Floor Slab at the Pentagon: Identifying a Likely Source of Upward Mechanical Impact

By Wayne Coste

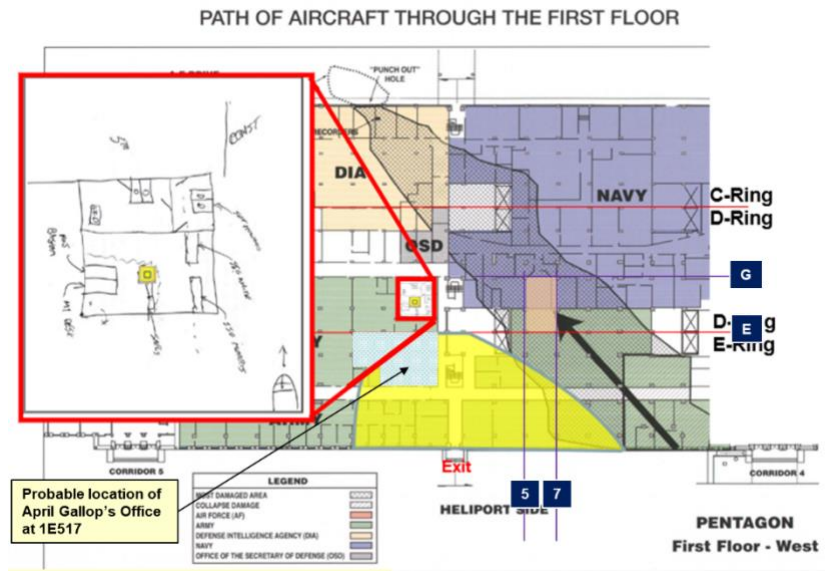
Major David King was in room 1D518 which is believed to be nearly adjacent to 1E517 where April Gallop was stationed at the time of impact. The location of King’s office is shown as a red square in both Figure 5 and Figure

6 and was near the area under the uplifted slab. A blast with enough force to snap and uplift a concrete slab would have been a very noticeable event to anyone in the vicinity. King did not recount an explosion⁴.

Figure 5: Best guess location of Maj David King in relation to the uplifted slab⁵ on the Floor Plan using the Arlington After Action Report⁶.

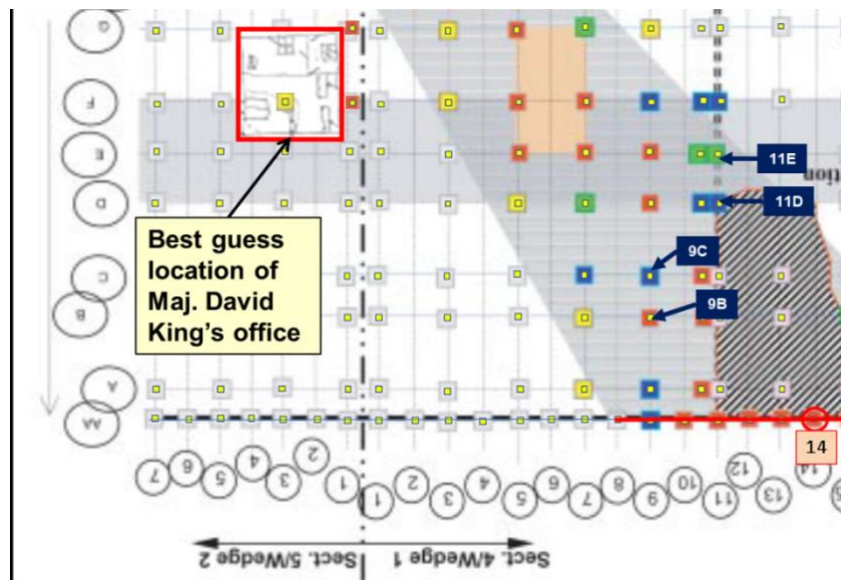
Figure 6: Best guess location of Maj David King's office using the ASCE Building Performance Report⁷.

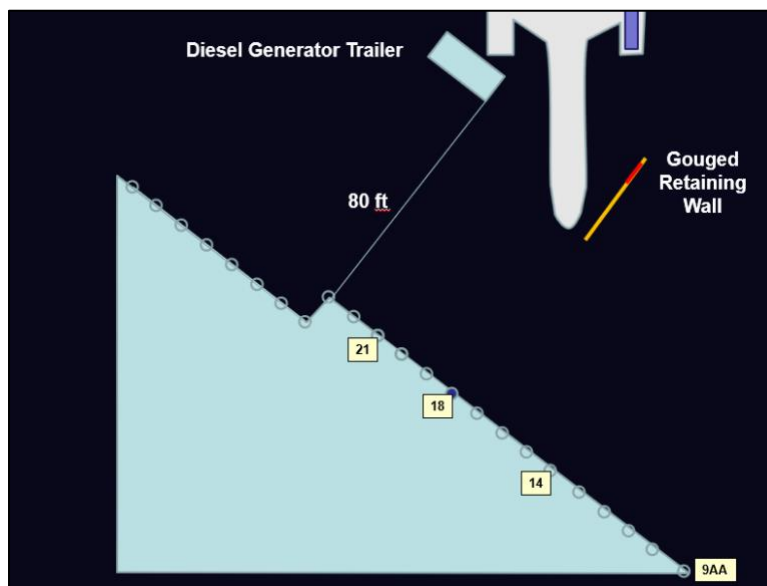
Figure 9 shows an approaching plane with the dimension of a Boeing 757 as well as the diesel generator trailer and the gouged retaining wall.

Figure 9: Right engine of plane impacts diesel generator trailer to begin yaw rotation. Left engine and gouged retaining wall highlighted.

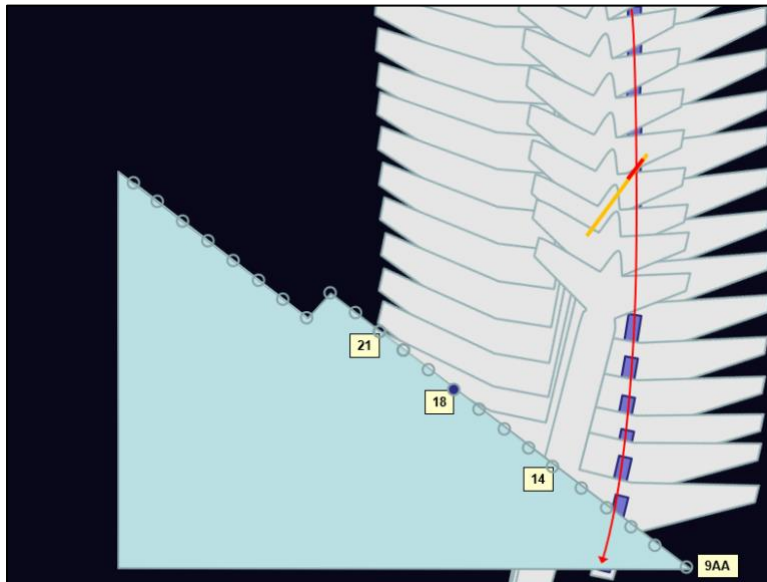
Once the right engine impacts the diesel generator trailer, the plane began a yaw rotation (around its z-axis). The sequential forward motion of the left engine is shown as a series of discrete steps in Figure 10. A red line

traces the location of the left engine through the retaining wall and into the building at an angle of about 56 degrees instead of 52 degrees for the plane's center of mass.

Figure 10: Trajectory of the impacting plane with yaw rotation. Angle of left engine impact is changed significantly.
