## Identification of the plane model that impacted the Pentagon

By Mehmet Inan

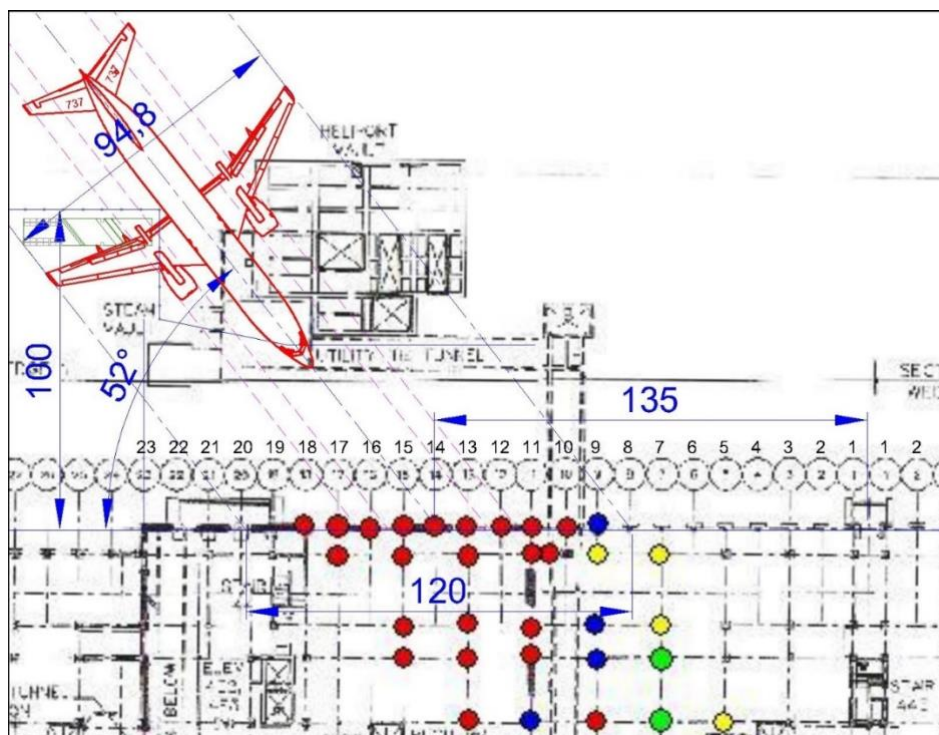
Figure 11: Scaled 2D model of the impact to the Pentagon.

Figures 11 and 12 show scaled 2D and 3D models of the impact using a 737-400. Everything fits perfectly with this aircraft model.

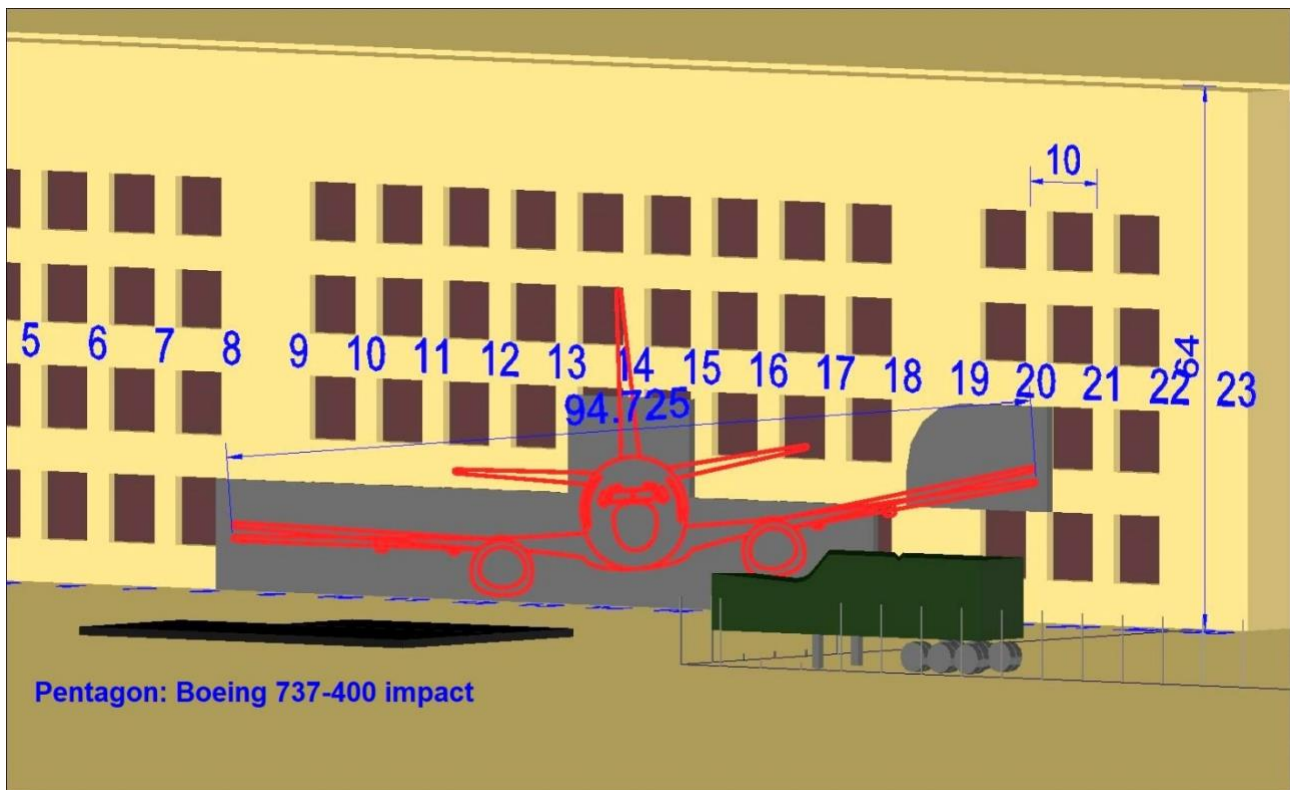
Figure 12: Scaled 3D model of the impact to the Pentagon.

It's important to notice that in the 3D models used in figure 12, 14 and 15, the plane is at about 100ft from the façade, the image is flat (not perspective), and the smallest direction change of about 0.5 degrees moves everything in the image. In other words, the Figure 12 is a very precise 3D model of the impact.

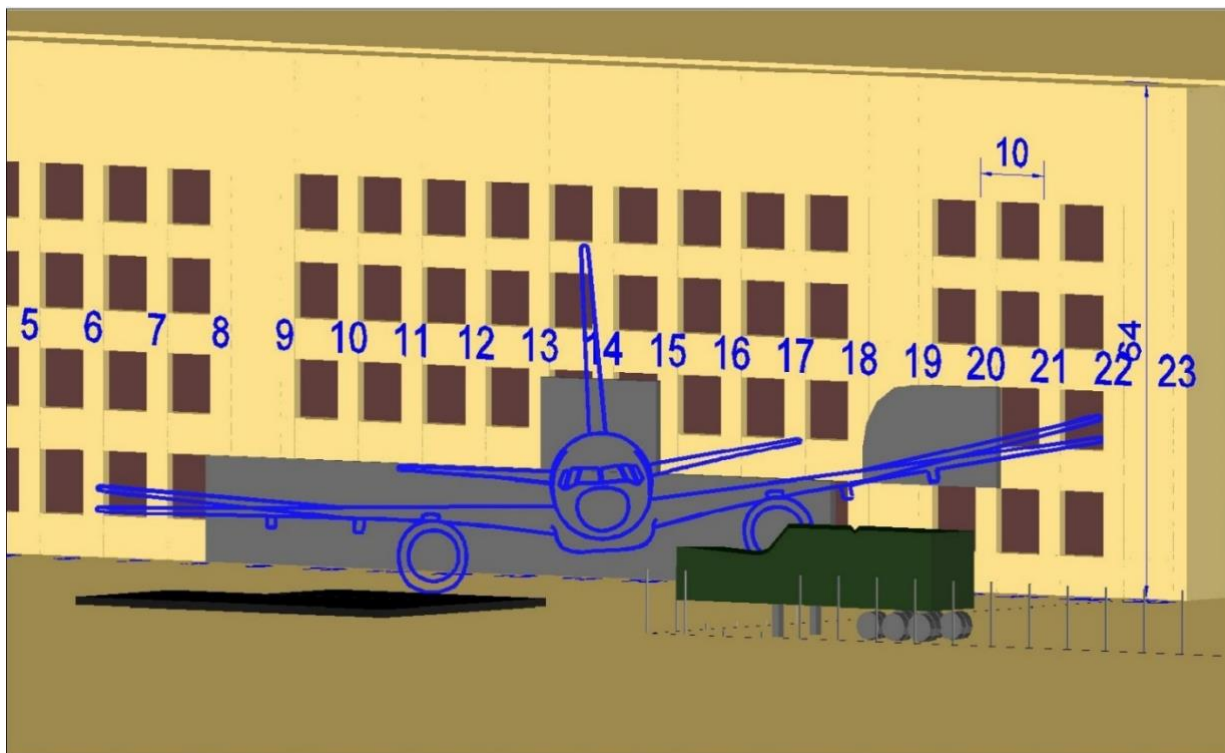
Figure 14: Scaled 3D modelling attempt of a B757 impact aligned to the entry hole.

Figures 14 and 15 are 3D models of the impact of 757-200 on the damages of the facade. If the generator is aligned, the hole is not and vice versa. Wings always exceed the damage. Always the left engine touches the ground but there is no single trace of such impact on the ground.

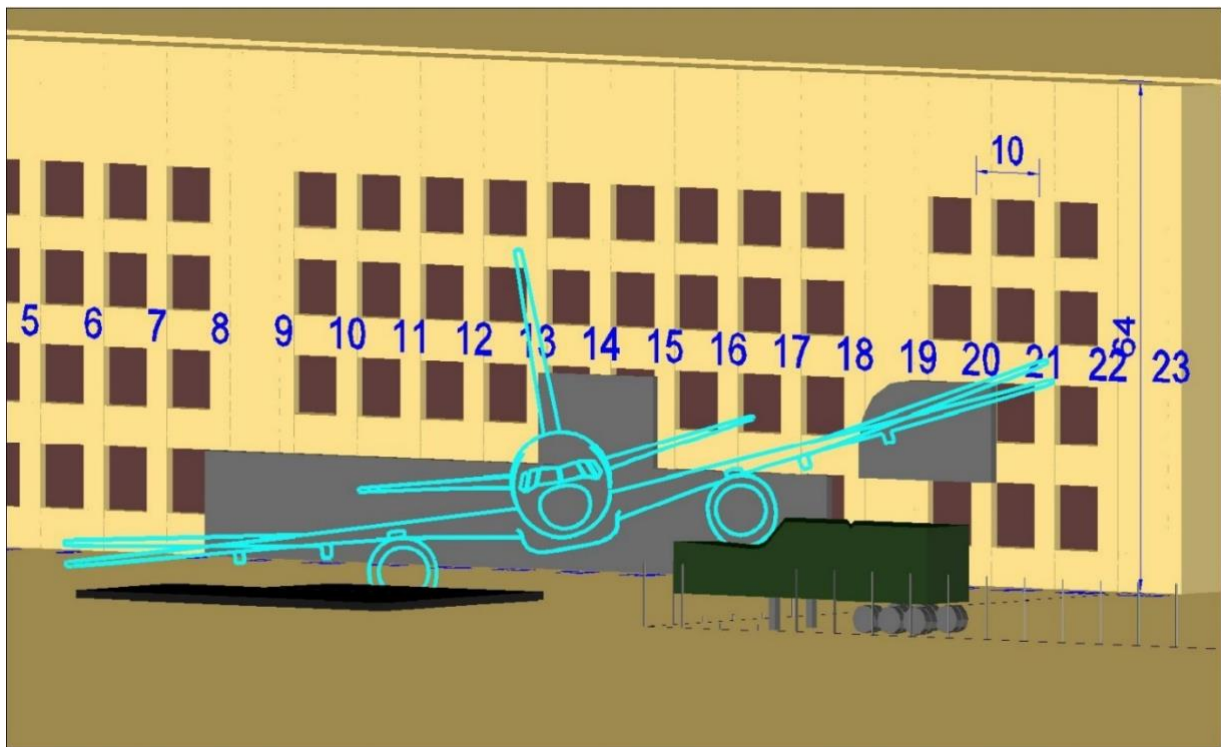
Figure 15: Scaled 3D modelling attempt of B757 impact aligned engines impacts.

In addition, the level difference between the wall and the damage to the generator requires an excessive oblique angle of the plane. Figure 15 shows this impossible position of the aircraft. In this case, the right wing is placed too high above the damage on the façade, and the left wing too low. To avoid having to explain this fact, 3D model included in the page 35 of ASCE report does not represent the generator. Also, this image could be at least 2 times larger to have better visibility.

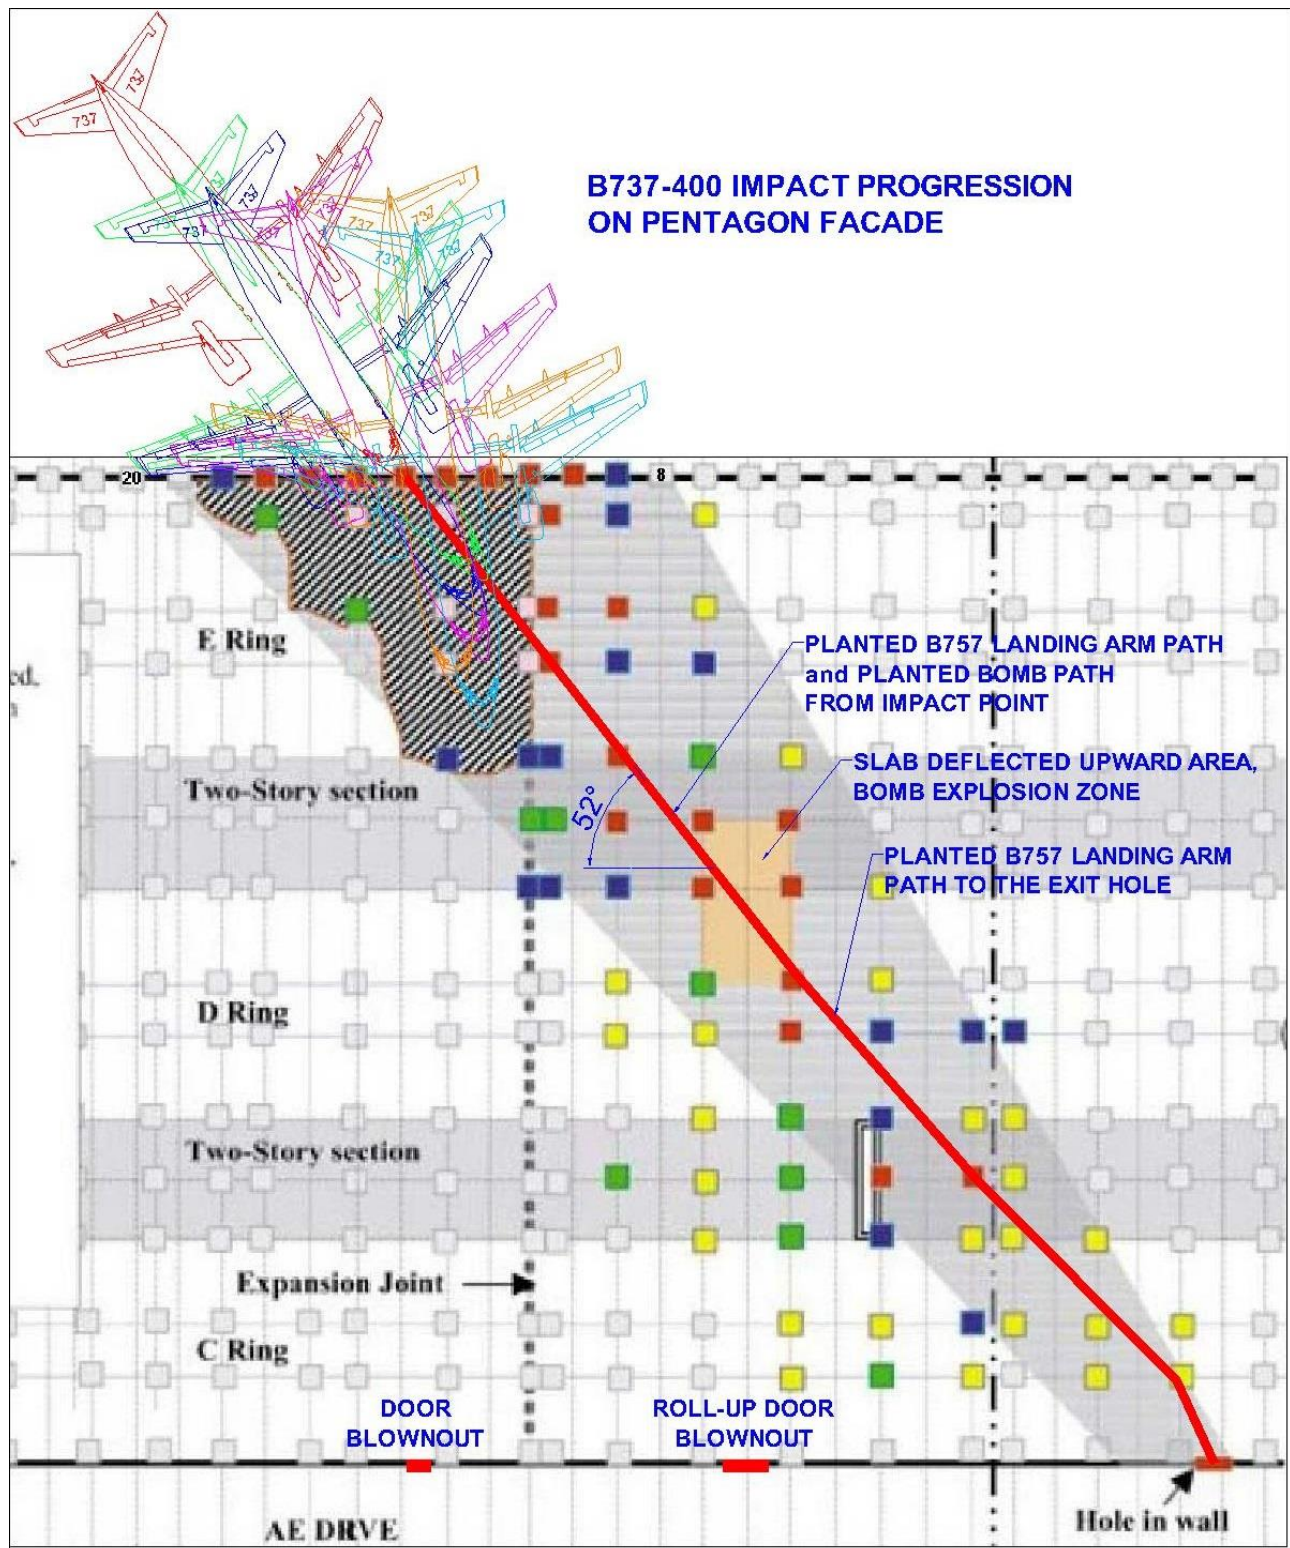
Figure 17: Progression of the impact with a 737-400.

- From the impact of the extremity of the right wing to column 20 of the façade, the aircraft started to rotate, slowing the right side and speeding the left side. This rotation reduced damages on the right side, and increased damages on the left side. Biggest difference is visible when comparing the damages of columns 18, 19 with columns 9, 10. Damage to columns 18 and 19 on the right side are much smaller than those in columns 9 and 10 on the left side, although the second-floor slab situated at impact level on column 18 also reduced the damage on this column. Figure 17 shows the progression of the impact.

In ASCE report “Figure 7.9 Path of ejected fuel in the first story”, see Figure 16, an orange area is drawn between columns E5 and G7. Figure 17 is made on basis of this figure 7.9 of ASCE report. The orange area is identified as “Slab deflected upward”.
