Reply to “Rebuttal to ‘Large Plane Impact Damage to the Wall of the Pentagon and Adjacent Objects’ ”

By David Chandler and Wayne Coste

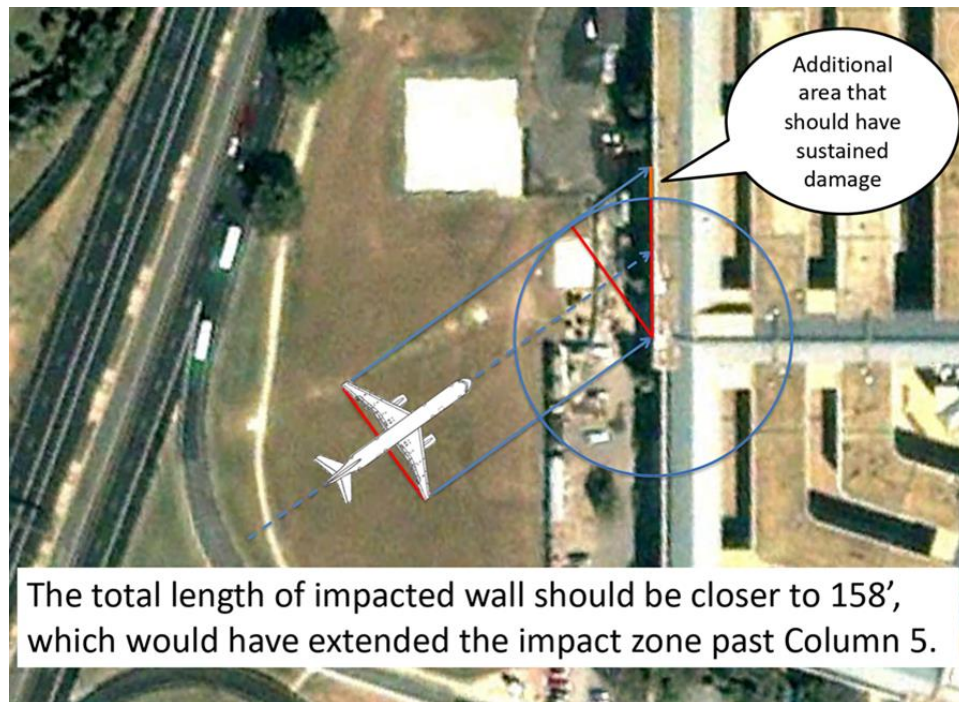
As shown in Figure 11, Arena just continues the initial trajectory of the wingtips of the incoming plane until these lines intersect the Pentagon wall. From his analysis he asserts that the left wingtip of a plane the size of a 757 approaching at a 52° angle would cause damage all the way to Column 5 instead of the observed damage which ends at Column 8 on the first floor. Note that in Arena's image, the left wingtip is the last part of the plane to encounter the wall. Key aspects of Arena's rebuttal are based on the expectation that the right wing and fuselage would pass through the Pentagon wall as though it were passing through a cloud without resistance. In his framework, the left wing would then continue in its initial direction of motion all the way to Column 5.

Figure 11: Repeat of Figure XA-9 showing outline of unimpeded initial trajectory.

However, forces encountered by the plane early in the impact sequence are transmitted to, and affect the motion of other structurally connected parts of the plane. Whereas the right wing, which is oriented nearly parallel to the wall, “slaps” the wall between Columns 18 and 20 in a nearly simultaneous action, the left wing, which is angled well away from the wall, impacts Columns 13 through 9 sequentially, with each impact deforming the wing and slowing the plane's motion. Columns 13 to 10 are destroyed, each consuming energy from the moving plane. However, Column 9AA is bowed and stripped, but not broken, indicating a significant impact from the outer third of the left wing, but which had insufficient kinetic energy to destroy the column entirely. This sequence of events stopped the forward progress of the outer end of the left wing preventing it from proceeding to Column 5. The wing is not found on the ground at the base of Column 9AA, which indicates it was carried by momentum into the building around that column.

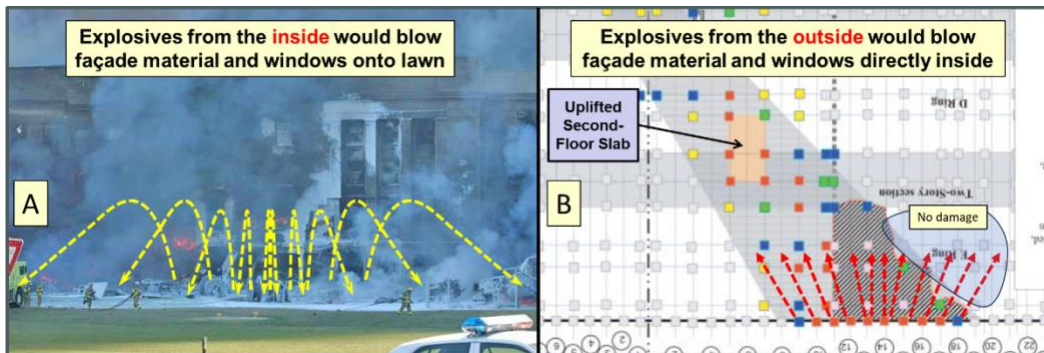
As shown in Figure 14, internally placed or detonated explosives would blow debris outward (left image) while externally planted explosives would blow material inward (right image). Arena provided no evidence supporting either internally placed explosives, externally placed explosives or any other mechanism associated with an explosive detonation.

Figure 14: Internally placed explosives would blow outward (left) while externally planted explosives would blow material inward to the right and left (right) which is inconsistent with the observed damage path toward the “C-Ring Exit Hole.”

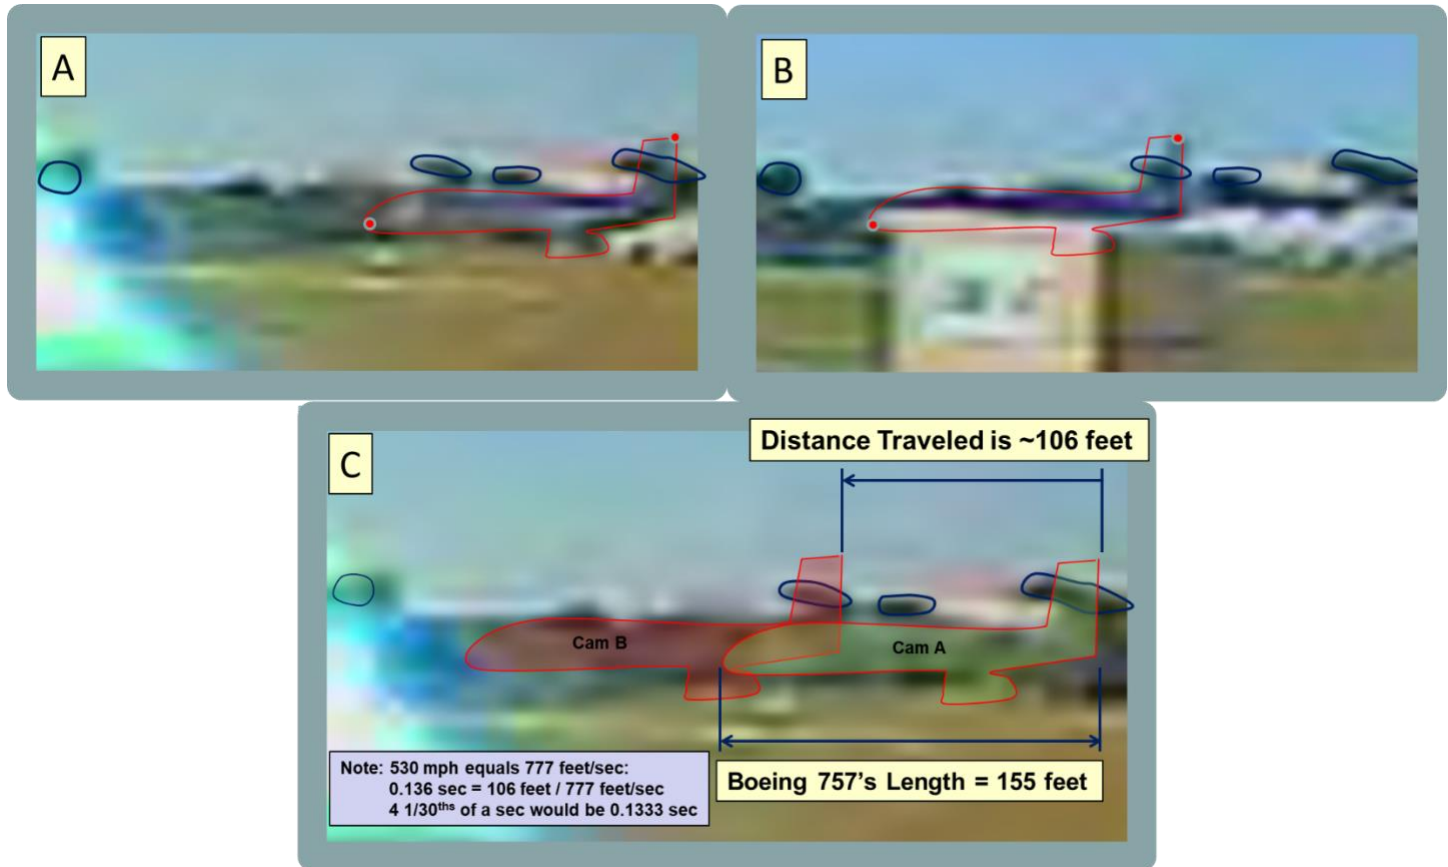
Arena asserts, based on imprecise comments from a small subset of witnesses, that the plane was banking to the left as it approached the Pentagon. There is no evidence for such banking near the Pentagon. The plane was very close to the ground where banking is nearly impossible due to ground-effect which increases uplift on a lower wing relative to the higher wing. Additionally, both security gate cameras show the plane traversing the lawn in a level orientation¹¹. Figure 16 shows a superposition of images from both security gate cameras.

The observed physical damage is consistent with a level approach.

Figure 16: Both security gate camera's show a plane with the dimensional proportions of a Boeing 757 flying level to the ground. Camera A shown in top left, Camera B shown in top right and the composite in the lower image.
