Rebuttal to Identification of The Plane Model That Impacted the Pentagon

Appendix B: Trajectory during the last quarter second
of a Boeing 757 Impact into the Pentagon

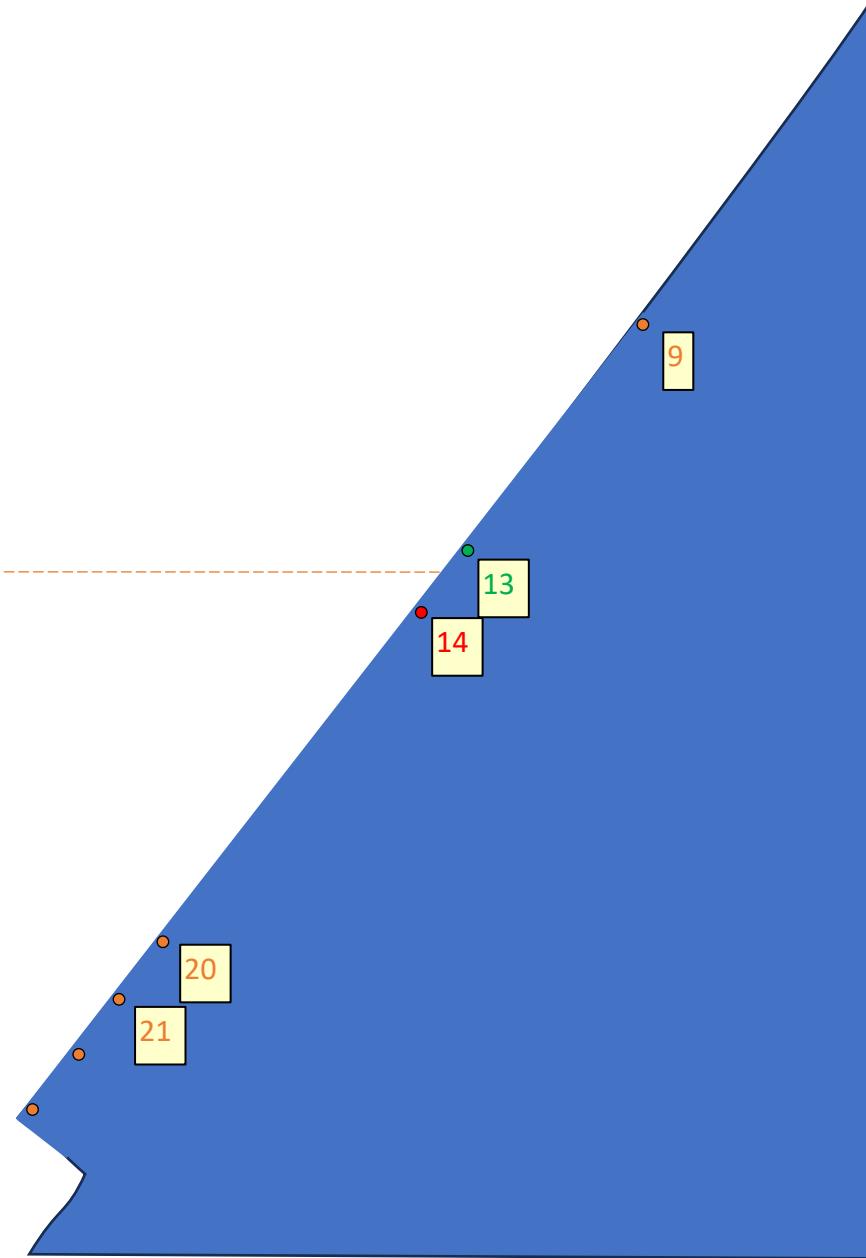
Boeing 757
at about
 $t=0.000$ sec

Just before impact.

The circle shown at the center of the plane is the assumed center of mass for rotation.

NOTE: The movement of wire spools #4 and #7 are estimated based on the assumed impact dynamics and the final resting locations seen in the Scott Boatright photo.

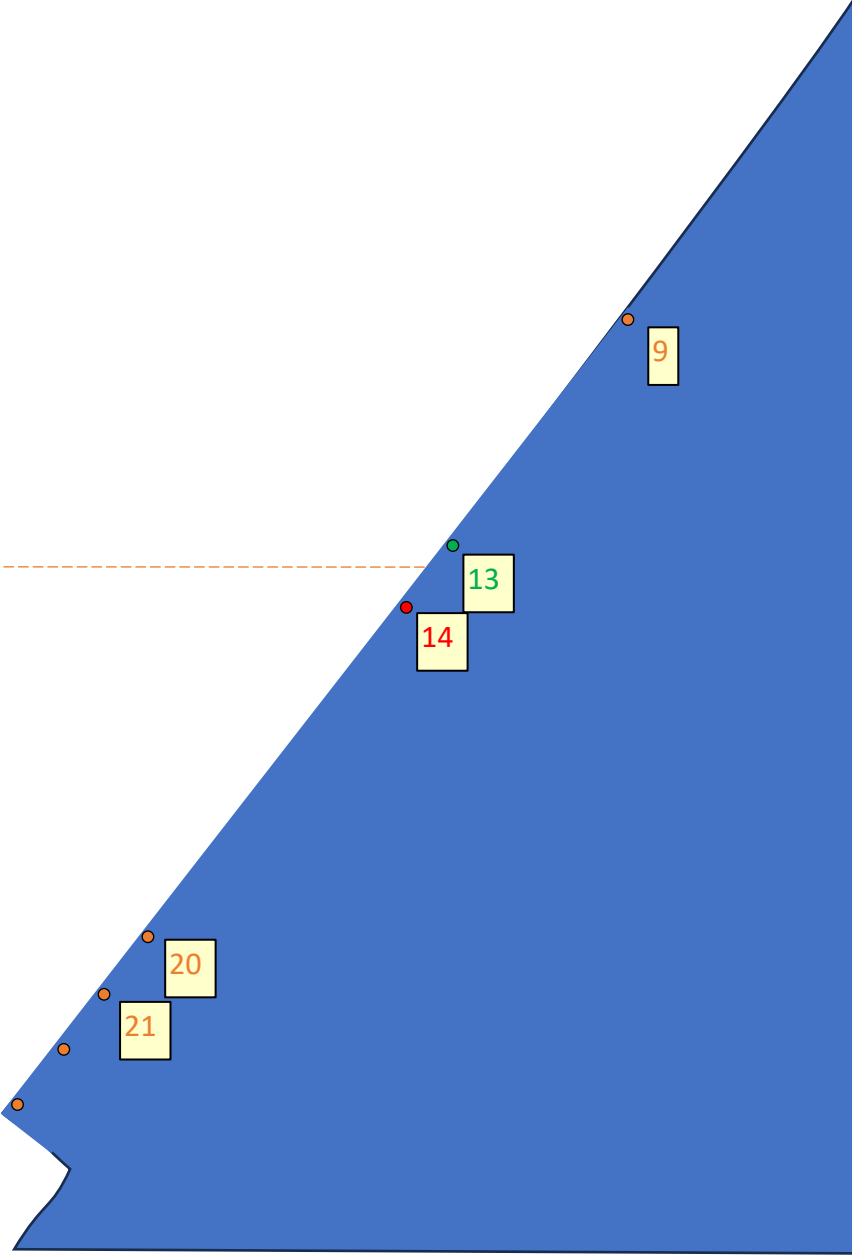
Boeing 757
at about
 $t=0.017$ sec

The impact begins.

Engine impacts at the
'bullseye' where the corrugated cabin
siding is hammered smooth.

The trailer's cabin is destroyed.

Both the aircraft and trailer begin rotating.
