**Rebuttal to ‘Identification of The Plane Model That Impacted the Pentagon’**

Wayne Coste, PE

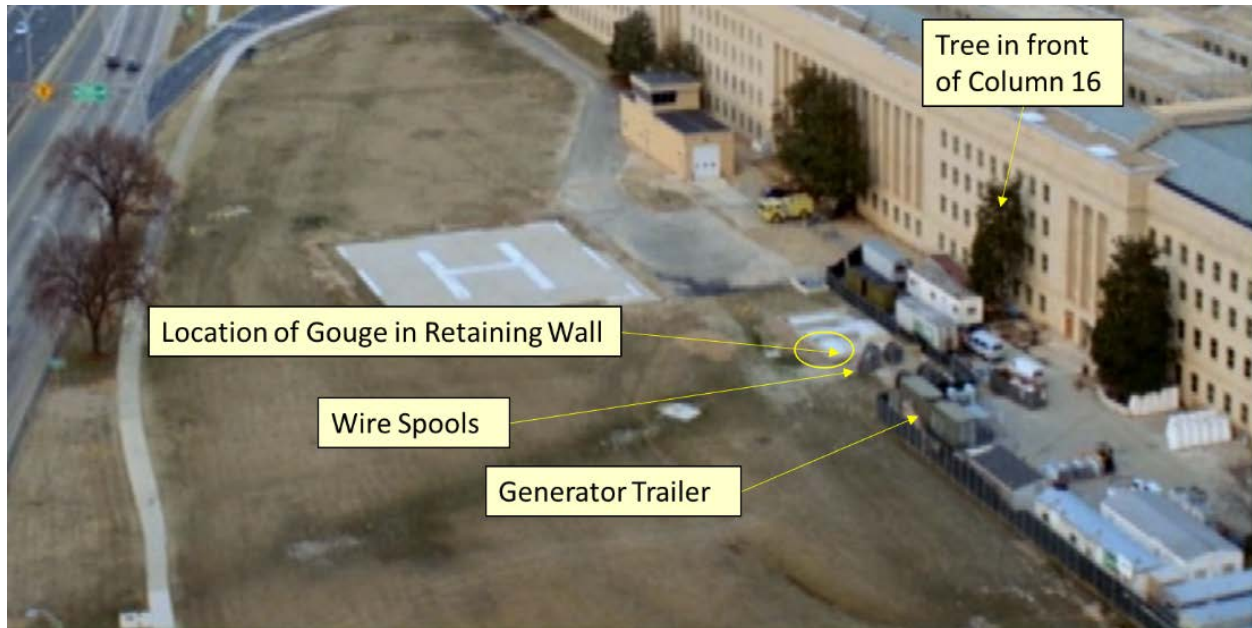
Figure 5 provides an overview of the west side of the Pentagon before 9/11 [3]. This image shows the location of the generator trailer, other adjacent structures, the wire spools, the gouged retaining wall, and the Pentagon facade. While soot can be seen discoloring the center of the trailer roof, there is no hint of the Flap Track Fairing trace in this pre-event image which shows only a smooth rear cabin roof. Additionally, the cabin roof at the front of the trailer has a uniform color that matches the uniform color of the rear. This suggests a satellite image would record the roof as a single color, except for the discolored center.

Figure 5: Overview of the west side of the Pentagon.

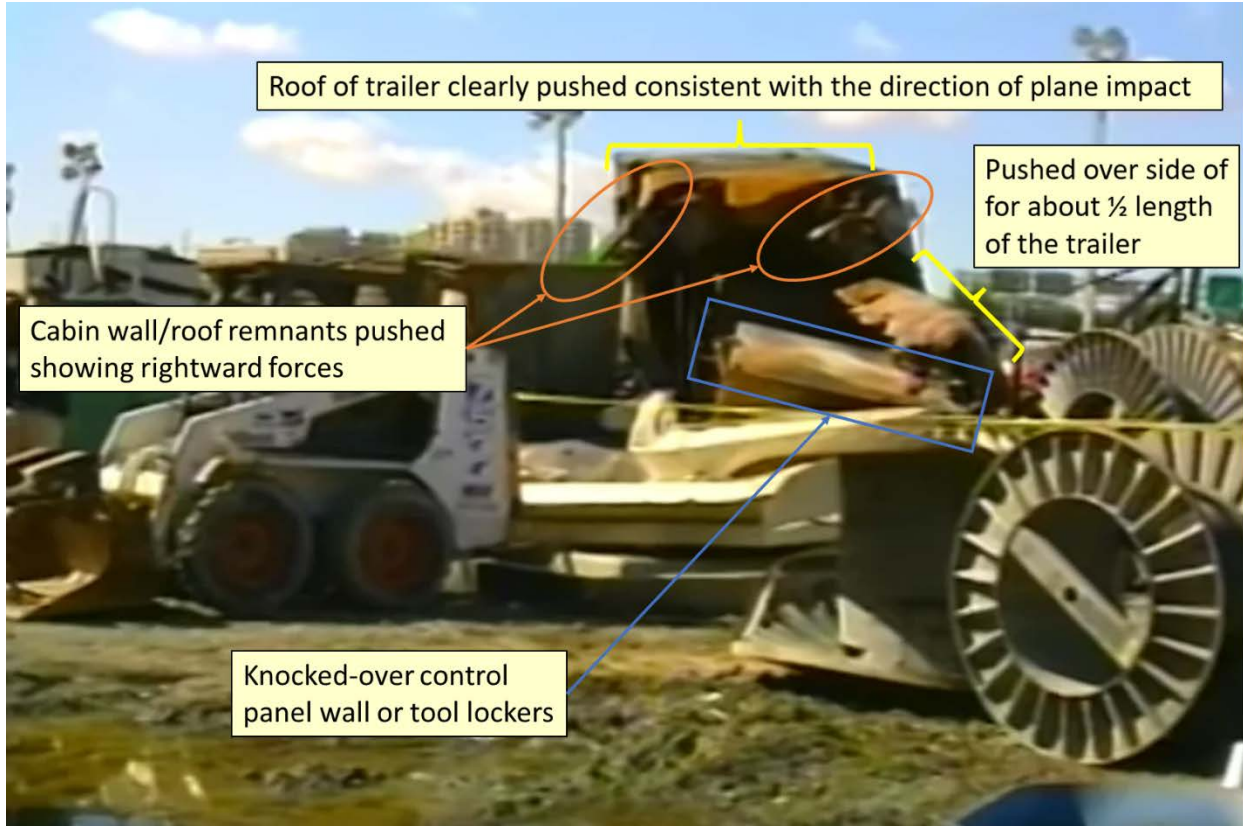
Figure 9 shows the interior of the front portion of the cabin from the front. The interior space shows what appears to be a large rectangular object that appears to have been a control panel, tool lockers or some other wall-mounted unit. The heavy diesel generator equipment would have been mostly over the multi-axle rear wheels giving a center of mass near the rear.

Figure 9: Interior view of the generator trailer from the front.

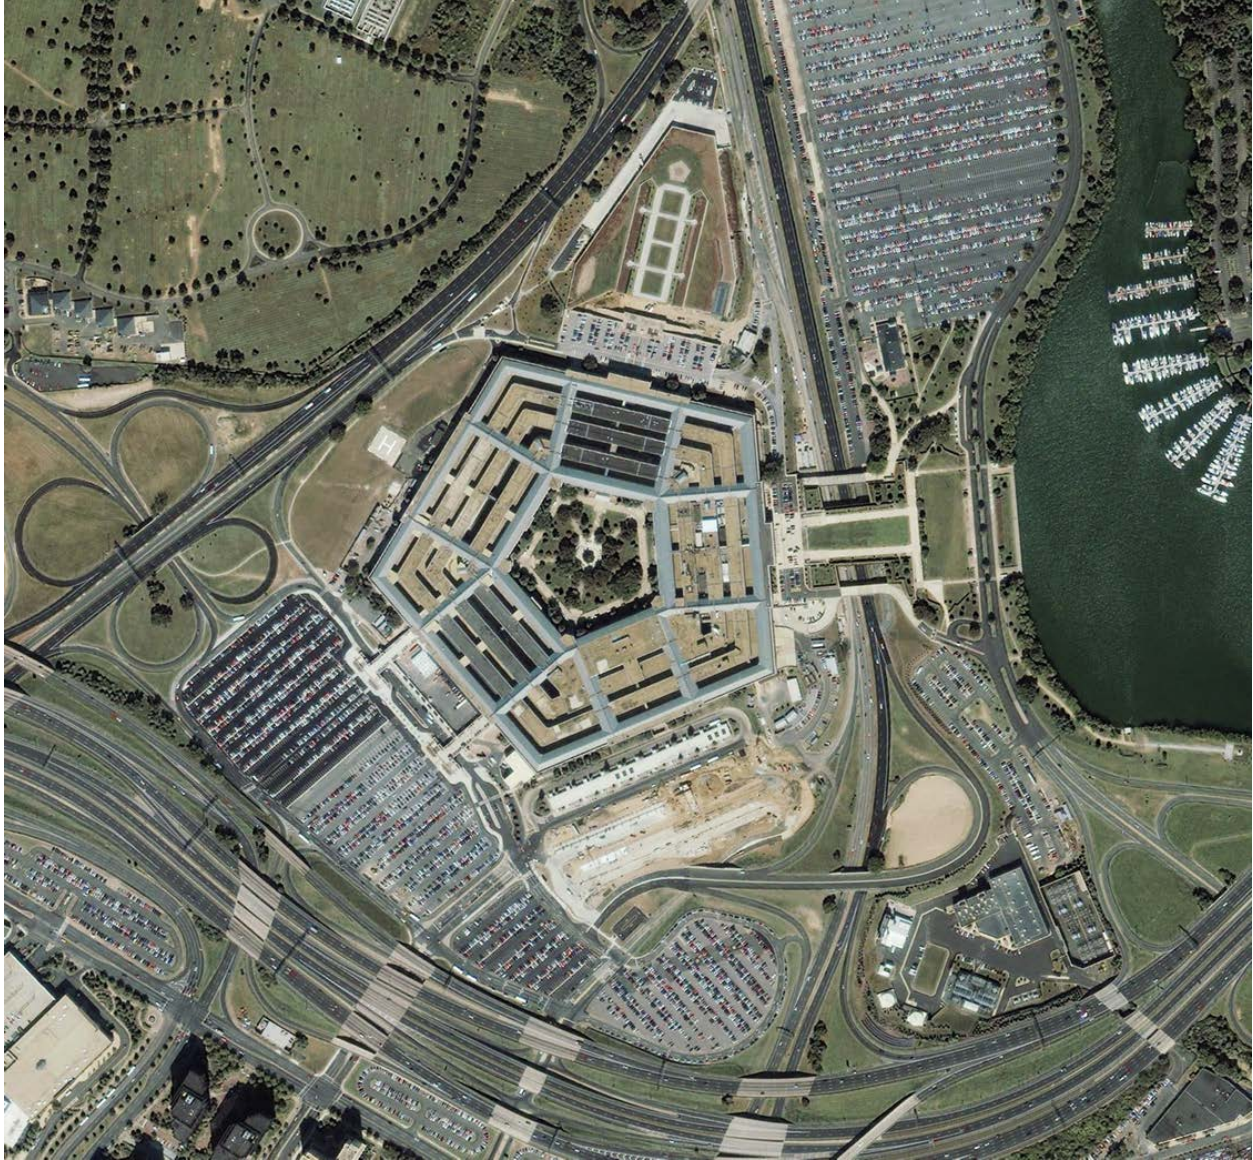
Figure 10 is a satellite image of the Pentagon from September 7, 2001 and will be used to establish all relevant dimensions. Using this single image eliminates problems with parallax and other distortions affecting measurements. It is believed that a resolution of about one foot ( $\pm 1$  foot) is reasonable when working with this image. This resolution is more than adequate for the analysis presented in this paper. Because of the very slight position of the satellite to the east, the edge of the visible roofline on the west represents a nearly perfect location of the column rows. The satellite's eastern location can be verified by the visibility of the "whiteish" wall on the west side of the interior courtyard and shadows cast around the heliport firehouse.

Figure 10: Satellite Image of the Pentagon from September 7, 2001 (the western direction is up and to the left). Source: [https://web.archive.org/web/20050212002810/http://www.spaceimaging.com/gallery/9-11/Pentagon/Pentagon\\_9\\_7\\_01.jpg](https://web.archive.org/web/20050212002810/http://www.spaceimaging.com/gallery/9-11/Pentagon/Pentagon_9_7_01.jpg)

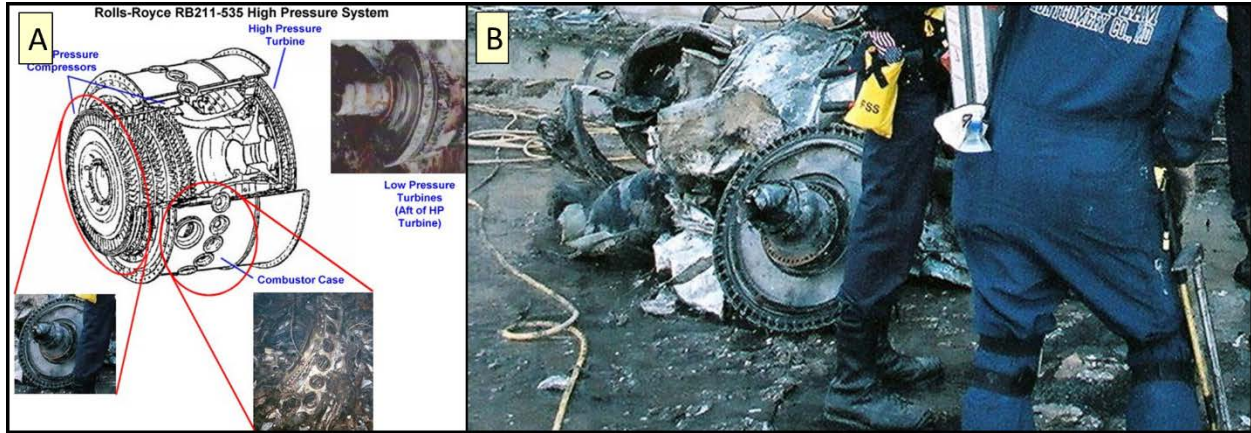
However, in his short list of explicit aircraft parts, he excludes a plethora of other parts that were photographed in and around the Pentagon. For example, many discussions about the aircraft debris show parts of a Rolls Royce RB-211-535 engine which is the type that powered American Airlines flight 77. The Boeing 737-400 uses the CFM International CFM56 engine for which no discussion of debris from this class of engine can be found in the literature about the Pentagon. Figure 21 shows some of the parts of the RB-211-535 engine.

Figure 21: Engine parts consistent with RB-211-535.

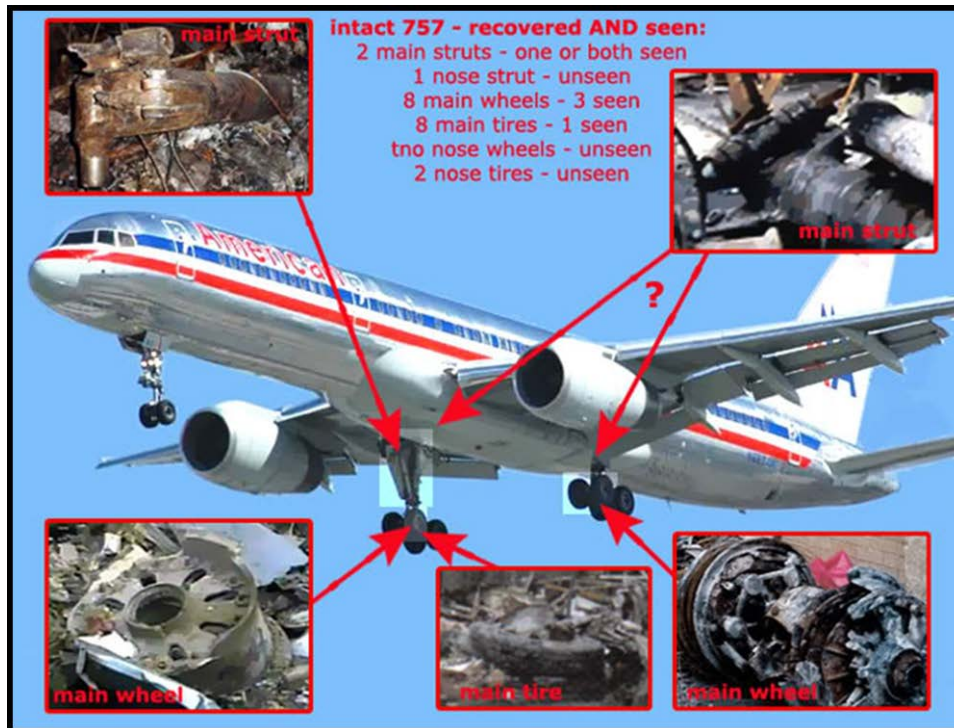
Figure 22 is an infographic showing some Boeing 757 parts that were observed in the debris. Figure 23 shows the unique rims that were used by the Boeing 757 and photographed outside the C-Ring exit hole immediately afterwards. Figure 24 shows the wheelsets of a Boeing 737-400. Boeing 737s do not have doors covering the main landing gear doors during flight. The wheels become flush with the fuselage when retracted and, consequently, they have streamlined covers on one side of the wheelset. To lighten the wheels of aircraft, the interiors are not solid but have cut-outs of various sizes to create “spokes.” The inner wheel rims of the 737 have cut-aways that are more wedge-shaped than the 757 which are smaller and more tear-shaped.

Figure 22: Infographic showing some of the Boeing 757 debris.

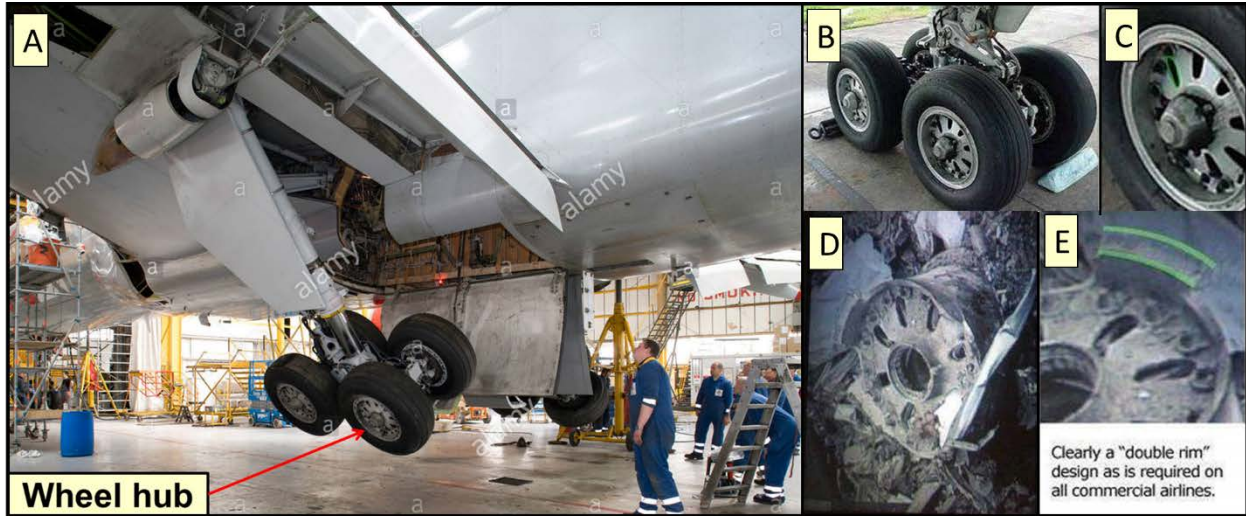
Figure 23: Wheel rims of a Boeing 757 showing tear-shaped cut-outs.

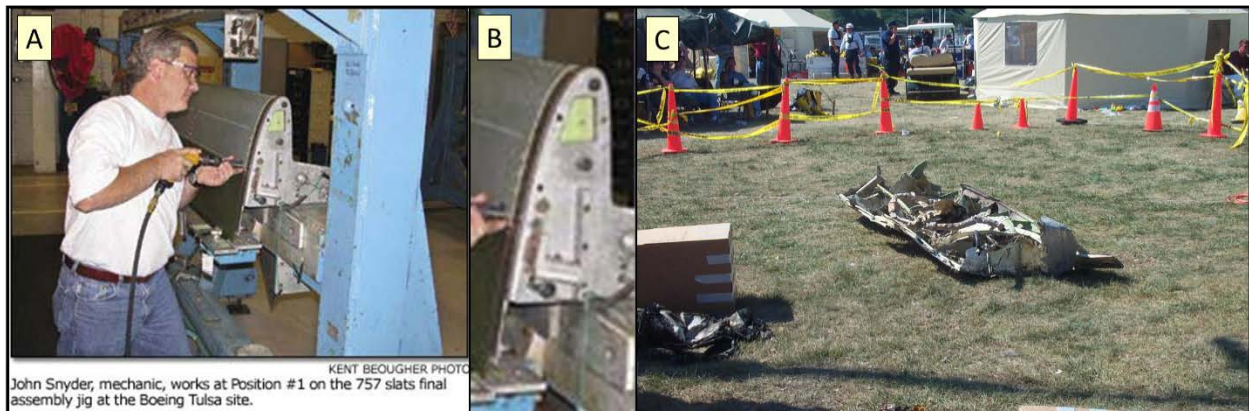
Finally, Figure 25 shows a leading wing slat for a Boeing 757 that was recovered and is compared to a similar slat in a machine shop. More documentation about 757 debris can be seen at [911Speakout.org](http://911Speakout.org) [9].

Figure 25: Leading wing slat of a Boeing 757.

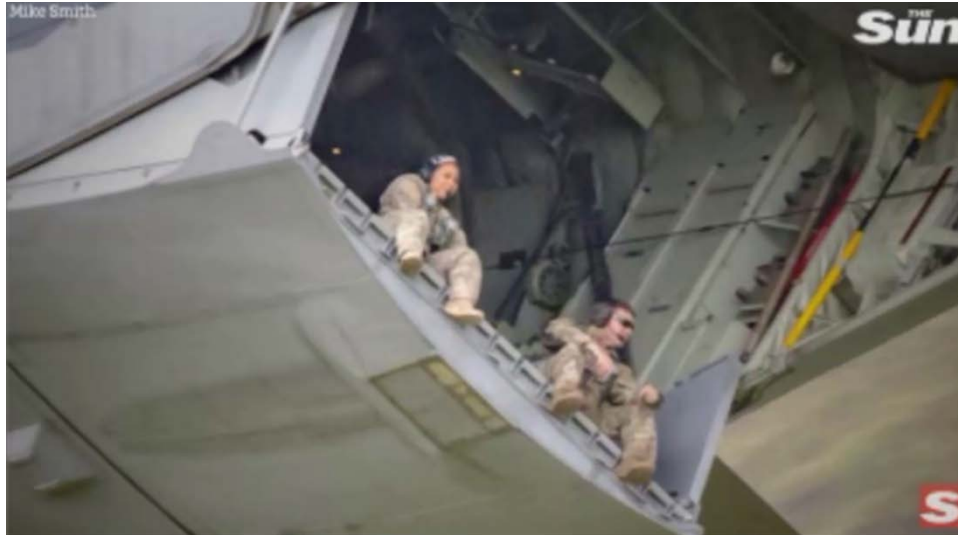
Regarding Inan’s comment about the devastation of over-pressurization “destroying the roll-up door in ring C and windows between columns 4 and 8 in ring E,” it is clear in this comment Inan neglects the phenomena of a trailing air mass behind an aircraft. The reality of a trailing air mass is observed in Figure 27. This image is from a video of a C-130 which shows crew members sitting in an area where the winds from the trailing air mass are approximately equal to the forward speed of the aircraft.

Figure 27: Trailing air mass has a velocity approximately equal to the plane's forward velocity.

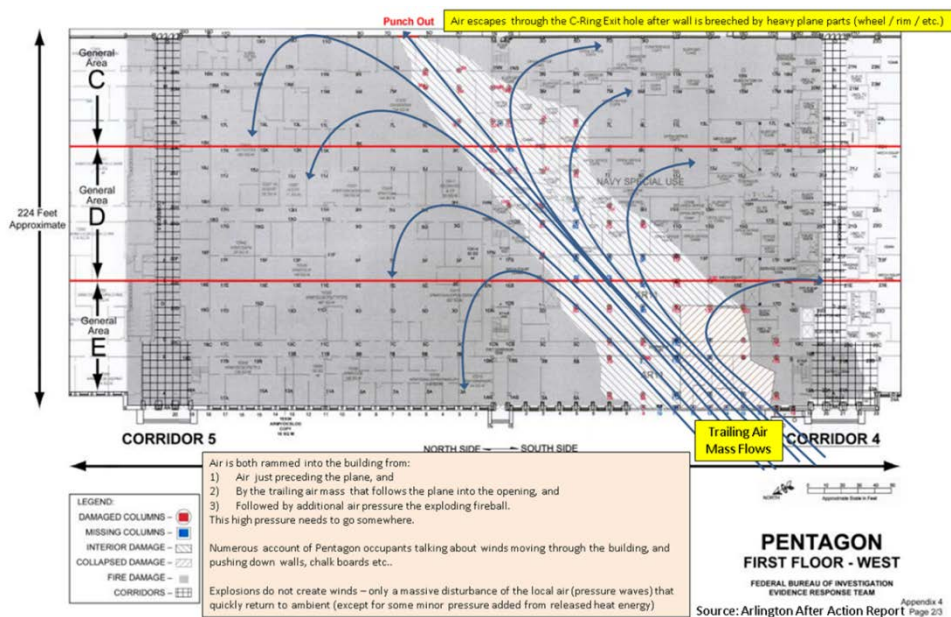
A trailing air mass would have attempted to follow the aircraft into the Pentagon. However, the trailing air mass would “pile-up” and create an over pressurization inside the Pentagon as well as near the façade that would deflect the trailing air mass to the north-west while simultaneously creating a very high pressure inside the Pentagon. The sudden insertion of an air volume equal to the volume of a 757-200 would, by itself, create a significant increase in air pressure that would be observable as winds inside the Pentagon capable of slamming doors and even puffing out a large surface-area garage door. The trailing air mass would amplify and sustain this effect for a short transitory period. Figure 28 shows how this would look from an air pressure perspective. This was explained in the video, “Peer Review of Barbara Honegger's Parallels Between the WTC and Pentagon Evidence and Why It Matters[11].”

Figure 28: Sudden insertion of a large volume followed by a trailing air mass will create the observed winds [11].
