Pentagon Approach Path of a Boeing 757 on 9/11/2001

By David Chandler

This paper presents evidence of a large plane, consistent with a Boeing 757, flying into the Pentagon on 9/11/2001, making contact with a number of obstacles along the approach path. This is a follow-up to the earlier paper in the IC911 Debated Topics Forum, “Large Plane Impact Damage to the Wall of the Pentagon and Adjacent Objects” by David Chandler and Wayne Coste. That paper considered evidence for impact by a large plane, consistent with a 757, based on the impact damage to the generator trailer, chain link fence, low concrete retaining wall, the large tree in front of Column 16, and the face of the Pentagon itself. As will be shown here, there is a substantial amount of corroborating physical evidence prior to the first contact of the plane with the generator trailer.

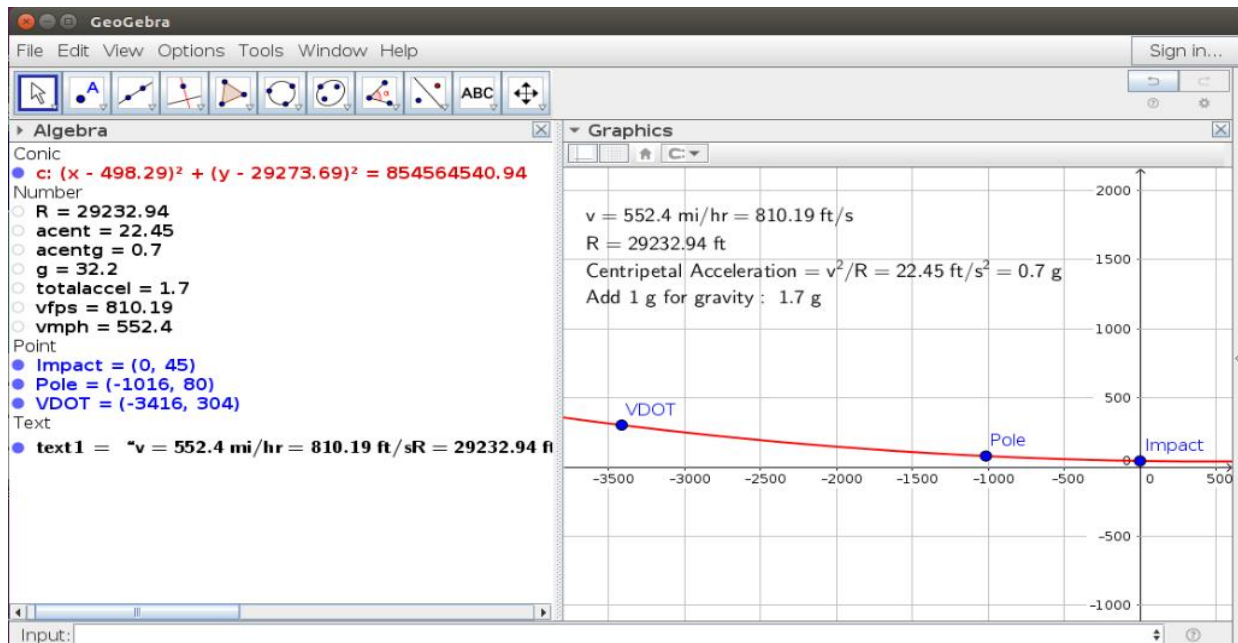
The Pentagon building lies in a depression. In order for an incoming plane to hit the building in level flight at ground level it would have to approach in a shallow dive, then pull up through some radius of curvature, with a concomitant upwardly directed centripetal force (experienced as a “g-force”). The corresponding g-force experienced by the plane and the passengers is a function of the speed of the plane and the radius of curvature of the pull-up maneuver. Pilots for 9/11 Truth (P4T) long featured a calculation on their website¹, asserting the impossibility of such a pull-up maneuver, claiming it would necessarily involve a g-force of 10.14 g’s, which would be far beyond the capabilities of a 757. This calculation was based on the unjustified assumption that the entire pull-up maneuver would have to be completed within the width of Hwy 27. Such a small radius of curvature would require an impossibly high centripetal acceleration. The P4T calculation assumes a straight-line approach to the first light pole on Hwy 27, followed by a rapid transition through a small arc to horizontal flight, followed by straight-line flight all the way across the lawn. There is no physical necessity for such a brief transition. In actuality there are multiple solutions for a pull-up maneuver that fit the evidence and hit the Pentagon wall horizontally without disturbing the lawn. The late Frank Legge pointed out this error in 2011. At the time I started working with Frank I made a similar but independent calculation with virtually identical results.² Our calculations show various feasible paths with g-loads as low as 1.6 g. The maximum upward acceleration measured by the FDR is 2.26 g, which is consistent with our calculations and well within the design limits of a Boeing 757. Our conclusion is that the high g objection is based on an unjustified assumption and is therefore irrelevant.

Figure 2 Graphical calculation of the g-force for a path from the top of the VDOT antenna, through the first light pole, avoiding the lawn, and striking the Pentagon first floor horizontally.

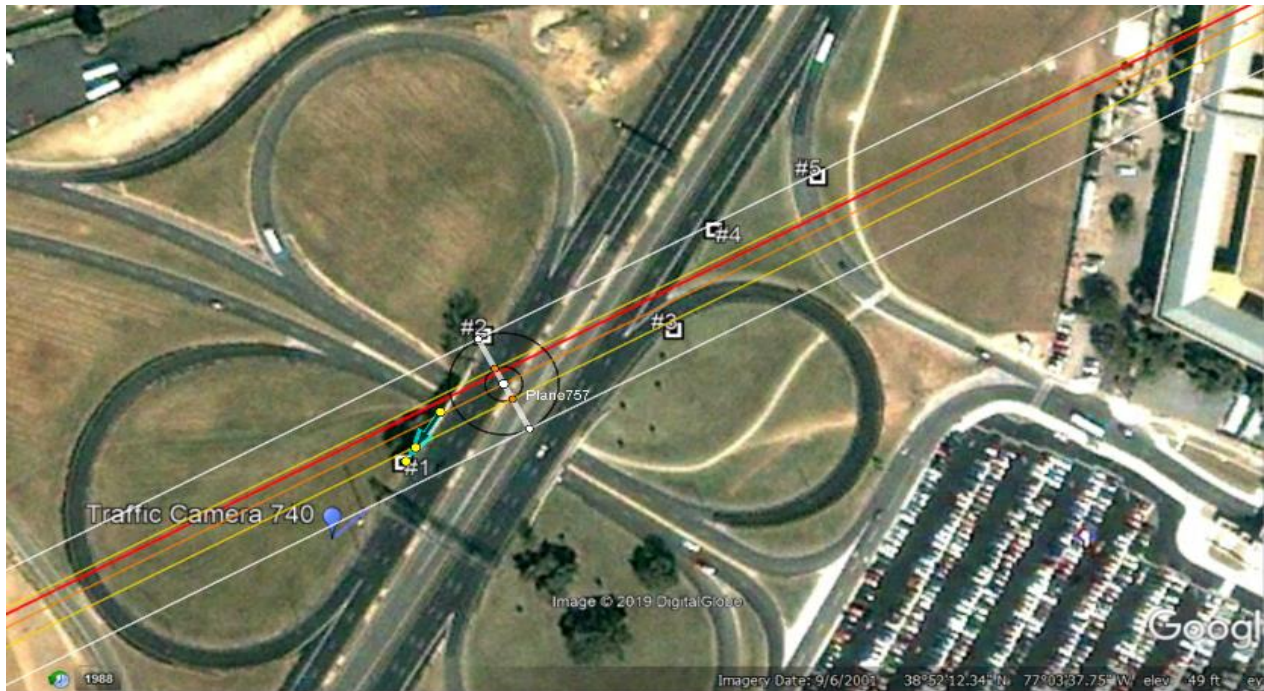
1. The location and direction of motion of the plane along the approach path,
2. The wingspan of the plane, and
3. Alignment with the radar path leading toward the Pentagon (Figure 4), the damage path inside the Pentagon (Figure 1), and the direction of motion indicated by the Flight Data Recorder (FDR), which was recovered in the Pentagon. (The FDR direction of motion is indicated by the red line in Figure 3. The FDR and radar data will be considered in detail in a separate paper.)

Figure 3 Precise location of the flight path through the light poles with the right engine (yellow line) impacting the front quarter of the generator trailer.

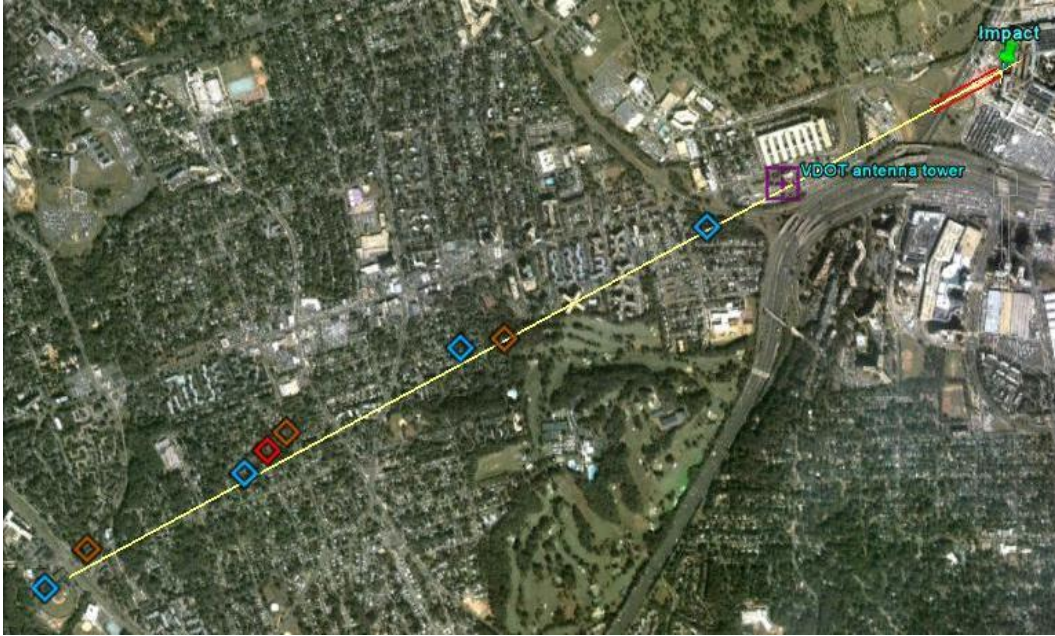
Figure 4 Extended backward, the path through the light poles is in alignment with the direction of motion indicated by the FDR (yellow line) and the radar path of the plane determined by several independent military and civilian radar stations (color coded boxes).

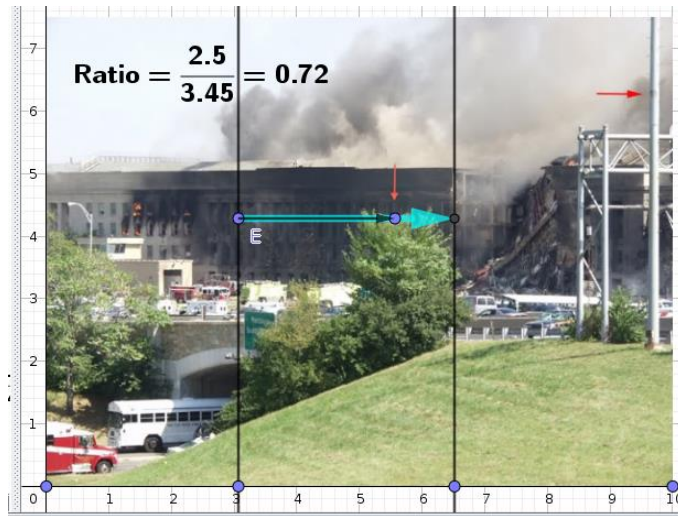
Near the camera pole and first light pole there is a tree at the top of the overpass with a circular notch with frayed ends scooped out as with a dull blade.

The notch in the top of the tree is not visible in the overhead view in Google Earth. I have therefore measured the location of the notch from a side view and transferred the proportions, indicated by the blue and black arrows in Figure 12 to the overhead view (Figure 13) to locate it more reliably.

Figure 12 Locating the notch in the tree, side view.

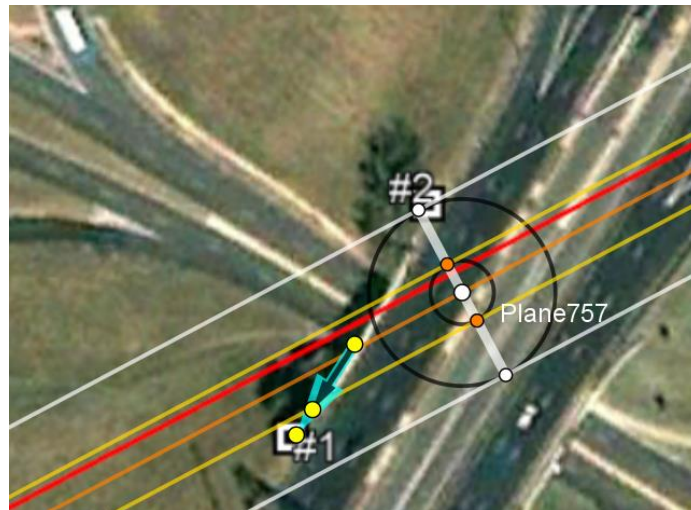
Figure 13 Locating the notch in the tree, Google Earth view.

Based on the dimensions of a 757 and precise location of the wingtips of the plane as it grazed the freeway camera pole and the second light pole, the position of the right engine can be identified with certainty as the cause of a semicircular gouge at the top of a tree on the overpass. The roundedness of the edge of the intake to the jet engine is not an issue. The front edge of the engine, moving at over 500 mi/hr, would act like a dull mower blade cutting through brush, leaving clipped and stripped whitish tipped branch ends along the notch outline.

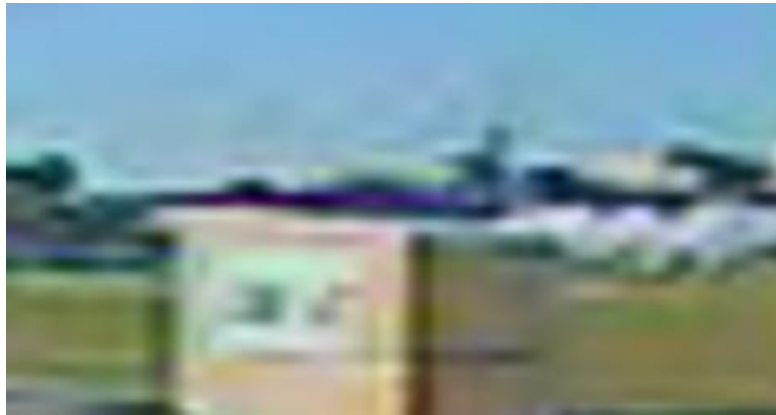
There were two security cameras located on the north side of the lawn set up to monitor cars entering the parking lot. They scanned adjacent lanes and both faced the same direction looking across the lawn nearly parallel with the west wall of the Pentagon. The two data streams were recorded onto the same recording device with a slight offset that Wayne Coste has measured to be 4/30 sec⁶. Five frames from one of the cameras were released (leaked?) in March, 2002. One of the frames purported to show the plane crossing the lawn, but the object in question was mostly hidden behind a post that contained the second security camera. Those five frames raised more questions than answers. The most notable feature was a turbulent white cloudy streak, which some (most notably Massimo Mazzucco in his film, *The New Pearl Harbor*, which appears to utilize 2006-era compressed and degraded YouTube video footage) interpreted to be the nose of the plane, but which upon closer inspection, is a smoke plume trailing the plane, as will be discussed below.

Figure 15 Plane crossing lawn obscured behind foreground post containing second camera. The diffuse whiteness is a smoke cloud being emitted from the far engine.

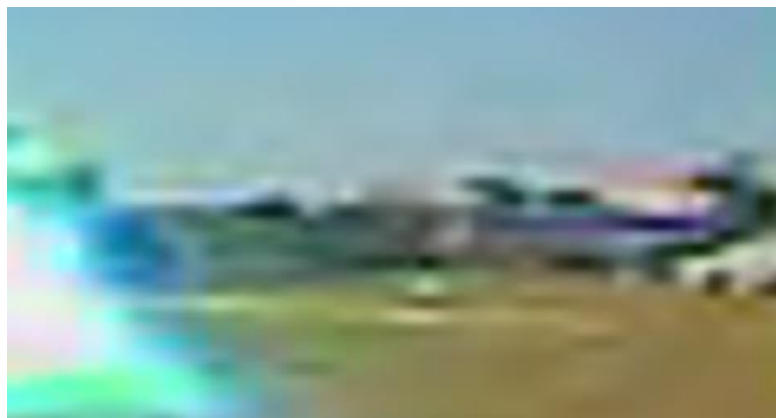
In 2006 the two security camera videos, filmed at 1 frame per second, were released under a FOIA, one of which contained the previously released 5 frames. One frame from each video captures the plane. Using a blink comparator technique the image of the plane becomes visible and it is clear that the white turbulent mass is a smoke plume.⁷ The earlier frame shows a short plume, with some recognizable edge details, and the later frame shows the same details with

Figure 16 Plane as shown in second camera, housed in the foreground post mentioned above. Note that the smoke cloud is less developed at this time.

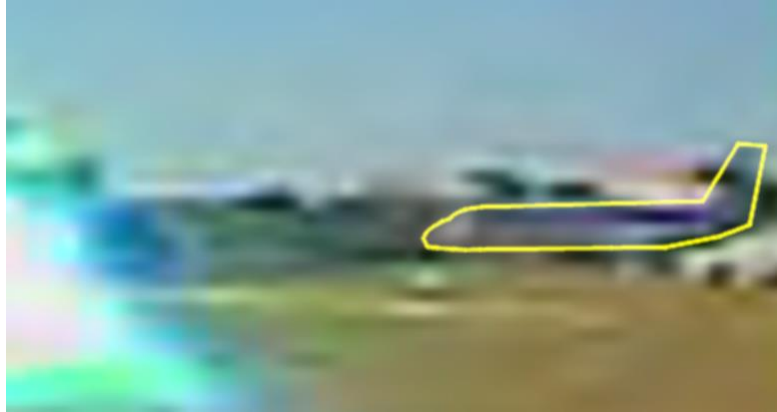
Figure 17 Plane outlined for identification purposes only.

additional length appended. The blinked images show the nose, fuselage, and tail of a large plane. Since the plane is near the edge of a wide angle photograph it appears compressed due to barrel distortion. When the barrel distortion is algorithmically removed, the plane image is substantially lengthened. Under these conditions the plane closely resembles a 757 with smoke billowing out of the right engine, on the far side of the plane as seen by the cameras. (These improved results are possible because they utilize images from the original FOIA release, not images degraded by YouTube compression.)
