Rebuttal to 'Identification of The Plane Model That Impacted the Pentagon'

Wayne Coste, PE

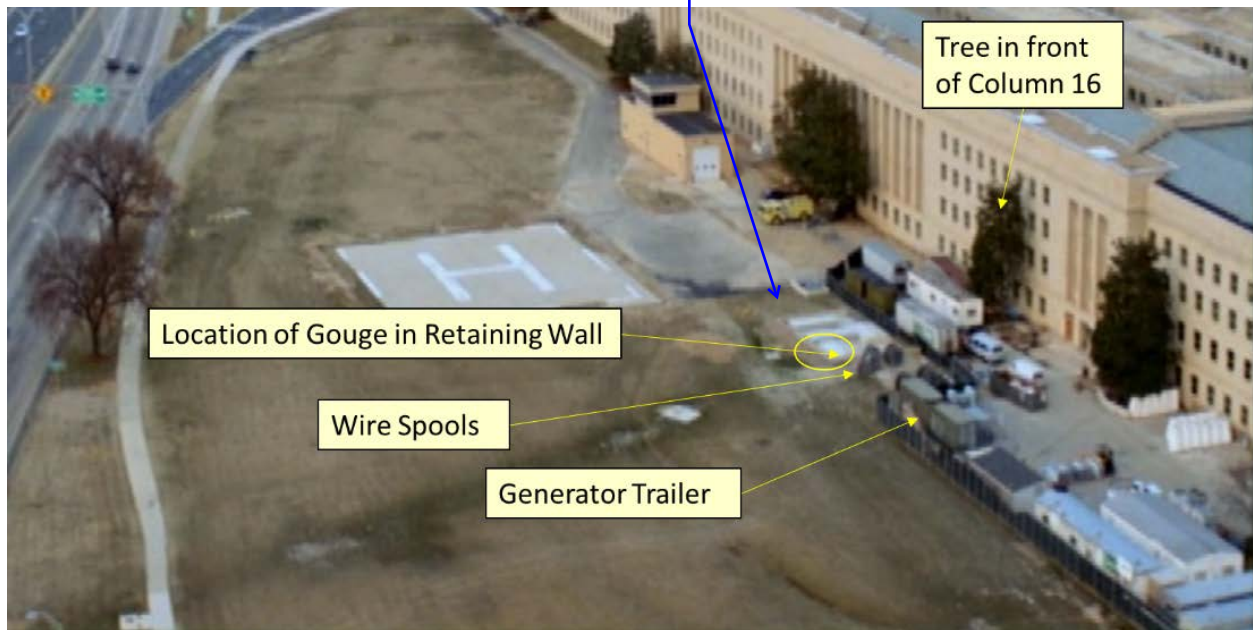
Figure 5: Overview of the west side of the Pentagon.

Figure 5 provides an overview of the west side of the Pentagon before 9/11 [3]. This image shows the location of the generator trailer, other adjacent structures, the wire spools, the gouged retaining wall, and the Pentagon facade. While soot can be seen discoloring the center of the trailer roof, there is no hint of the Flap Track Fairing trace in this pre-event image which shows only a smooth rear cabin roof. Additionally, the cabin roof at the front of the trailer has a uniform color that matches the uniform color of the rear. This suggests a satellite image would record the roof as a single color, except for the discolored center.

Such images do not permit precise measurements. They only show the approximate position of objects. The video where this was taken from is not dated. It does not fit to the satellite image from 9/7/2001 shown in figure 10 below. This image cannot be used as reference.

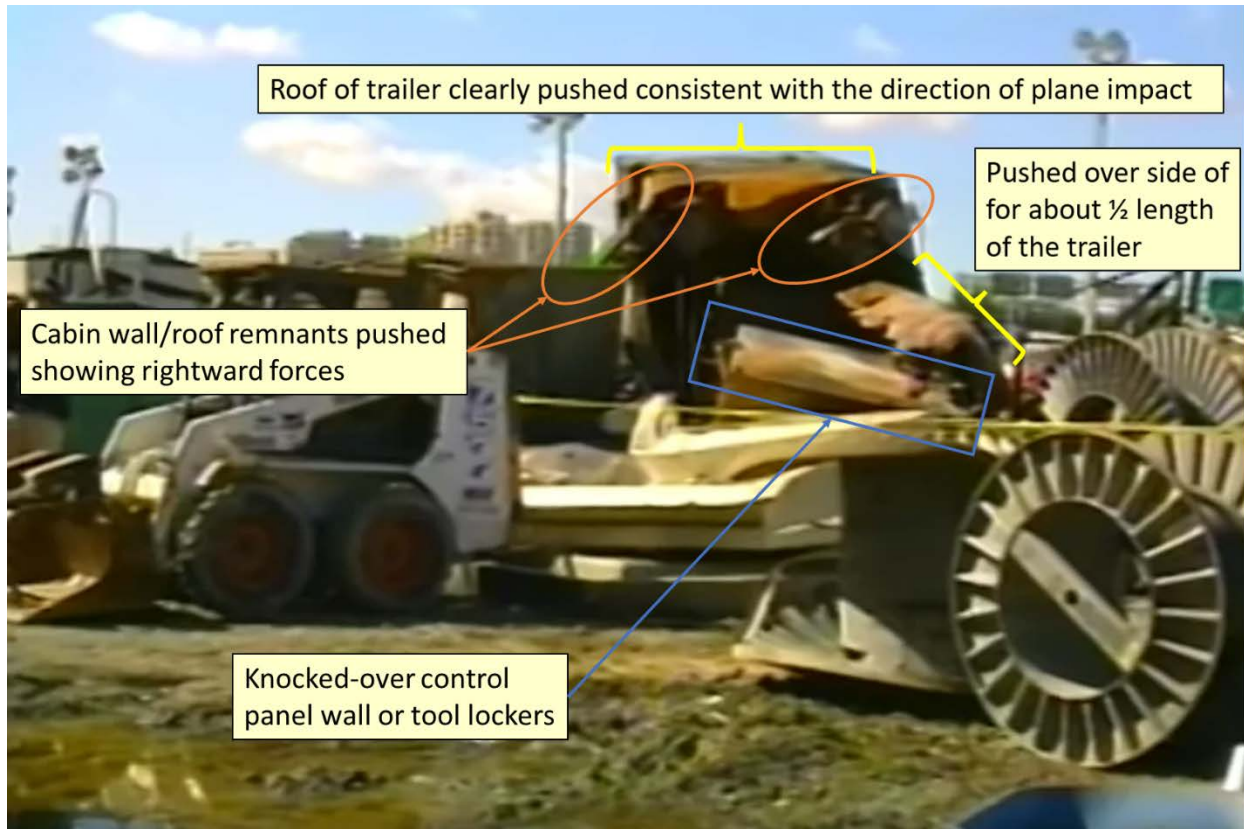
Figure 9: Interior view of the generator trailer from the front.

Figure 9 shows the interior of the front portion of the cabin from the front. The interior space shows what appears to be a large rectangular object that appears to have been a control panel, tool lockers or some other wall-mounted unit. The heavy diesel generator equipment would have been mostly over the multi-axle rear wheels giving a center of mass near the rear.

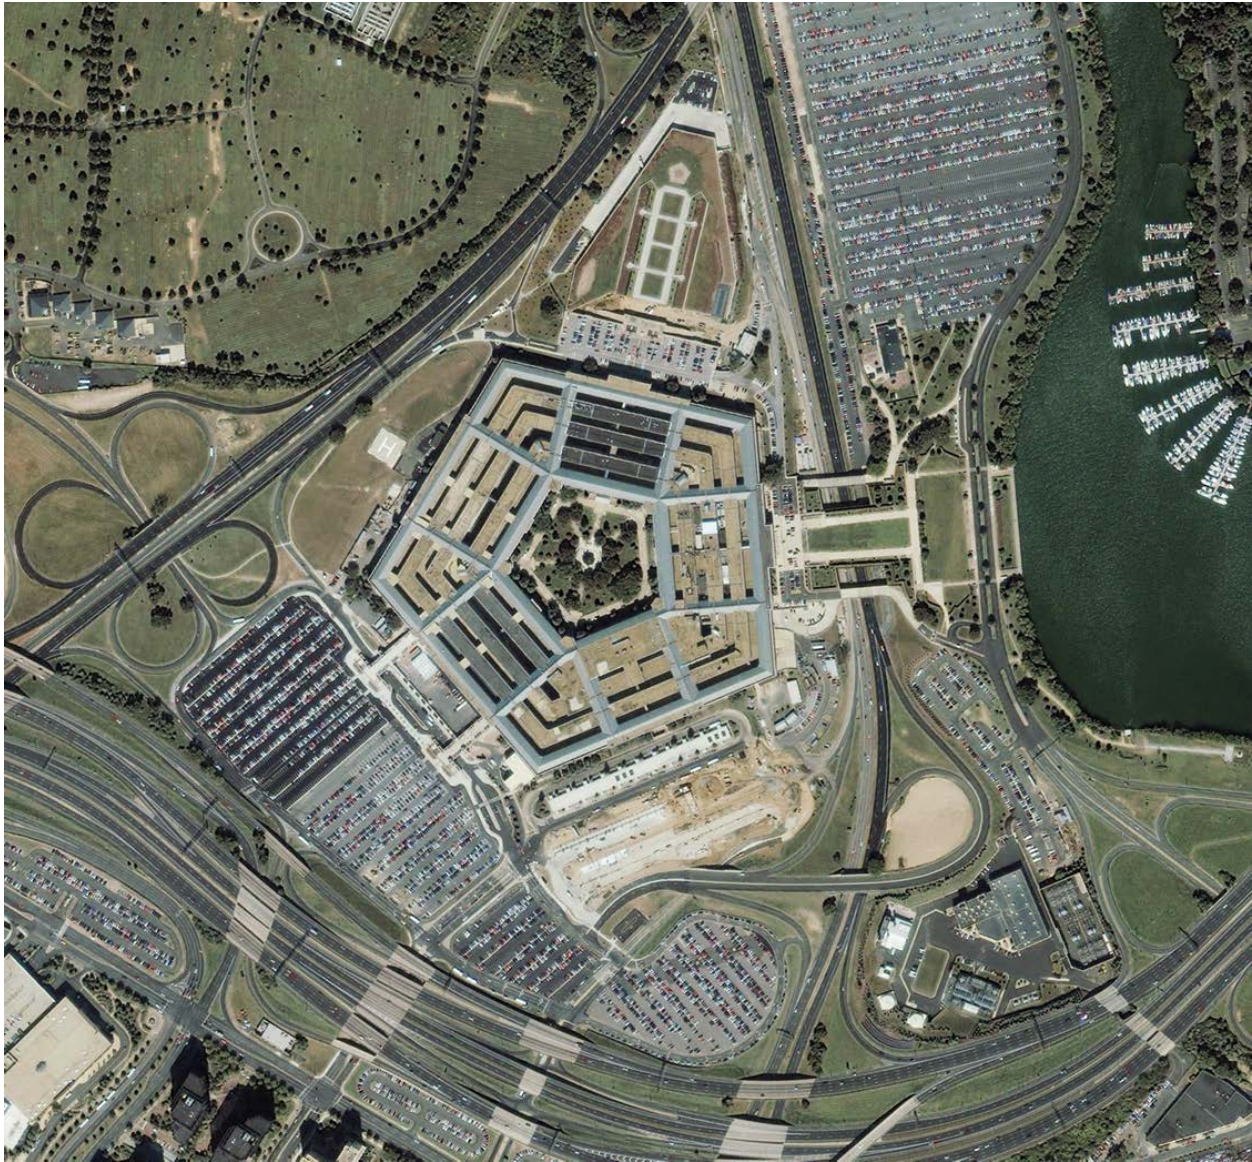
Figure 10: Satellite Image of the Pentagon from September 7, 2001 (the western direction is up and to the left). Source: https://web.archive.org/web/20050212002810/http://www.spaceimaging.com/gallery/9-11/Pentagon/Pentagon_9_7_01.jpg

Figure 10 is a satellite image of the Pentagon from September 7, 2001 and will be used to establish all relevant dimensions. Using this single image eliminates problems with parallax and other distortions affecting measurements. It is believed that a resolution of about one foot (± 1 foot) is reasonable when working with this image. This resolution is more than adequate for the analysis presented in this paper. Because of the very slight position of the satellite to the east, the edge of the visible roofline on the west represents a nearly perfect location of the column rows. The satellite's eastern location can be verified by the visibility of the "whiteish" wall on the west side of the interior courtyard and shadows cast around the heliport firehouse.

The shadow and the satellite position are independent.

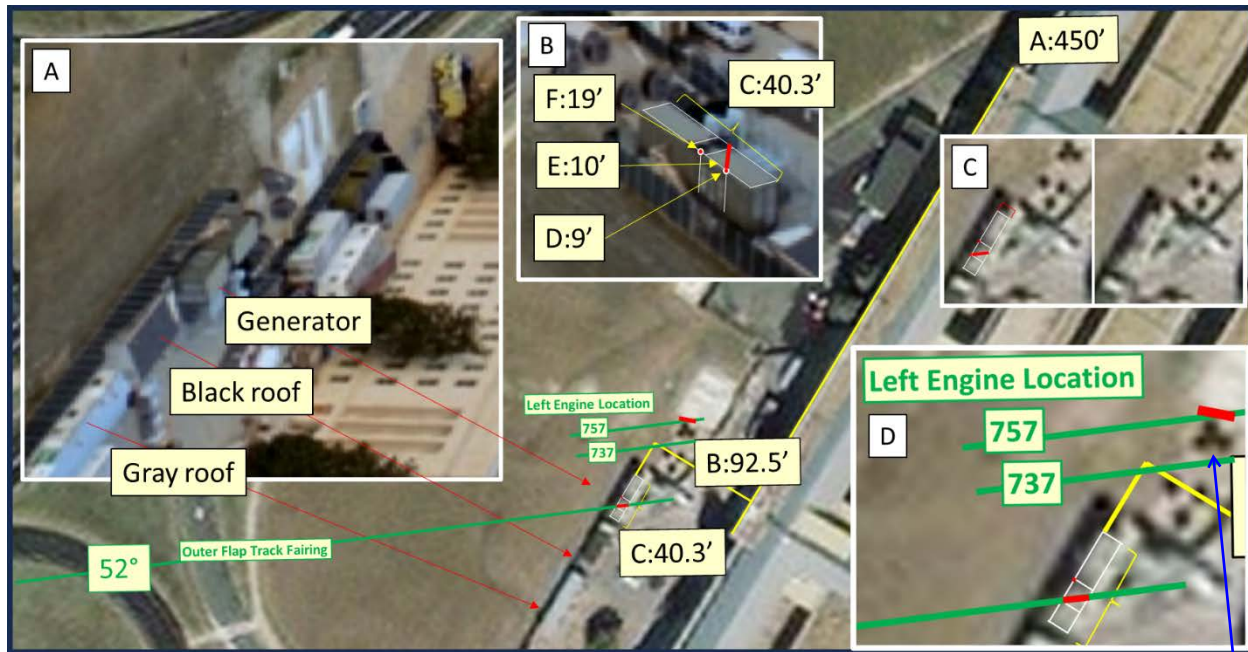
Figure 11: Zoom-in of satellite image taken September 7, 2001 with insets to provide additional context and detail.

Figure 11 shows the relevant section of the satellite image along with dimensions and other information. The first inset, “A,” shows a rotated version of Figure 5 which identifies the generator trailer and two other adjacent buildings. The second inset, “B,” shows a detail of the generator trailer with dimensions that can be estimated once its length has been determined from the satellite image. The area between the white lines topped with red dots locate the side air intake vents. The third inset, “C,” shows the trailer with and without outlines. The outline of the trailer is bounded by the consistent light color of the roof with the only deviation being the area in the center that was discolored by diesel soot. While the soot can be seen discoloring the center of the trailer roof, there is no hint of the trace in this image. The fourth inset, “D,” provides a larger view of the trailer in the satellite image.

Because photographs showing the front of the trailer before the event do not have sufficient granularity to gauge the size of the gap between the front of the trailer and fence along the front accurately, a five-foot extension of the trailer will be presented as a sensitivity in Appendix “A” for completeness. This extension is shown as a red outline in inset “C.”

The basis of all measurements is the length of the bay of the facade which is labeled as 450 feet.

The image shows six key dimensions plus some additional annotations using green lines and green text.

- A. Length of window bay. This is 450 feet long and provides the primary basis for all dimensions
- B. Distance from facade to the far side of generator trailer is about 92.5 feet
- C. Length of generator trailer is about 40.3 feet
- D. Distance from back of the generator trailer to the beginning of the first vent is about 9 feet
- E. Distance from back of the generator trailer to the Flap Track Fairing scar is about 10 feet
- F. Distance from back of the generator trailer to the end of the third vent is about 19 feet

The spools before the impact are best visible here.

The green lines are important because they establish the location of the outer Flap Track Fairing that impacted at 52 degrees as well as the location of the opposite engine in relation to it. The location of the opposite engine is shown by two short parallel green lines. These two additional green lines are associated with either a 757-200 or a 737-400. The green line identified as the "737" is separated from the fairing trace by 46.1 feet while the green line identified by the "757" is separated by 63.1 feet. The "757" line intersects with a red line segment that locates a gouge in the retaining wall that has been associated with the impact of an aircraft's left engine.

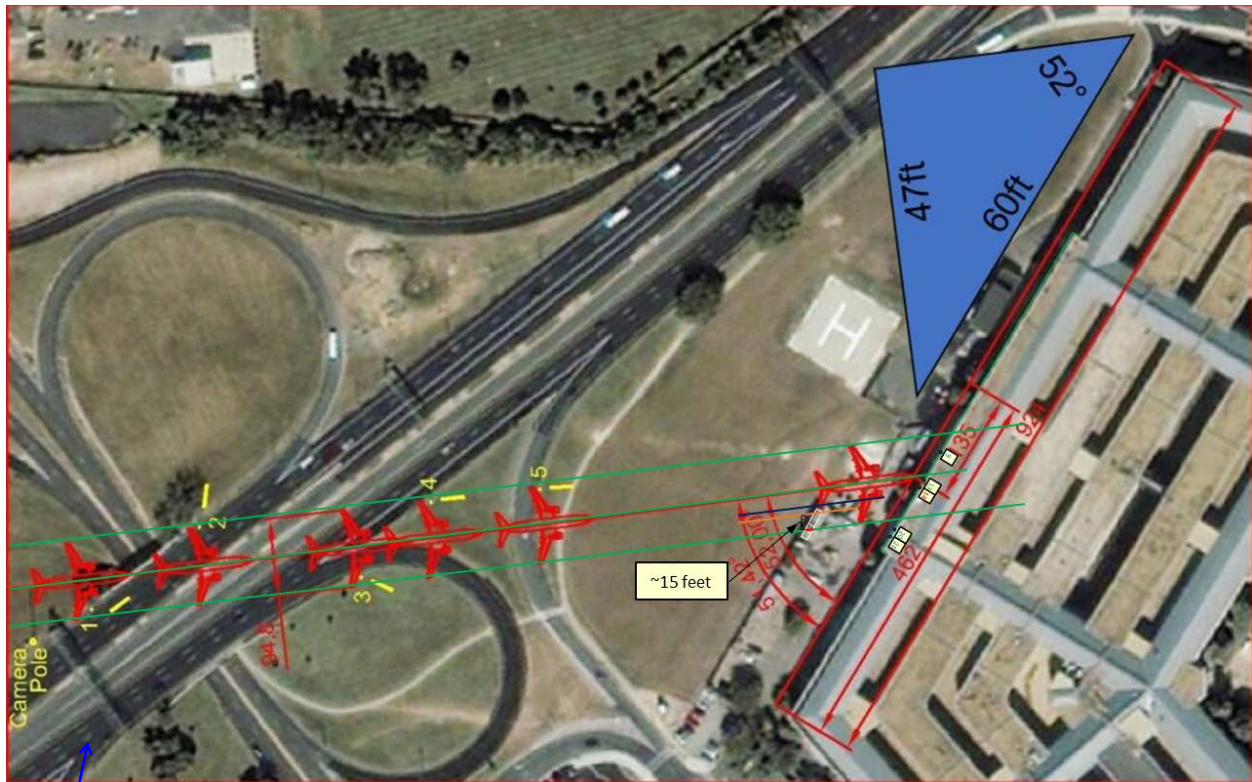
Figure 16: Annotated version of Inan's Figure MI-9.

Figure 16 is an annotated version of Inan's Figure MI-9. The column locations that are added are based on actual scale drawing of the wall extracted from the Arlington Fire Department's After-Action Report [7]. Five columns of interest are marked (columns 9, 13, 14, 20 and 21) and their size is approximately shown to scale. Inan's Figures MI-16 and MI-17 rely on the sizes of the column shown in the ASCE Pentagon Performance report that are shown $3\frac{1}{2}$ times larger than actual size for the purpose of color-coding amounts of damage sustained by the columns. The uncolored columns in Figure MI-11 shows the actual column sizes (e.g., see the little squares in column row 5).

Inan shows the 737-400 approaching along a straight path constrained by the need to impact all five light poles. With this axial alignment, the nose impacts the Pentagon façade to the left of columns 13 (e.g., between columns 12 and 13). The plane's dimensions are verified to be consistent with a Boeing 737-400 having a wingspan of about 94 feet. However, the right-wing tip cannot reach column 20 and the right engine does not clip the corner of the diesel generator trailer. Given the approaching aircraft is at an altitude allowing the Flap Track Fairing to create the trace through the roof of the trailer, the engine, which hangs about 6 feet below the wing, could not impact the generator trailer unless it were shifted 10 or more feet to the right. However, if the 737 is shifted to the right, then the light poles #2, #4 and #5 could not all be hit solidly enough to sever the light poles, as was observed.

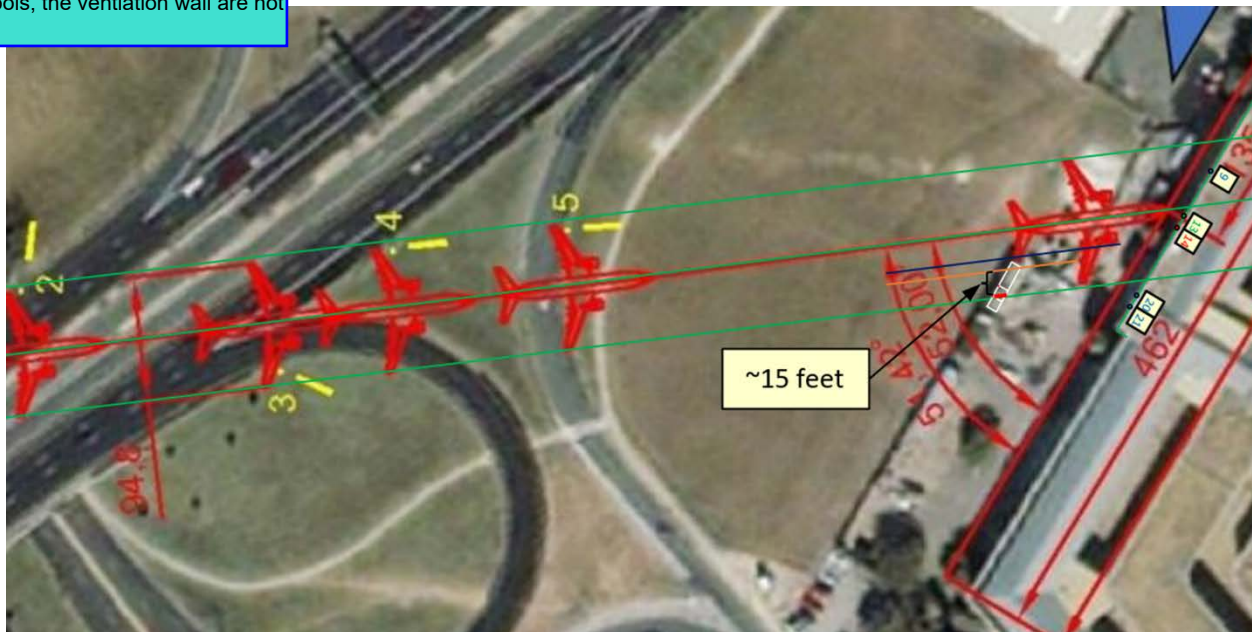
Figure 17: Locating the Flap Track Fairing trace on the satellite photo.

Figure 17 zooms into this image to focus on establishing the location of the Flap Track Fairing trace on the trailer in the satellite image. The green lines provide a wingtip-to-wingtip envelope of the

The orange line shows the location of the outer Flap Track Fairing and the short outside limit of the right engine. The thick red line on the roofline of the generator or intake vent panel shows the location of the observed trace.

This image was updated with better precision. All these comments are not more valid.

Also, the most precise measurement is the right side damage on the Pentagon facade. The generator, the spools, the ventilation wall are not precise enough.

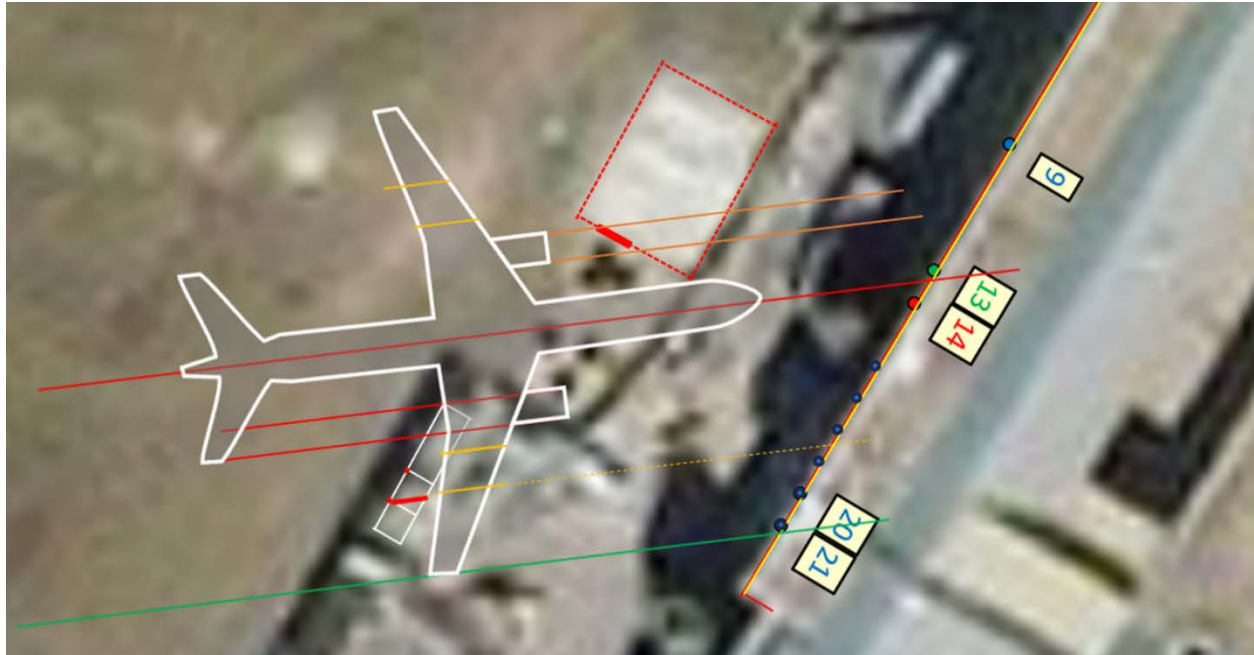
Figure 19: Boeing 757-200 shows alignment with Flap Track Fairing.

As shown in Figure 19, a Boeing 757-200 traveling along approximately the same axial path as hypothesized in Figure MI-9 almost fits the observations perfectly. With an axial alignment toward the right of column 13, the outer Flap Track Fairing aligns with the trace in the generator trailer roof. The right engine impacts the trailer at approximately the middle of the front half of the trailer where the 'bullseye' records an impact. Additionally, without considering any yaw rotation, the outer right wingtip would impact column 21. Wire spool 7 would be impacted while wire spools 6 and 5 would be underneath the left wing between the fuselage and engine. The left engine is perfectly aligned to impact, and gouge, the retaining wall section which is shown in red. While more detailed explanations about the 757 Impact can be seen at 911Speakout.org [8], the measurements in this analysis are more precise.

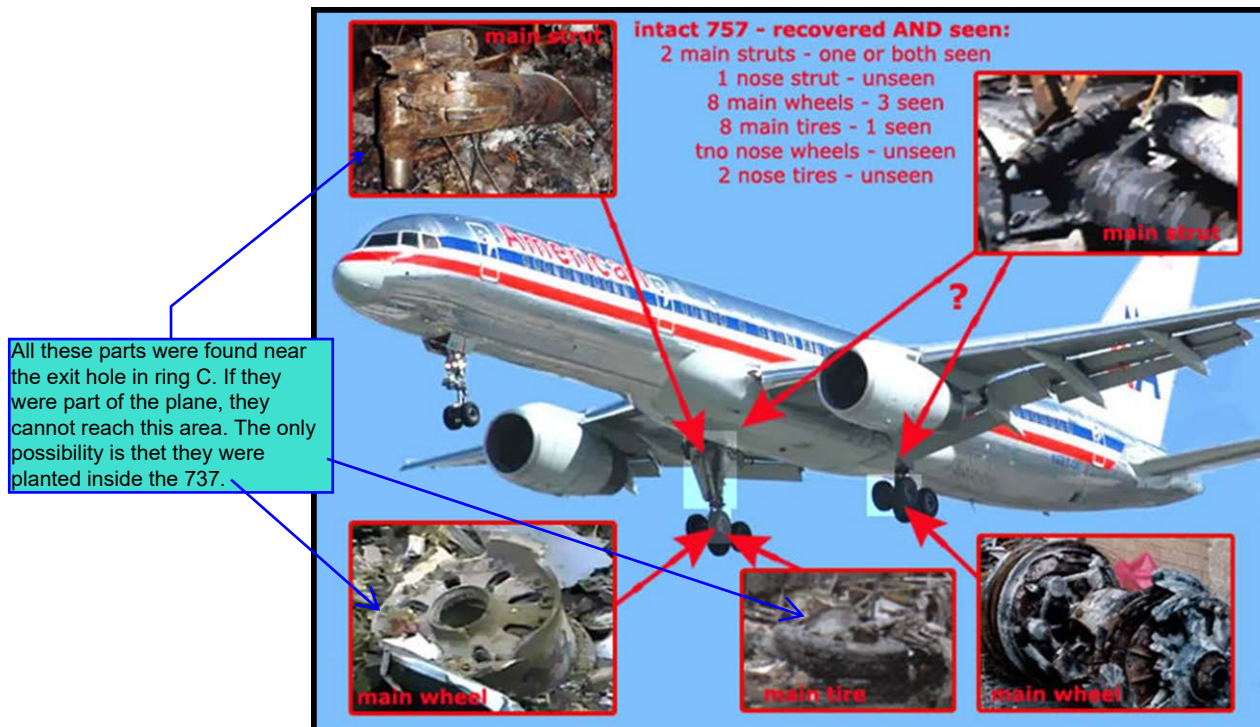
Figure 22: Infographic showing some of the Boeing 757 debris.

Figure 22 is an infographic showing some Boeing 757 parts that were observed in the debris. Figure 23 shows the unique rims that were used by the Boeing 757 and photographed outside the C-Ring exit hole immediately afterwards. Figure 24 shows the wheelsets of a Boeing 737-400. Boeing 737s do not have doors covering the main landing gear doors during flight. The wheels become flush with the fuselage when retracted and, consequently, they have streamlined covers on one side of the wheelset. To lighten the wheels of aircraft, the interiors are not solid but have cut-outs of various sizes to create “spokes.” The inner wheel rims of the 737 have cut-aways that are more wedge-shaped than the 757 which are smaller and more tear-shaped.

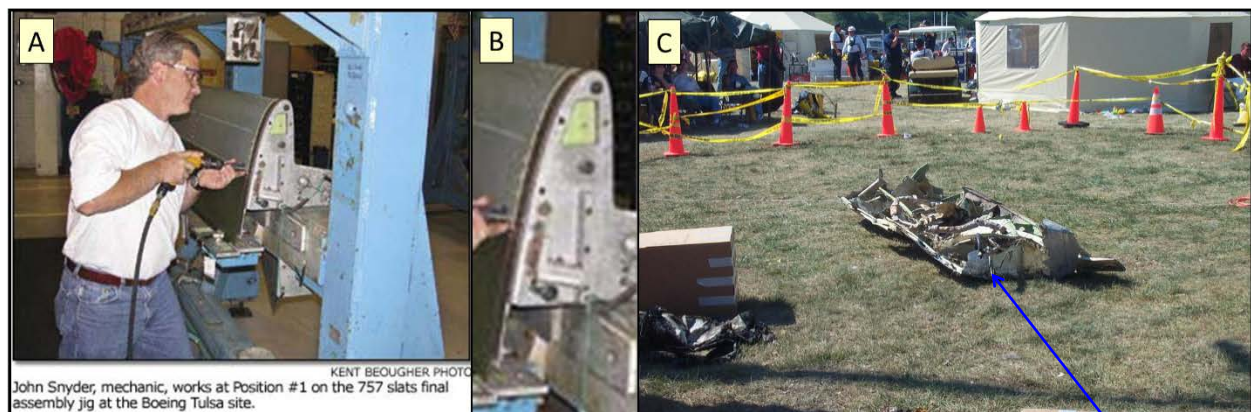
Figure 25: Leading wing slat of a Boeing 757.

Finally, Figure 25 shows a leading wing slat for a Boeing 757 that was recovered and is compared to a similar slat in a machine shop. More documentation about 757 debris can be seen at 911Speakout.org [9].

This is a planted debris of 757. On 9/11/2001 day, the lawn was immediately cleaned up. Do not expect to let such huge debris on the lawn days or weeks after the events.

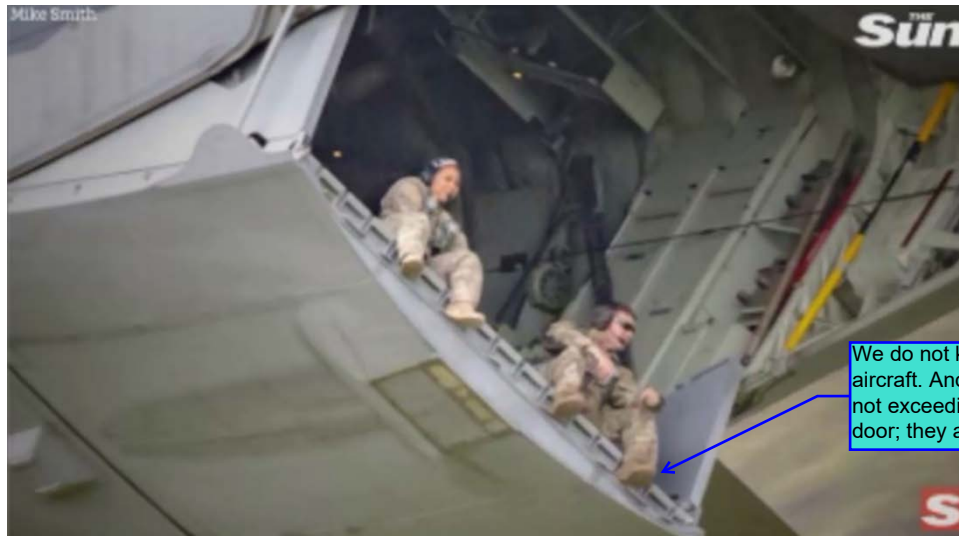
Figure 27: Trailing air mass has a velocity approximately equal to the plane's forward velocity.

Regarding Inan’s comment about the devastation of over-pressurization “destroying the roll-up door in ring C and windows between columns 4 and 8 in ring E,” it is clear in this comment Inan neglects the phenomena of a trailing air mass behind an aircraft. The reality of a trailing air mass is observed in Figure 27. This image is from a video of a C-130 which shows crew members sitting in an area where the winds from the trailing air mass are approximately equal to the forward speed of the aircraft.

The trailing air mass cannot reach the second floor in ring C.

In my text, these refers to the first floor, not in the second floor.

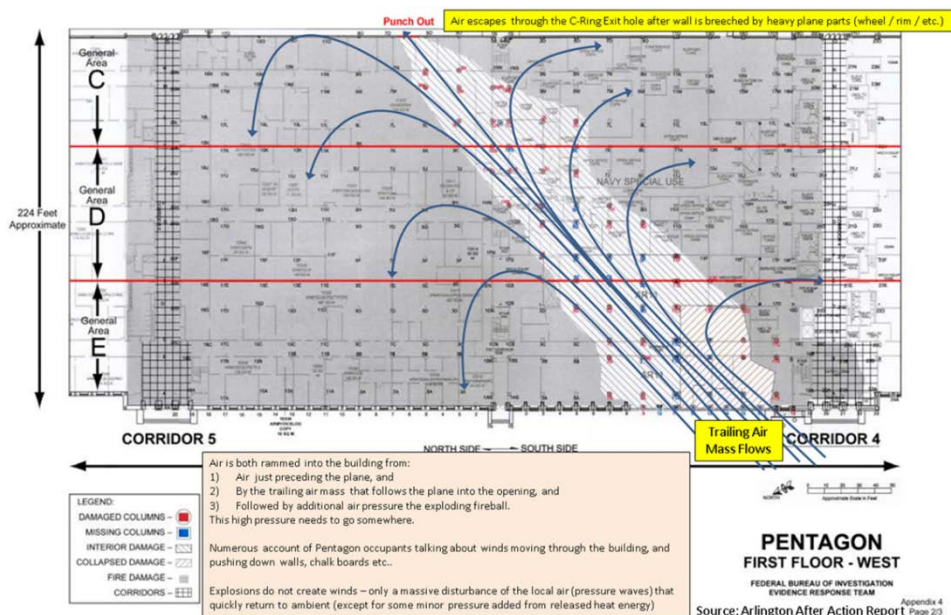
Figure 28: Sudden insertion of a large volume followed by a trailing air mass will create the observed winds [11].

A trailing air mass would have attempted to follow the aircraft into the Pentagon. However, the trailing air mass would “pile-up” and create an over pressurization inside the Pentagon as well as near the façade that would deflect the trailing air mass to the north-west while simultaneously creating a very high pressure inside the Pentagon. The sudden insertion of an air volume equal to the volume of a 757-200 would, by itself, create a significant increase in air pressure that would be observable as winds inside the Pentagon capable of slamming doors and even puffing out a large surface-area garage door. The trailing air mass would amplify and sustain this effect for a short transitory period. Figure 28 shows how this would look from an air pressure perspective. This was explained in the video, “Peer Review of Barbara Honegger's Parallels Between the WTC and Pentagon Evidence and Why It Matters[11].”
